78J ELECTRICAL SYS 50-AMP

| WINNEBAGO | | 99 M37B |
| TITLE: WIRING DIAGRAM-BODY 110V | | |

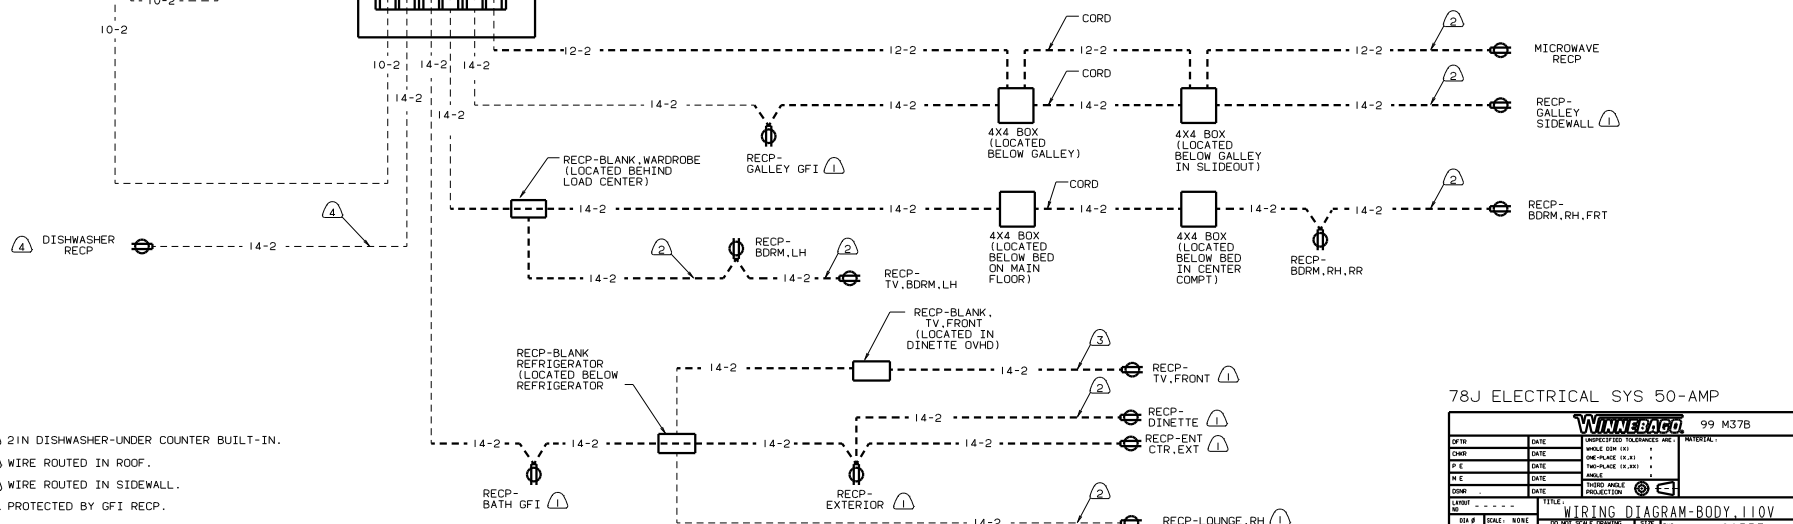
| SHEET 1 OF 2 | | 128553 |

CENTRAL AIR UNIT (LOCATED IN RIGHT REAR COMPARTMENT BELOW FLOOR)

- ④ 2IN DISHWASHER-UNDER COUNTER BUILT-IN.
- ③ WIRE ROUTED IN ROOF.
- ② WIRE ROUTED IN SIDEWALL.
- ① PROTECTED BY GFI RECP.
