02 P36L/LD/G/CD

TITLE		WIRING INSL-CHASSIS	
DO NOT SCALE DRAWING	REV	NO	137991
SHEET 2	OF 2	IF NO

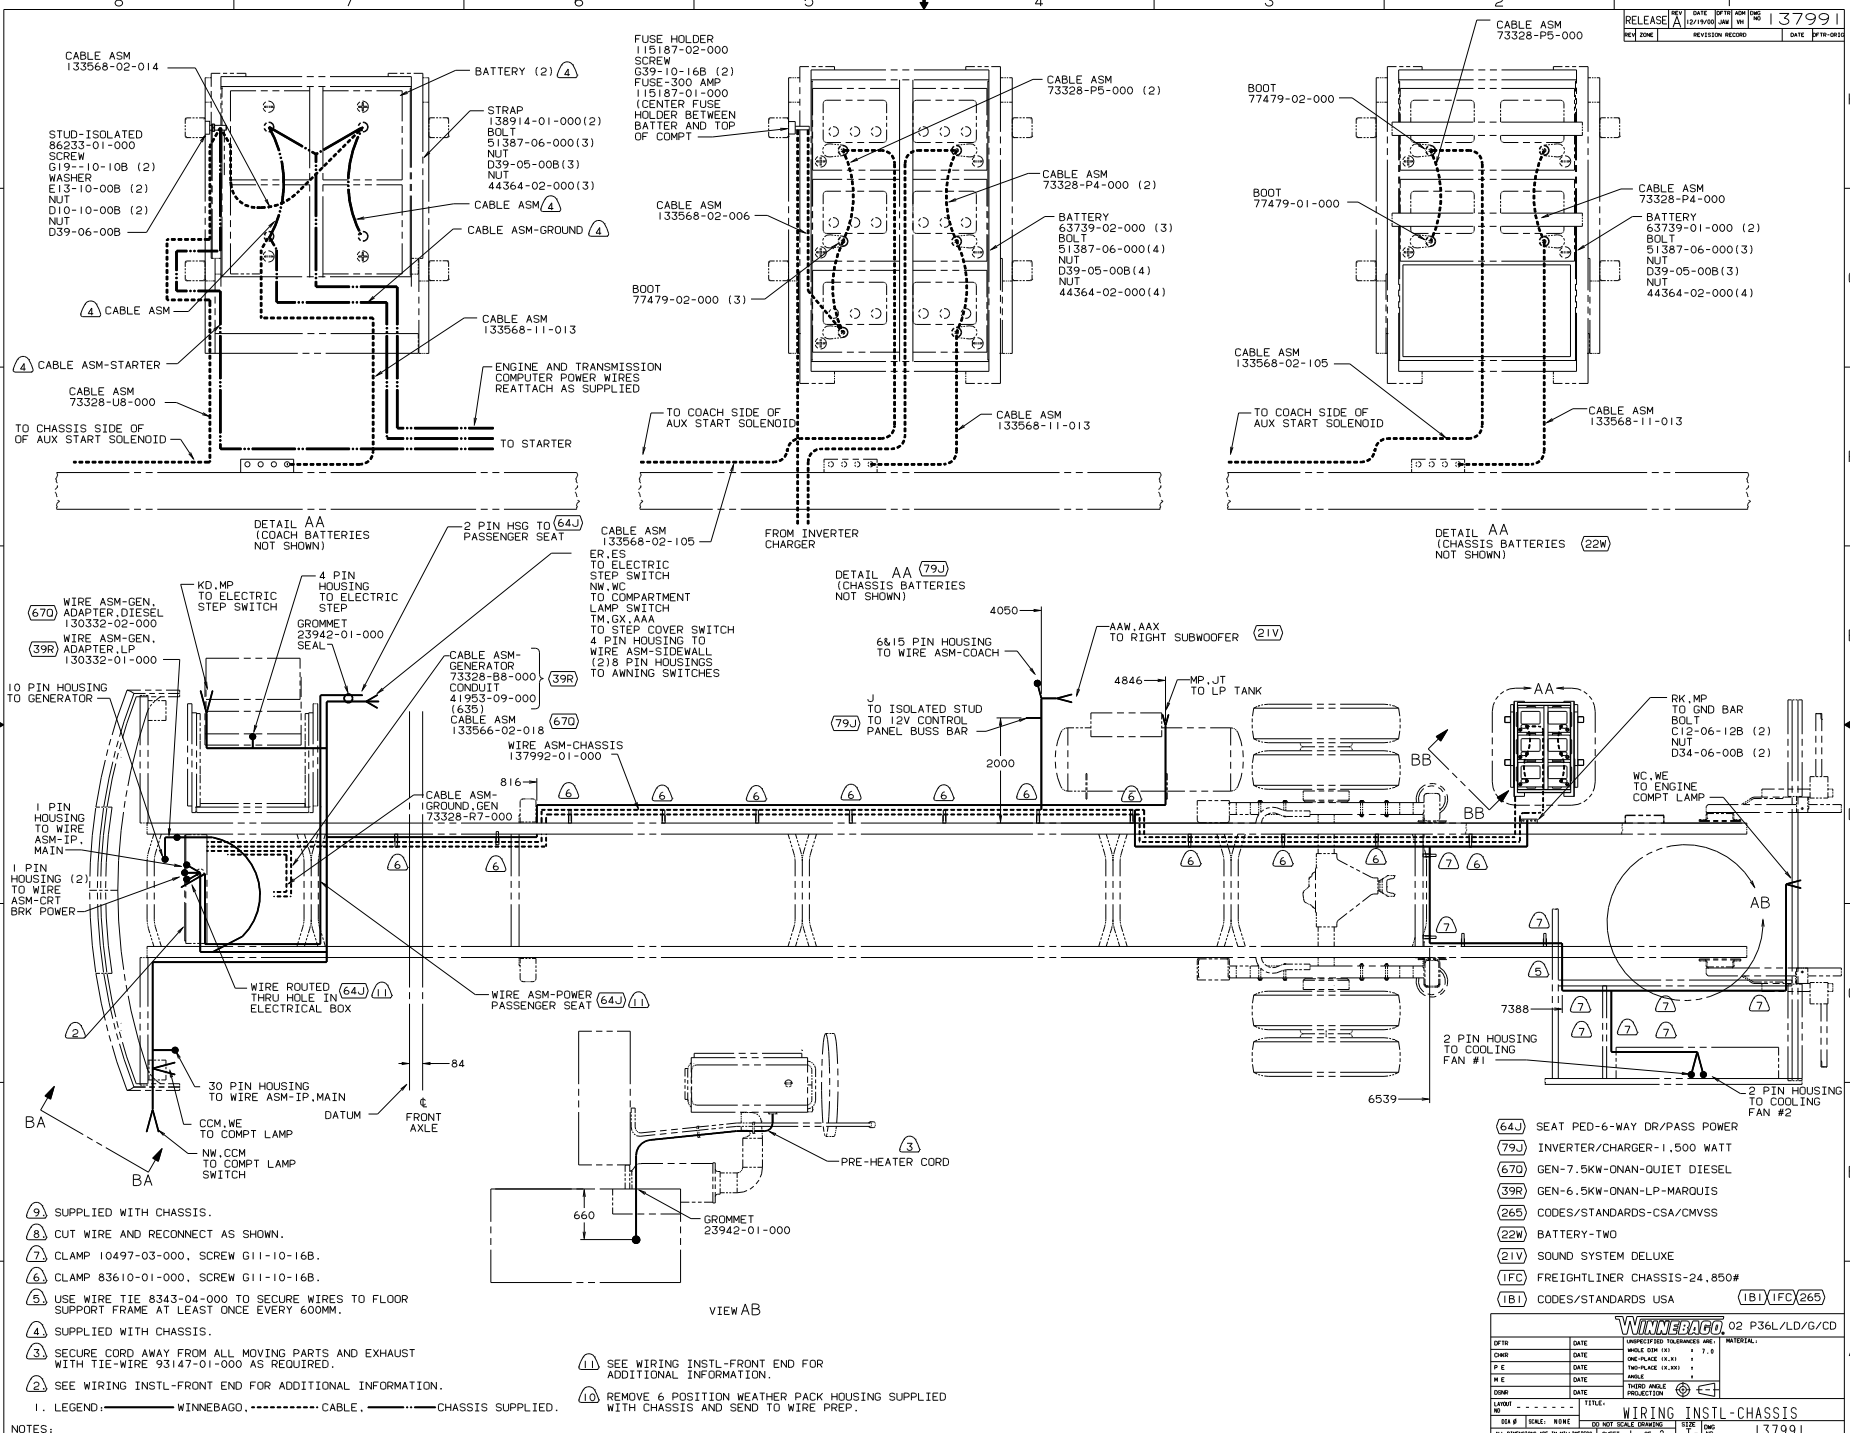
- (19D) SLIDEOUT ROOM REAR LEFTHAND
- (79J) INVERTER/CHARGER-1,500 WATT BATTERY-TWO
- (22J) BATTERY-TWO

(A) CLAMP WIRES TO TUBES WITH ENOUGH SLACK TO PULL BATTERY TRAY OUT 20 INCHES.

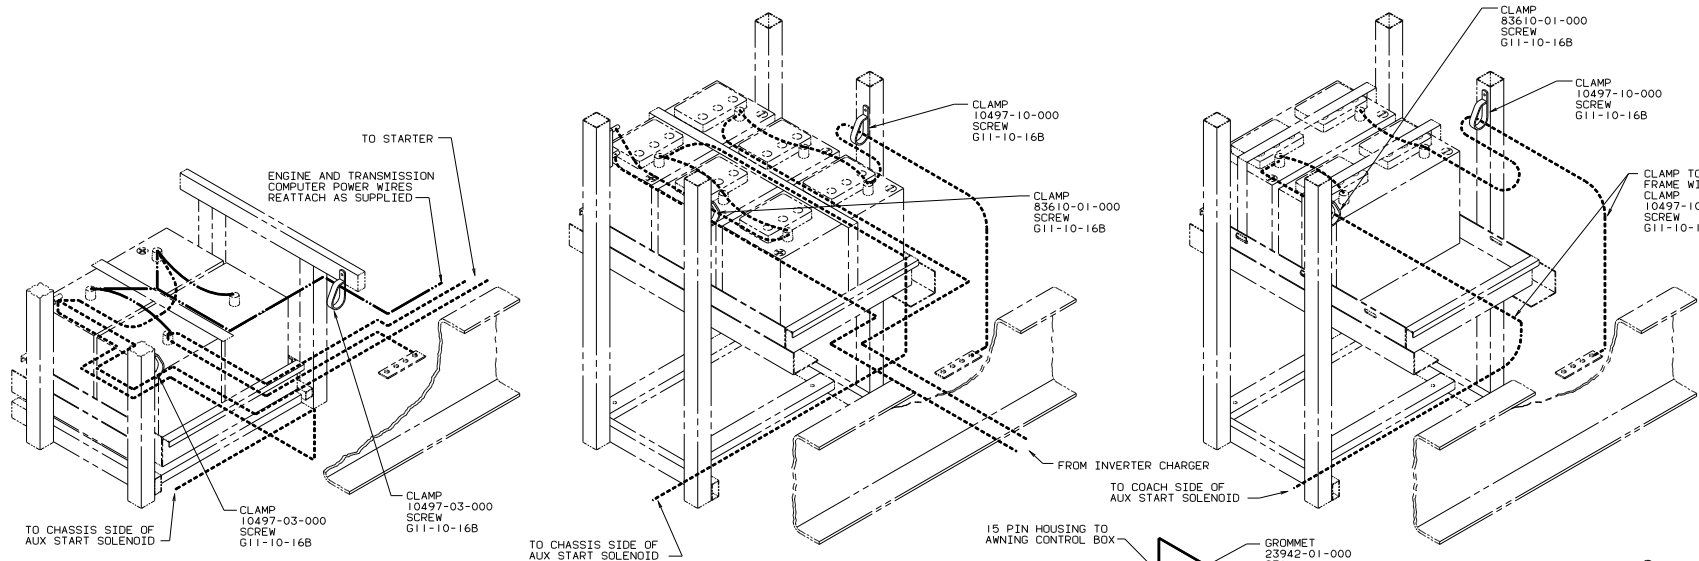
VIEW BB-BB (A)

VIEW BB-BB (79J) (A)

VIEW BB-BB (22J) (A)
