<b>WINNEBAGO</b>		COPYRIGHT 2003 WINNEBAGO INDUSTRIES, INC.	
DFTR	ORIG. DATE	ALL DIMENSIONS ARE IN MILLIMETERS	
CHKR		FIRST USED	
P.E.		04 S40KD	
M.E.		UNSPECIFIED TOLERANCES ARE:	
DSNR		MATERIAL:	
WHOLE DIM (X)		:	
ONE-PLACE (X.X)		:	
TWO-PLACE (X.XX)		:	
ANGLE		:	
THIRD ANGLE PROJECTION		:	
<b>DO NOT SCALE DRAWING</b>			
TITLE: WIRING DIAGRAM-BODY, 110V			
SHEET 1 OF 1	PART NO	147321	
REF: 145021 1 09/10/03

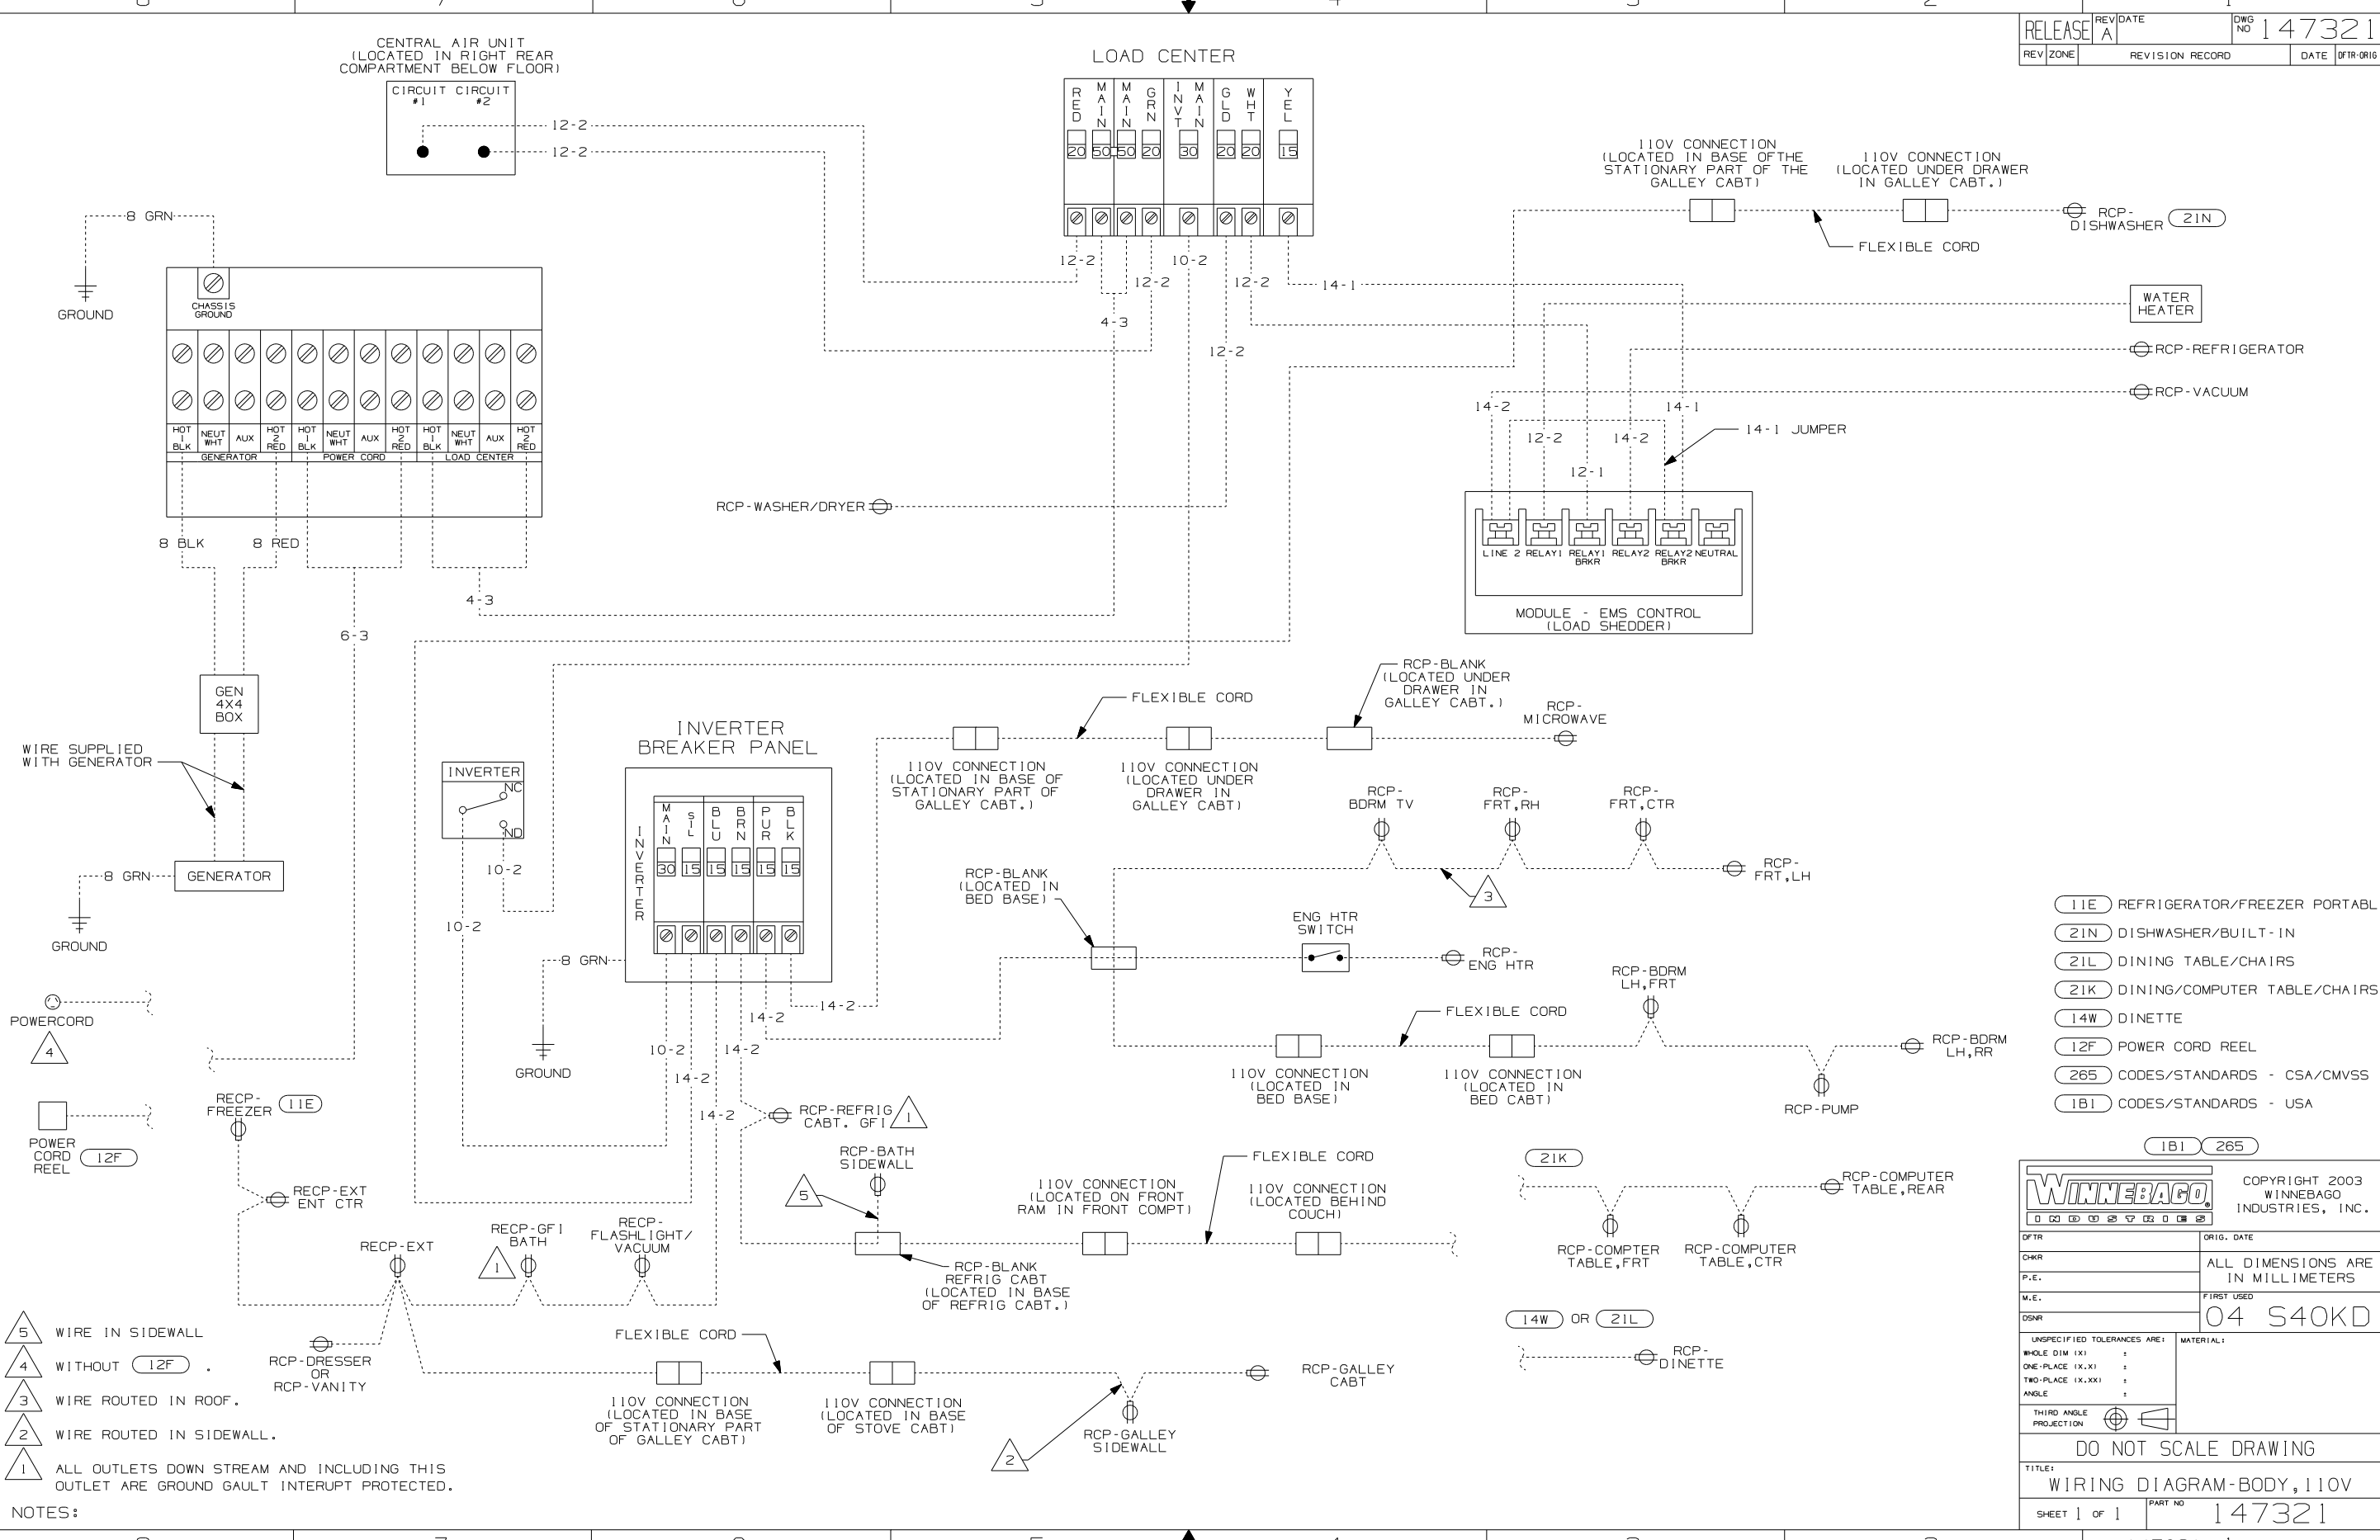
CENTRAL AIR UNIT  
(LOCATED IN RIGHT REAR  
COMPARTMENT BELOW FLOOR)

LOAD CENTER
