<b>WINNEBAGO</b>		COPYRIGHT 2004 WINNEBAGO INDUSTRIES, INC.	
DFTR	ORIG. DATE		
CHKR	ALL DIMENSIONS ARE IN MILLIMETERS		
P.E.	FIRST USED	05 329K	
M.E.			
DSNR			
UNSPECIFIED TOLERANCES ARE:		MATERIAL:	
WHOLE DIM (X)	:		
ONE-PLACE (X.X)	:		
TWO-PLACE (X.XX)	:		
ANGLE	:		
THIRD ANGLE PROJECTION		DO NOT SCALE DRAWING	
TITLE: WIRING DIAGRAM-BODY, 110V			
SHEET 1 OF 1	PART NO	150399

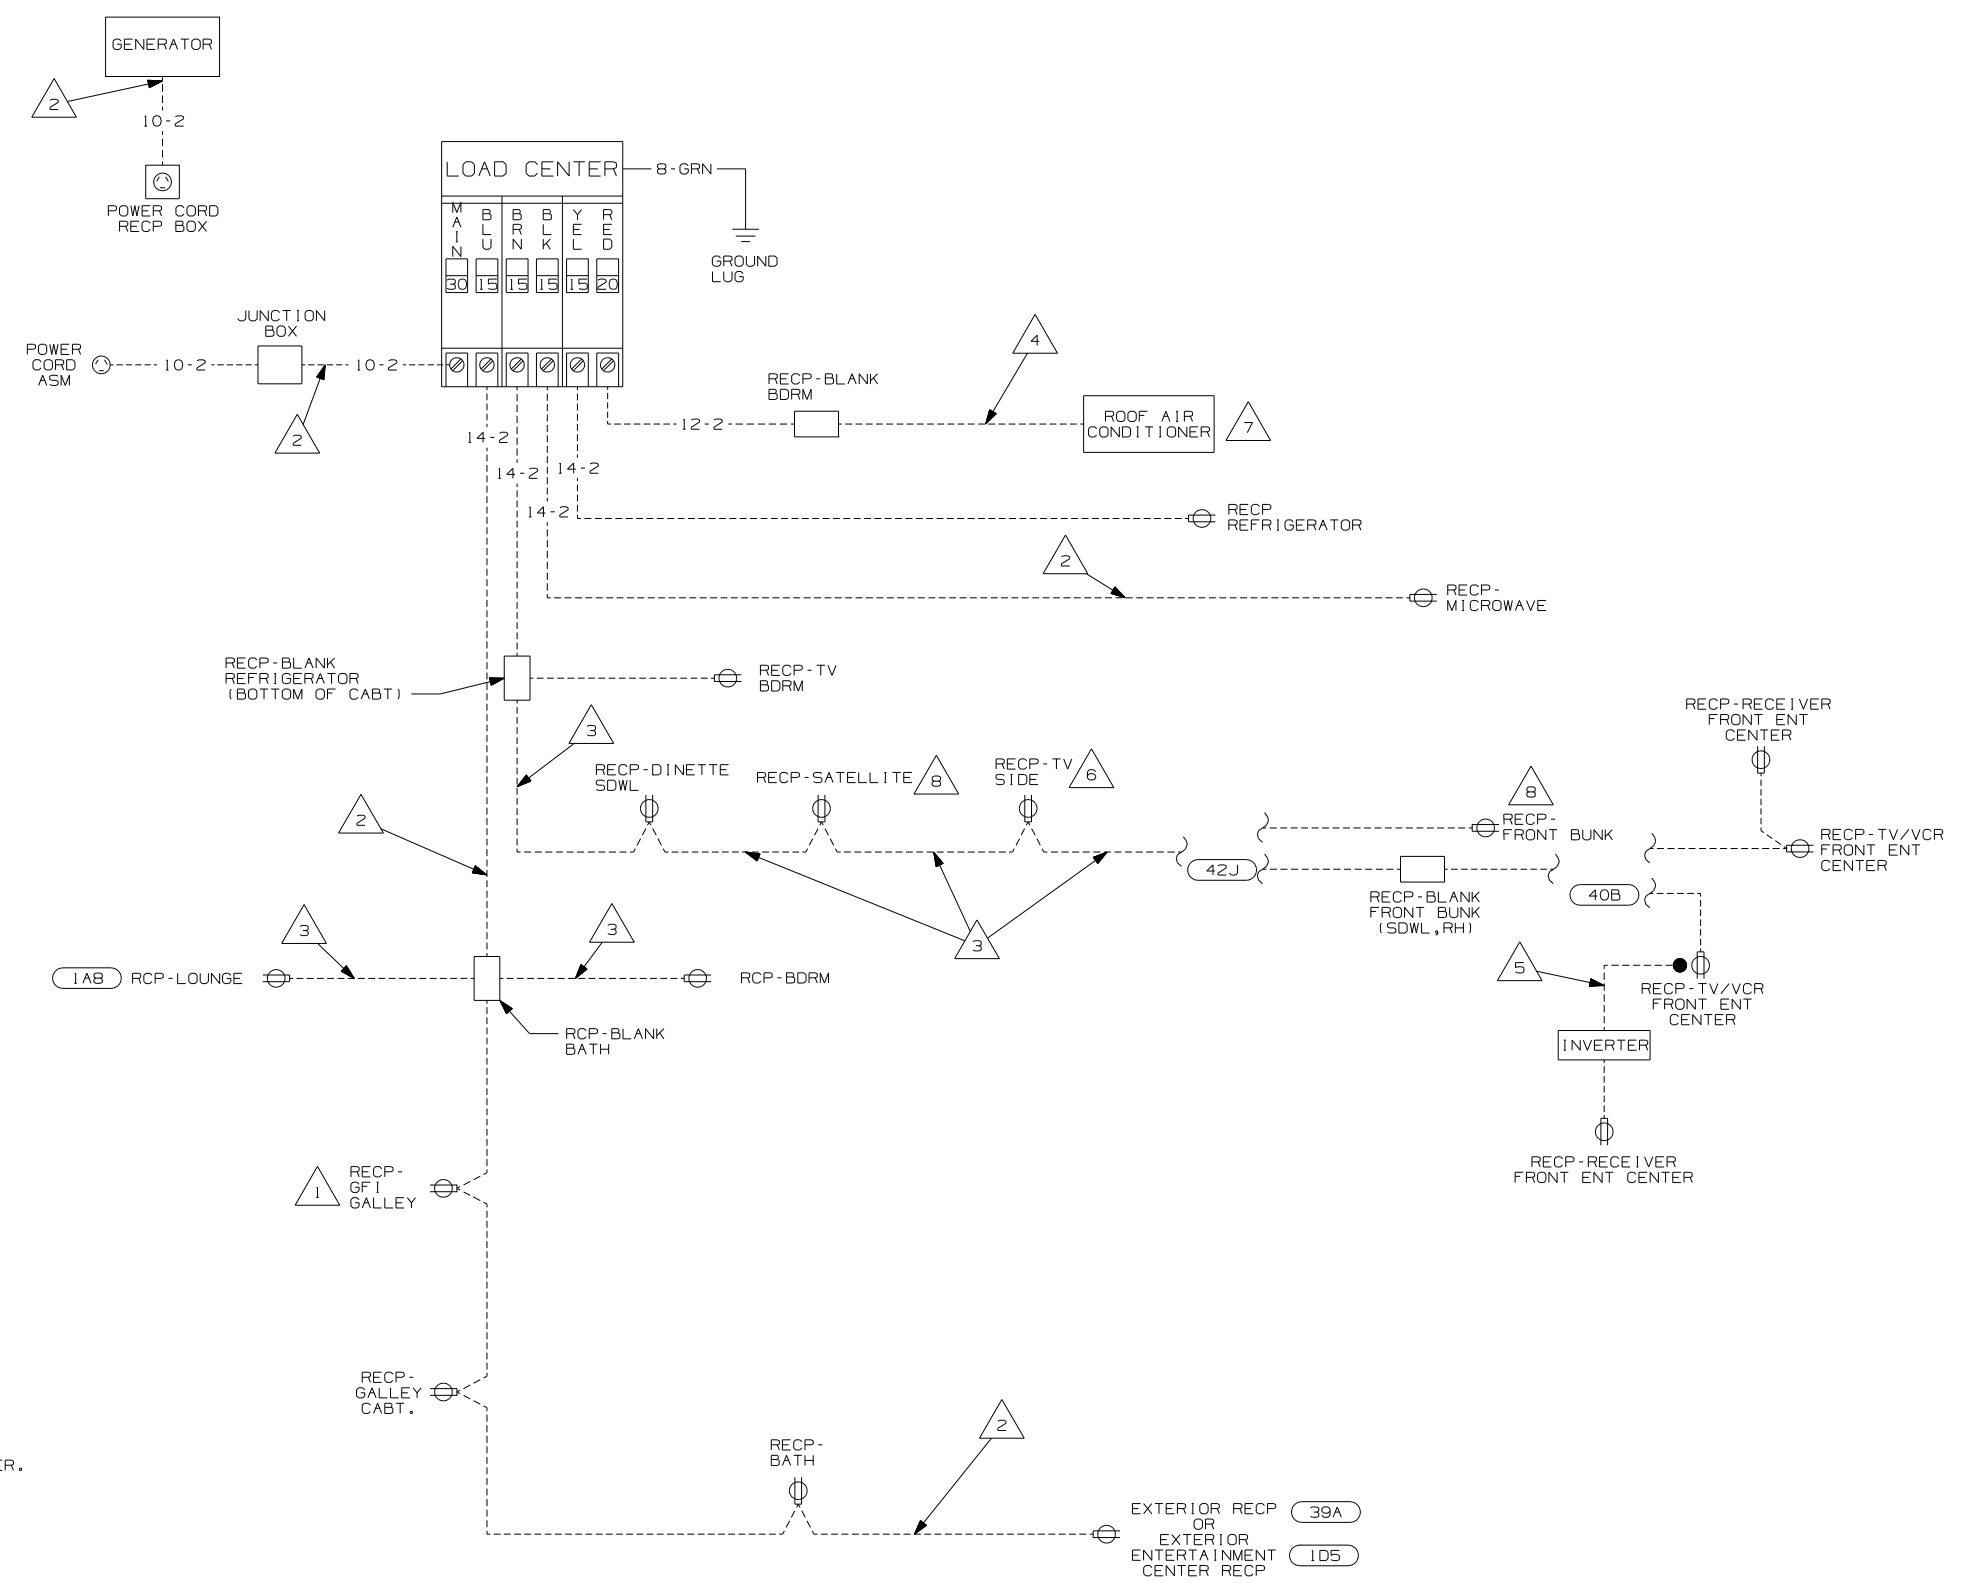
- 8 NOT USED WITH 42J
- 7 SEE MANUFACTURERS DIAGRAM.
- 6 NOT USED WITH 42J OR 1JR .
- 5 POWER CORD SUPPLIED WITH INVERTER.
- 4 WIRE ROUTED IN ROOF.
- 3 WIRE ROUTED IN SIDEWALL.
- 2 WIRE ROUTED THRU FLOOR.
- 1 ALL WIRES DOWN STREAM AND INCLUDING THIS OUTLET ARE GROUND FAULT CIRCUIT INTERRUPT PROTECTED.
