WINNEBAGO COPYRIGHT 2004 WINNEBAGO INDUSTRIES, INC.

TITLE: WIRING DIAGRAM-BODY, 110V

SHEET 1 of 1 PART NO 153052

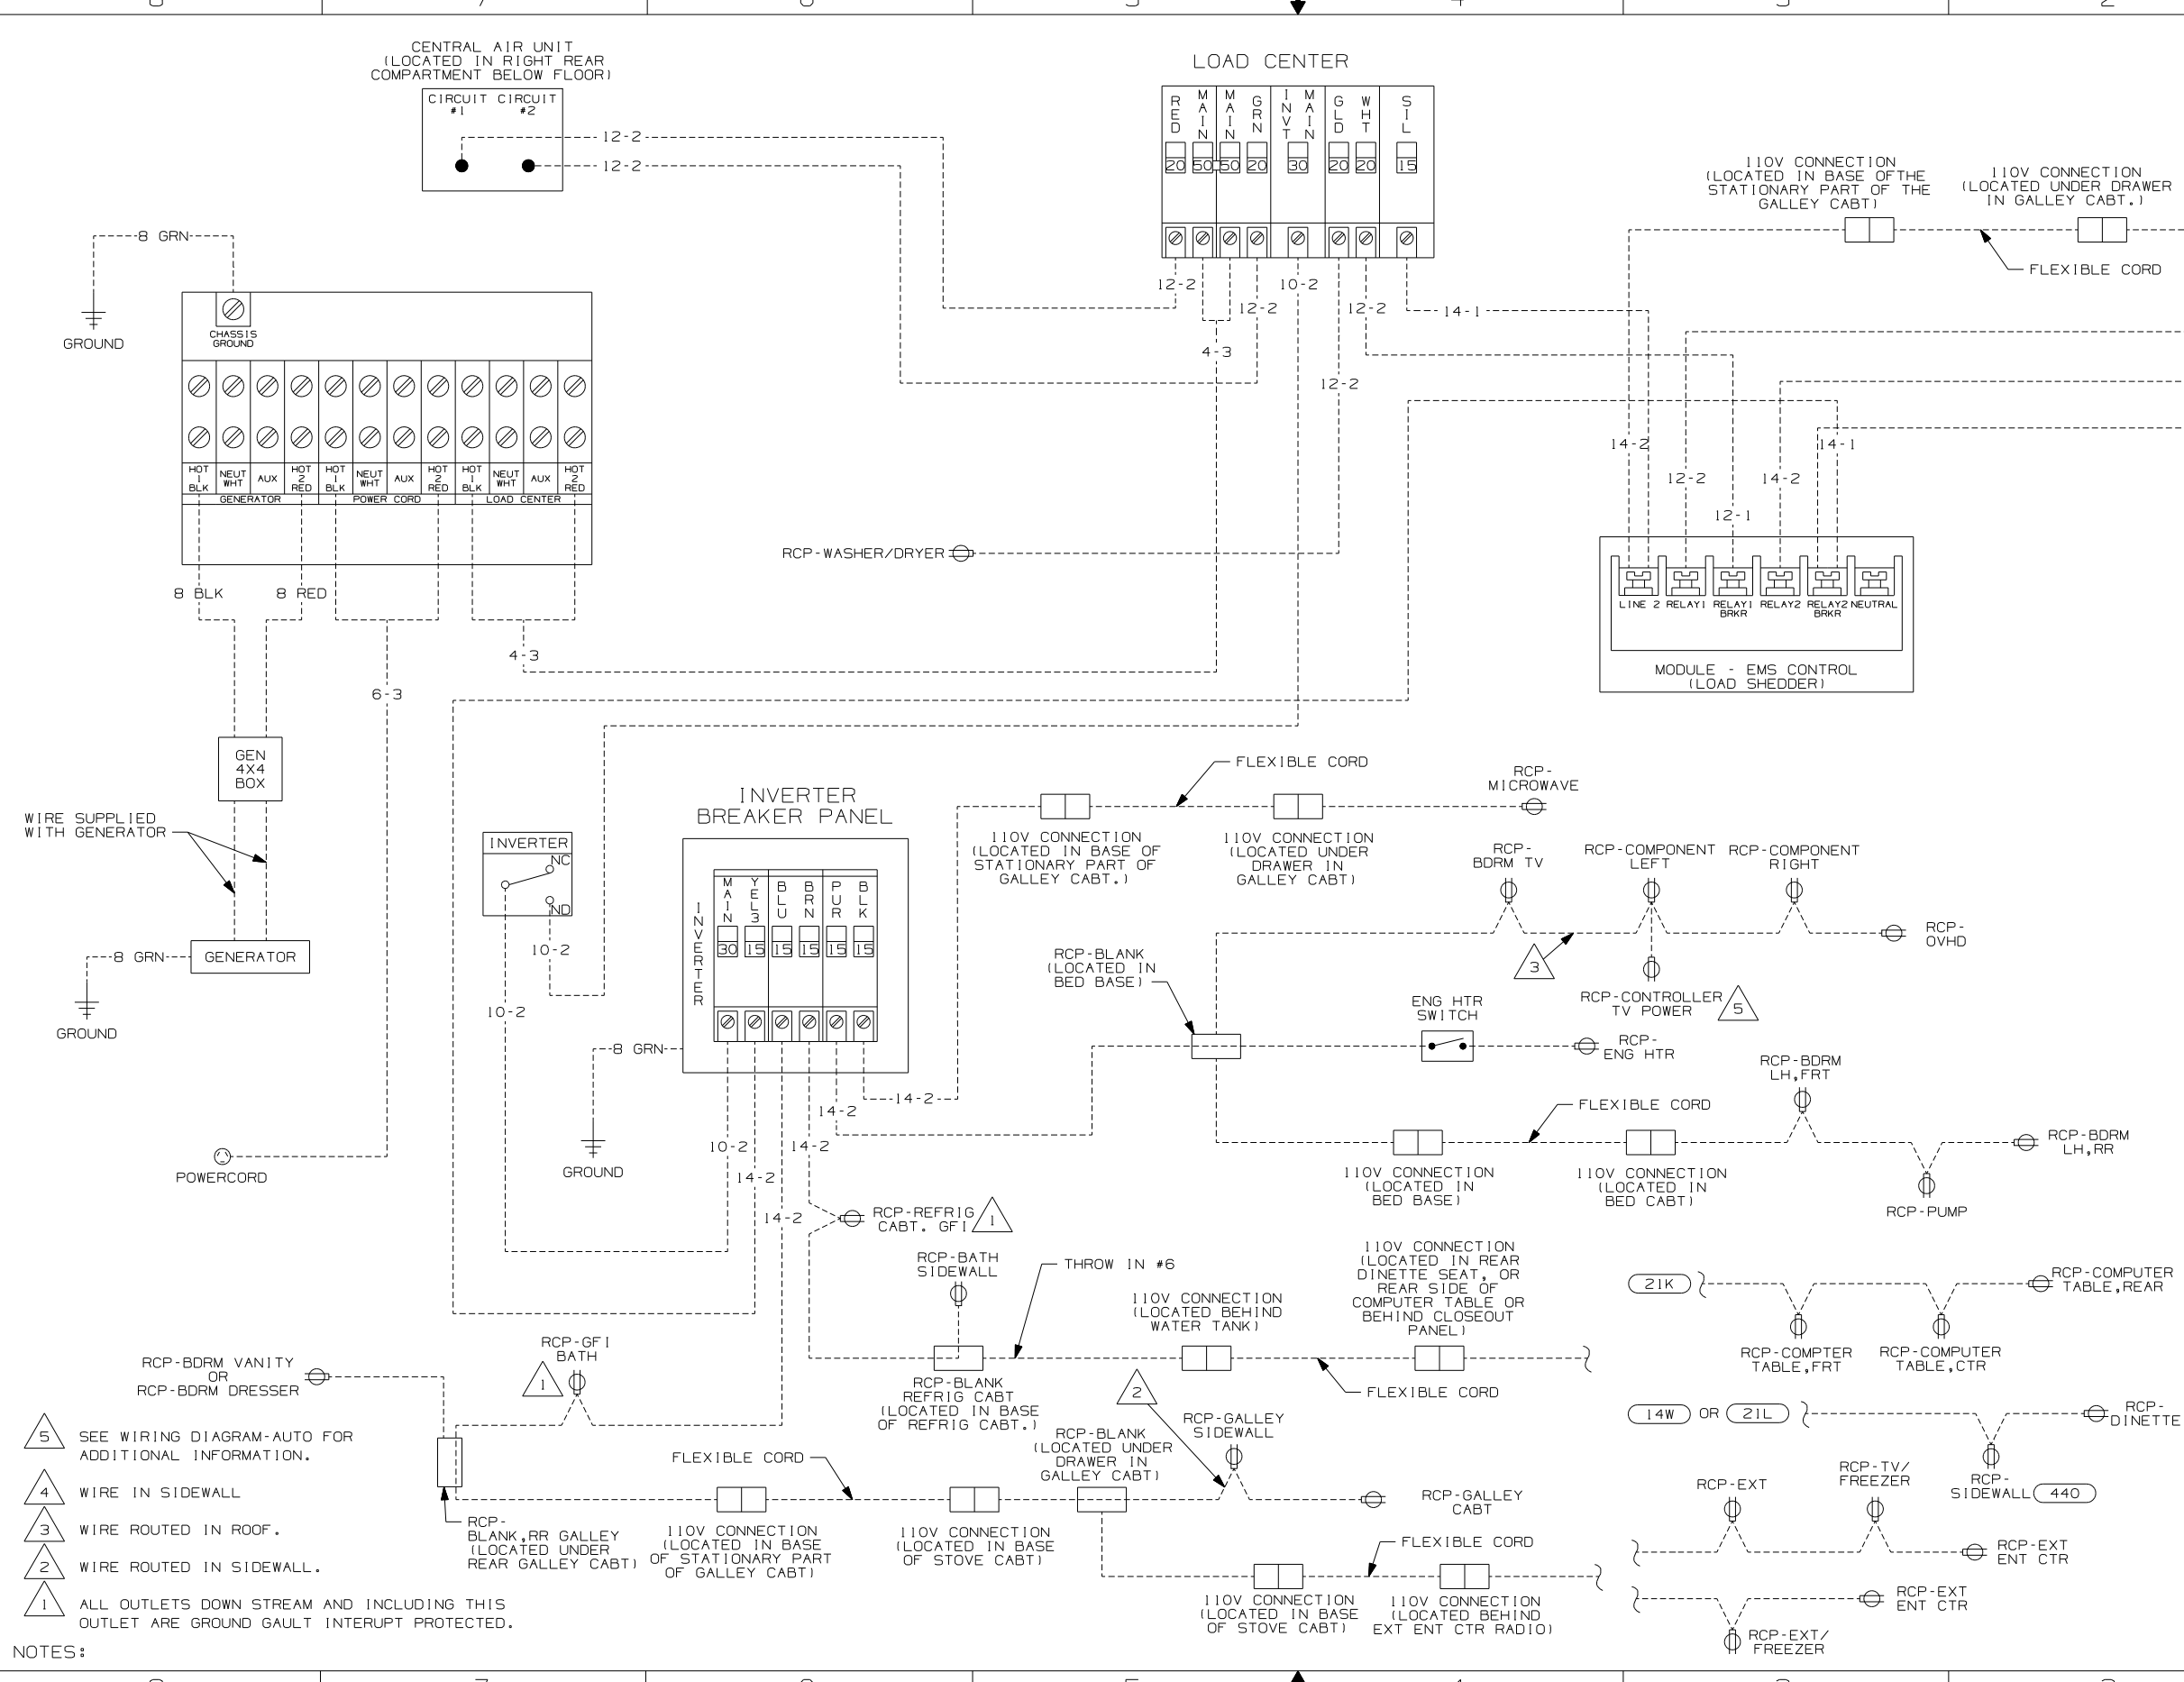
- NOTES:
- 5 SEE WIRING DIAGRAM-AUTO FOR ADDITIONAL INFORMATION.
 - 4 WIRE IN SIDEWALL
 - 3 WIRE ROUTED IN ROOF.
 - 2 WIRE ROUTED IN SIDEWALL.
 - 1 ALL OUTLETS DOWN STREAM AND INCLUDING THIS OUTLET ARE GROUND GAULT INTERRUPT PROTECTED.
