TITLE: WIRING DIAGRAM-BODY, 110V

SHEET 1 OF 1 PART NO 154267

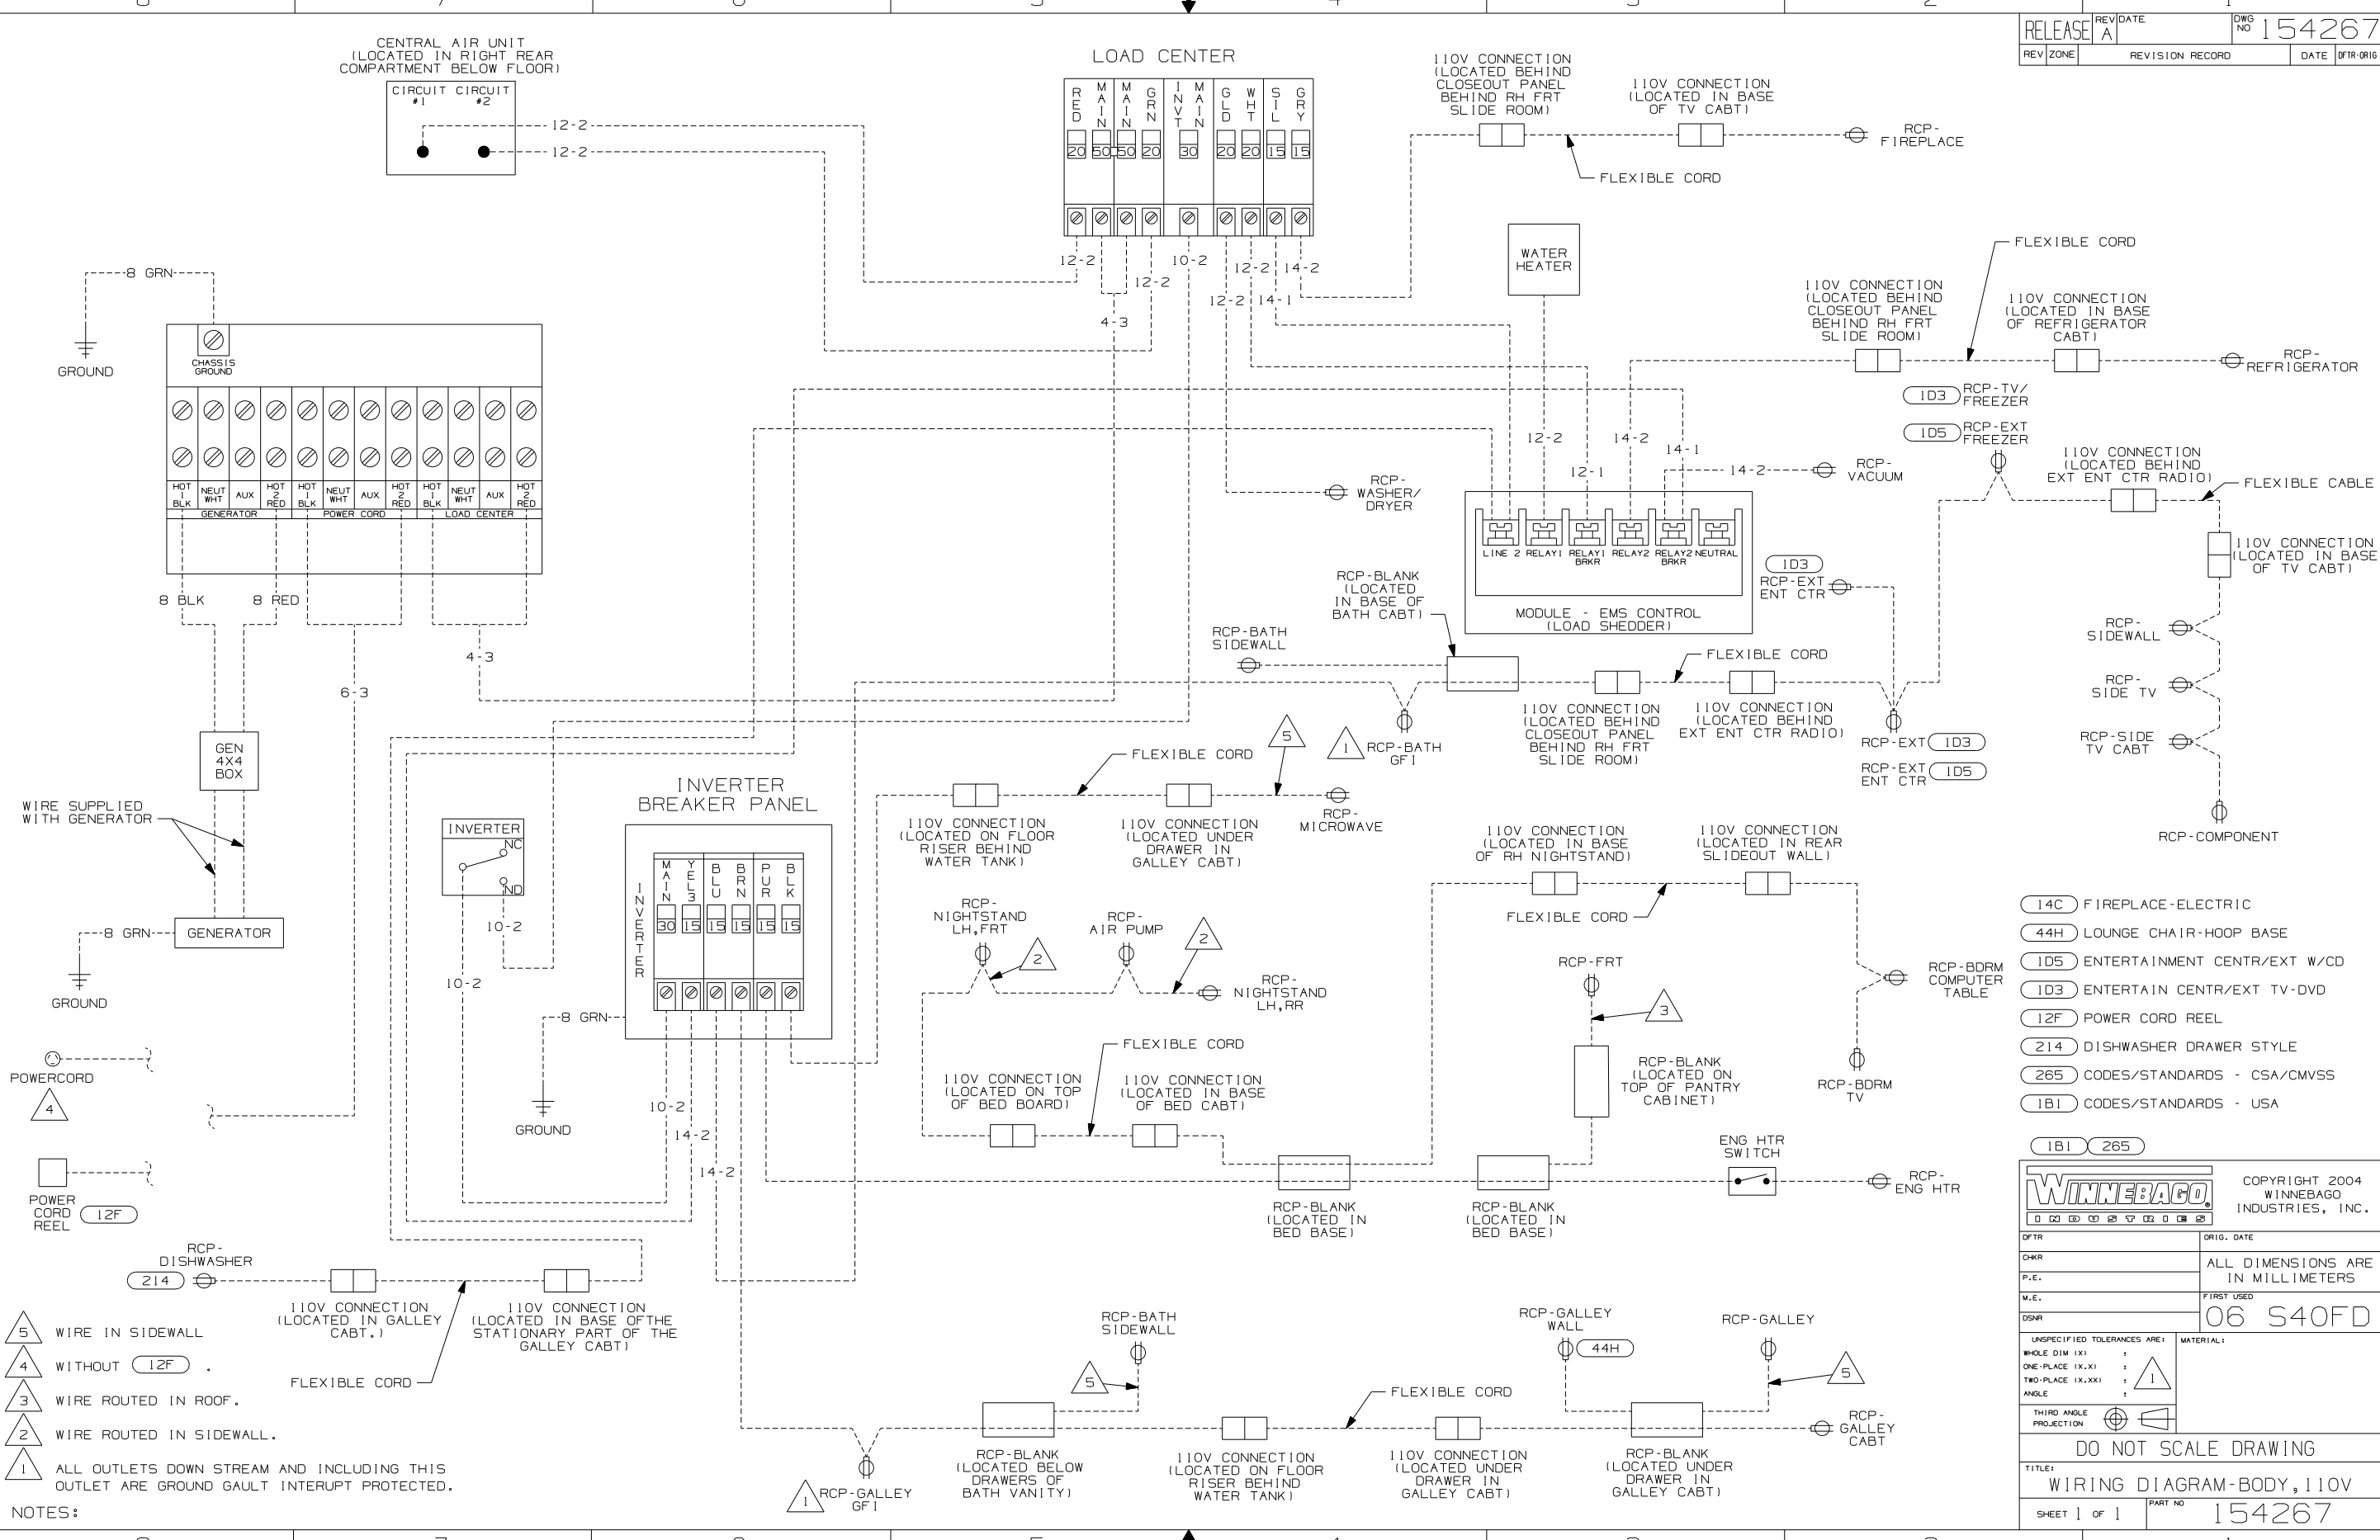
CENTRAL AIR UNIT
 (LOCATED IN RIGHT REAR
 COMPARTMENT BELOW FLOOR)

LOAD CENTER

- NOTES:
- 5 WIRE IN SIDEWALL
 - 4 WITHOUT 12F
 - 3 WIRE ROUTED IN ROOF.
 - 2 WIRE ROUTED IN SIDEWALL.
 - 1 ALL OUTLETS DOWN STREAM AND INCLUDING THIS OUTLET ARE GROUND GAULT INTERRUPT PROTECTED.
