<b>WINNEBAGO</b>		COPYRIGHT 2006 WINNEBAGO INDUSTRIES, INC.	
DFTR	ORIG. DATE	ALL DIMENSIONS ARE IN MILLIMETERS	
CHKR		FIRST USED	
P.E.		07 S40KD	
M.E.			
DSNR			
UNSPECIFIED TOLERANCES ARE:		MATERIAL:	
WHOLE DIM (X)	:		
ONE-PLACE (X.X)	:		
TWO-PLACE (X.XX)	:		
ANGLE	:		
THIRD ANGLE PROJECTION			
<b>DO NOT SCALE DRAWING</b>			
TITLE: WIRING DIAGRAM-BODY, 110V			
SHEET 1 OF 1	PART NO	156182	REV
REF:	1 12/19/2006

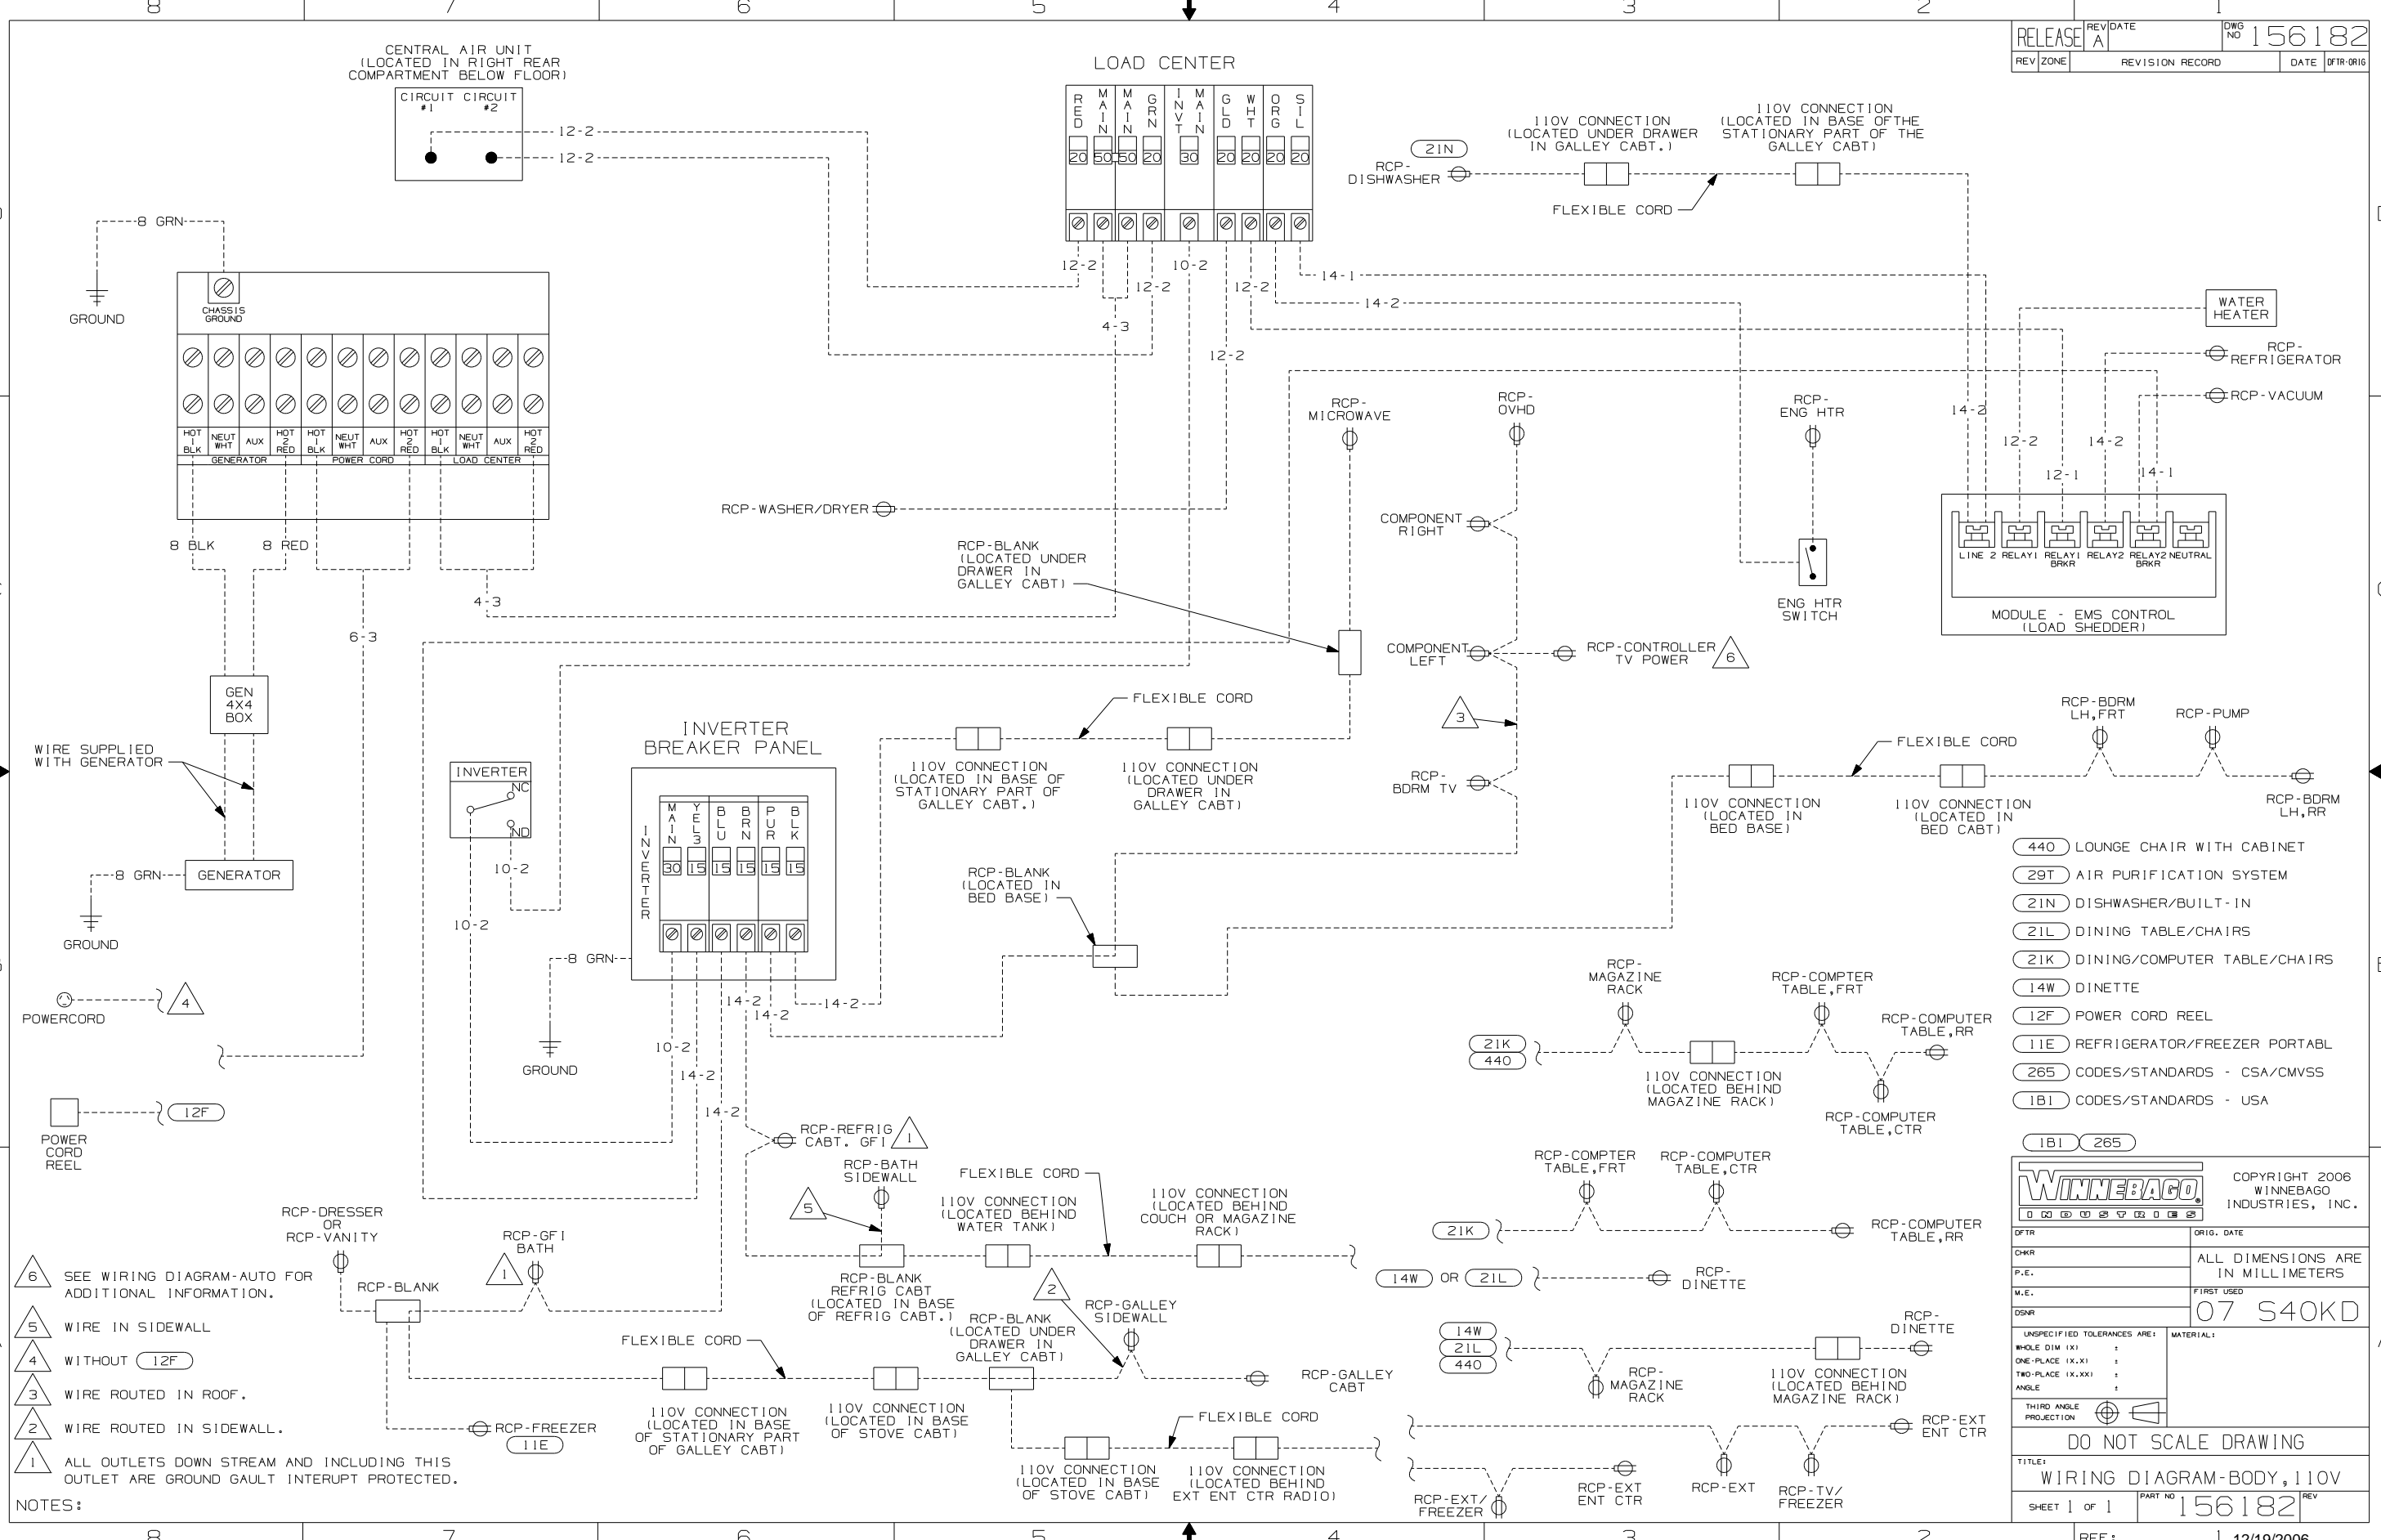
- NOTES:
- 6 SEE WIRING DIAGRAM-AUTO FOR ADDITIONAL INFORMATION.
  - 5 WIRE IN SIDEWALL
  - 4 WITHOUT 12F
  - 3 WIRE ROUTED IN ROOF.
  - 2 WIRE ROUTED IN SIDEWALL.
  - 1 ALL OUTLETS DOWN STREAM AND INCLUDING THIS OUTLET ARE GROUND GAULT INTERRUPT PROTECTED.
