WINNEBAGO		COPYRIGHT 2006 WINNEBAGO INDUSTRIES, INC.	
DFTR	ORIG. DATE		
CHKR	ALL DIMENSIONS ARE IN MILLIMETERS		
P.E.	FIRST USED	09 P37H	
M.E.			
DSNR			
UNSPECIFIED TOLERANCES ARE:		MATERIAL:	
WHOLE DIM (X)	:		
ONE-PLACE (X.X)	:		
TWO-PLACE (X.XX)	:		
ANGLE	:		
THIRD ANGLE PROJECTION			
DO NOT SCALE DRAWING			
TITLE: WIRING DIAGRAM-BODY, 110V			
SHEET 1 OF 1	PART NO	168602	REV
REF:	1 4/7/2008

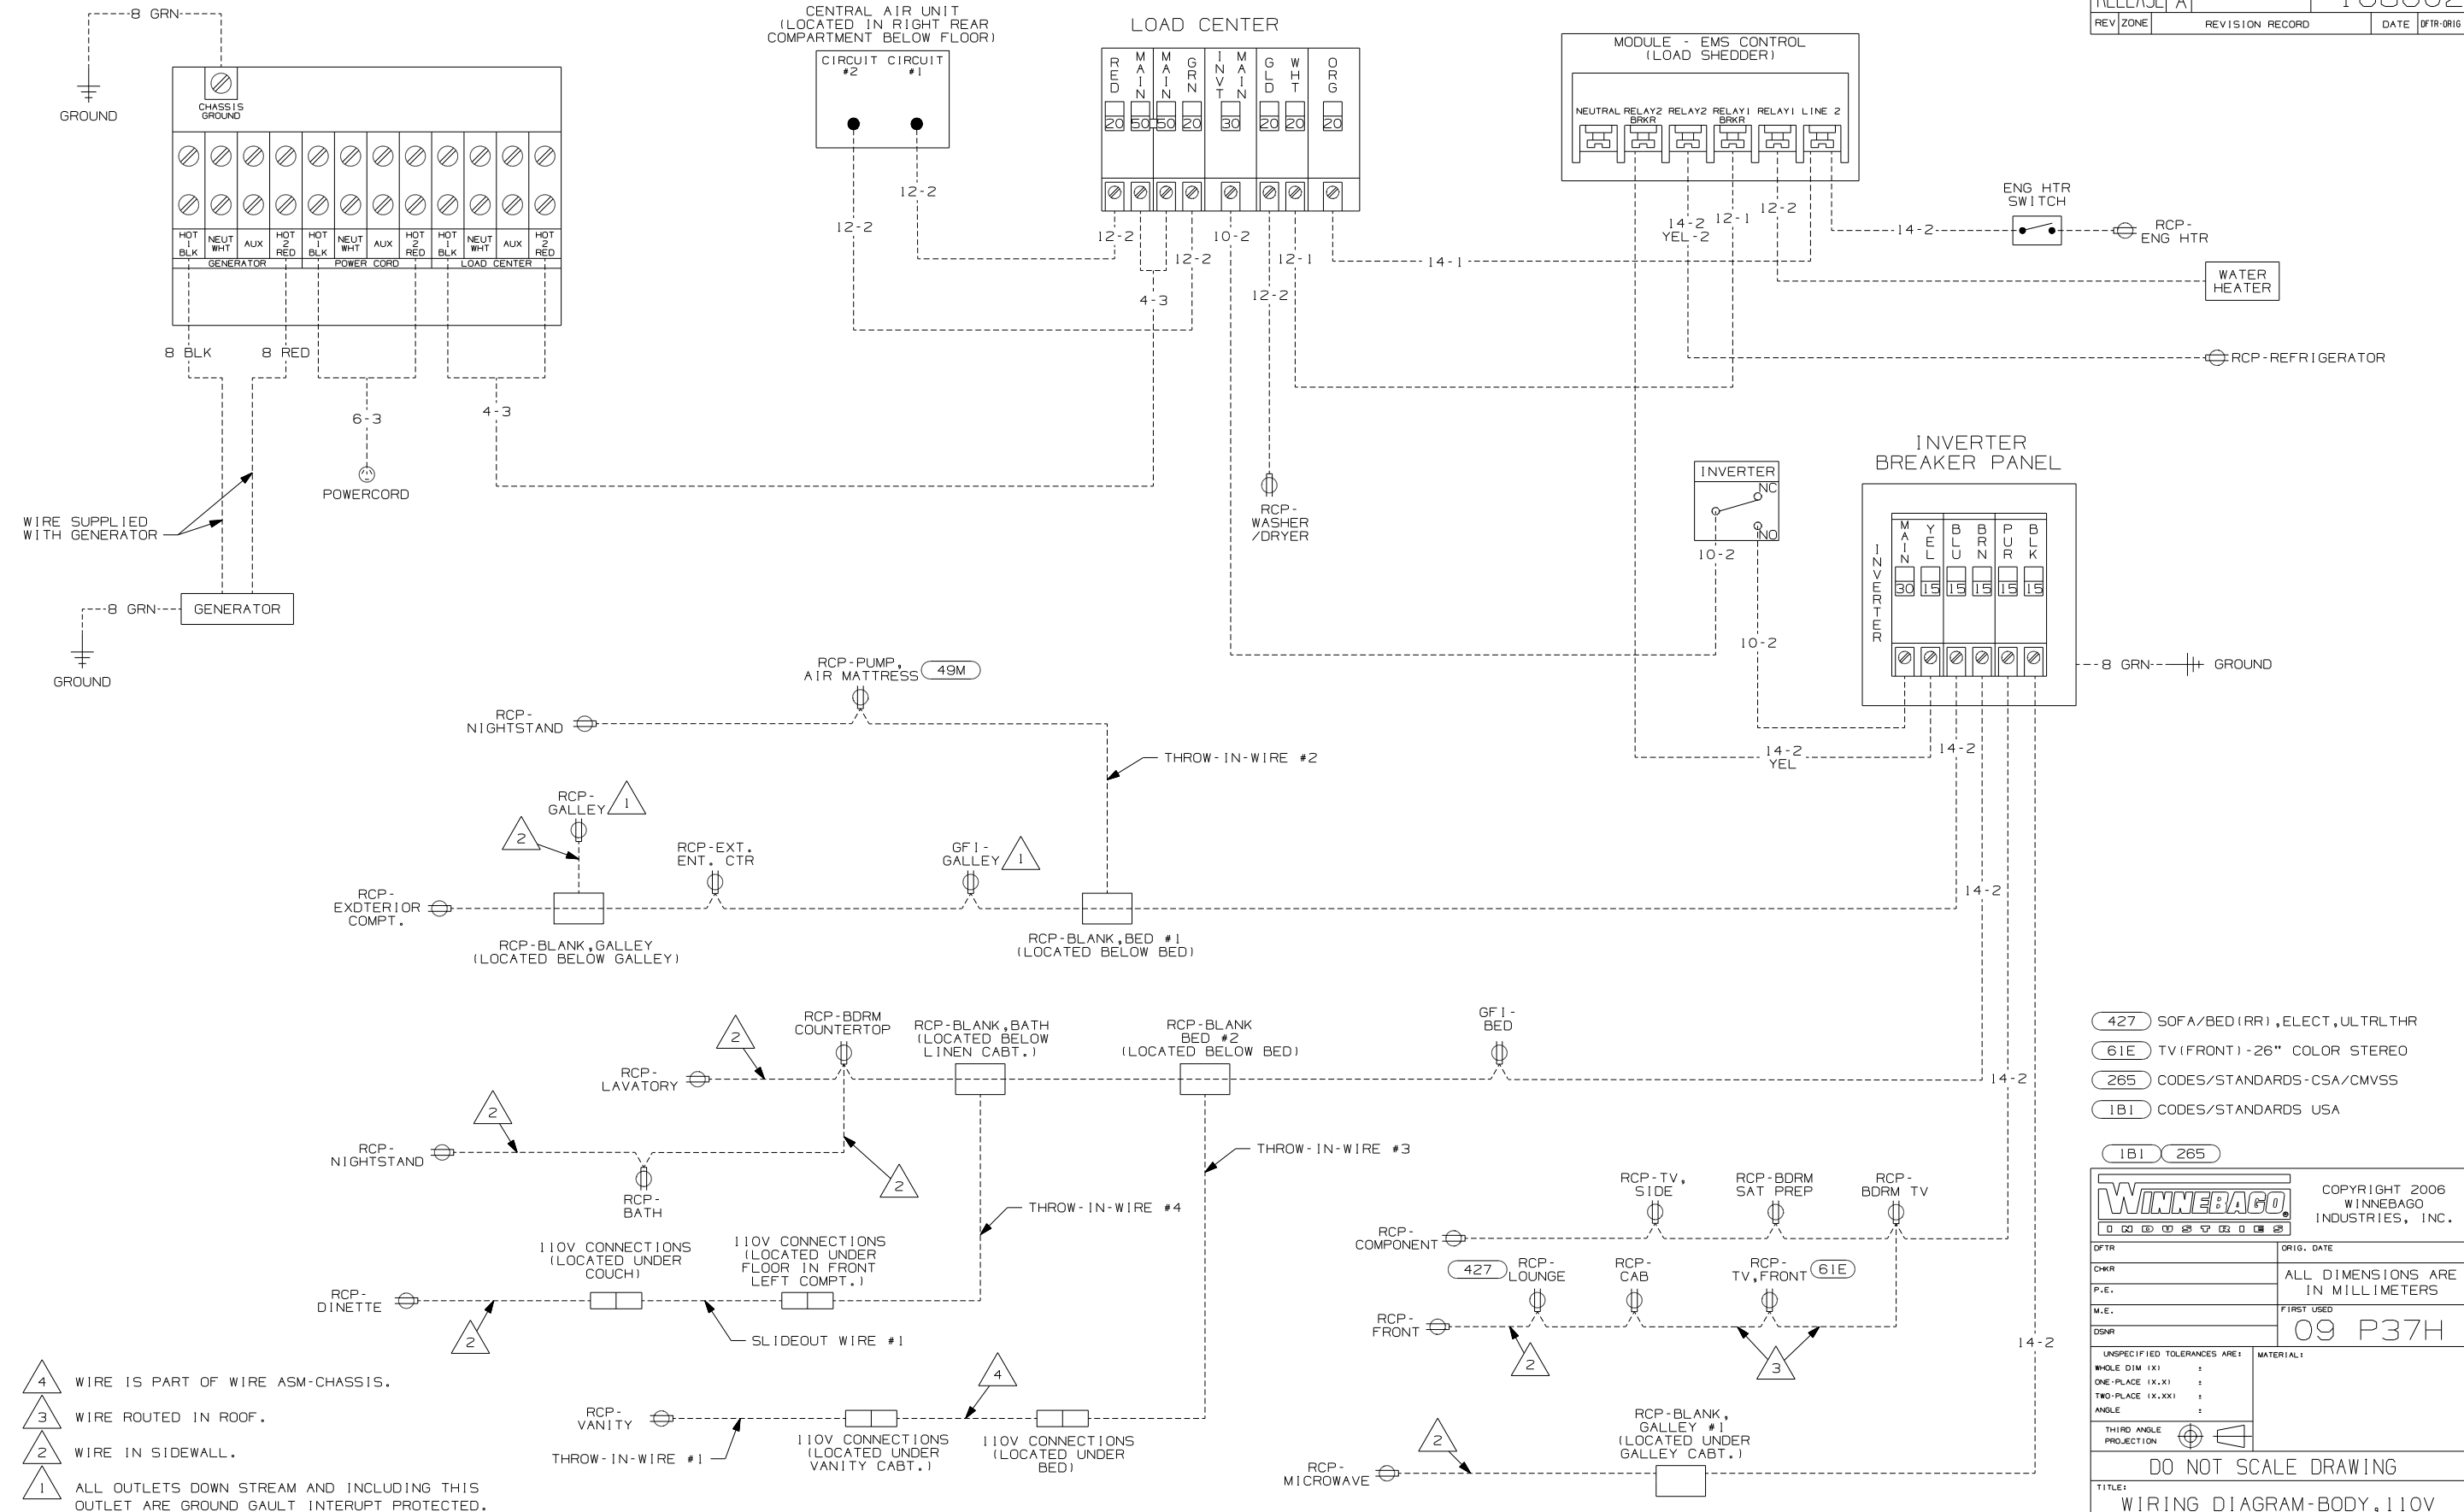
- NOTES:
- 4 WIRE IS PART OF WIRE ASM-CHASSIS.
 - 3 WIRE ROUTED IN ROOF.
 - 2 WIRE IN SIDEWALL.
 - 1 ALL OUTLETS DOWN STREAM AND INCLUDING THIS OUTLET ARE GROUND GAULT INTERRUPT PROTECTED.
