WINNEBAGO

| TITLE: WIRING DIAGRAM-BODY, 110V | |
| SHEET 1 OF 1 | PART NO 174947 |

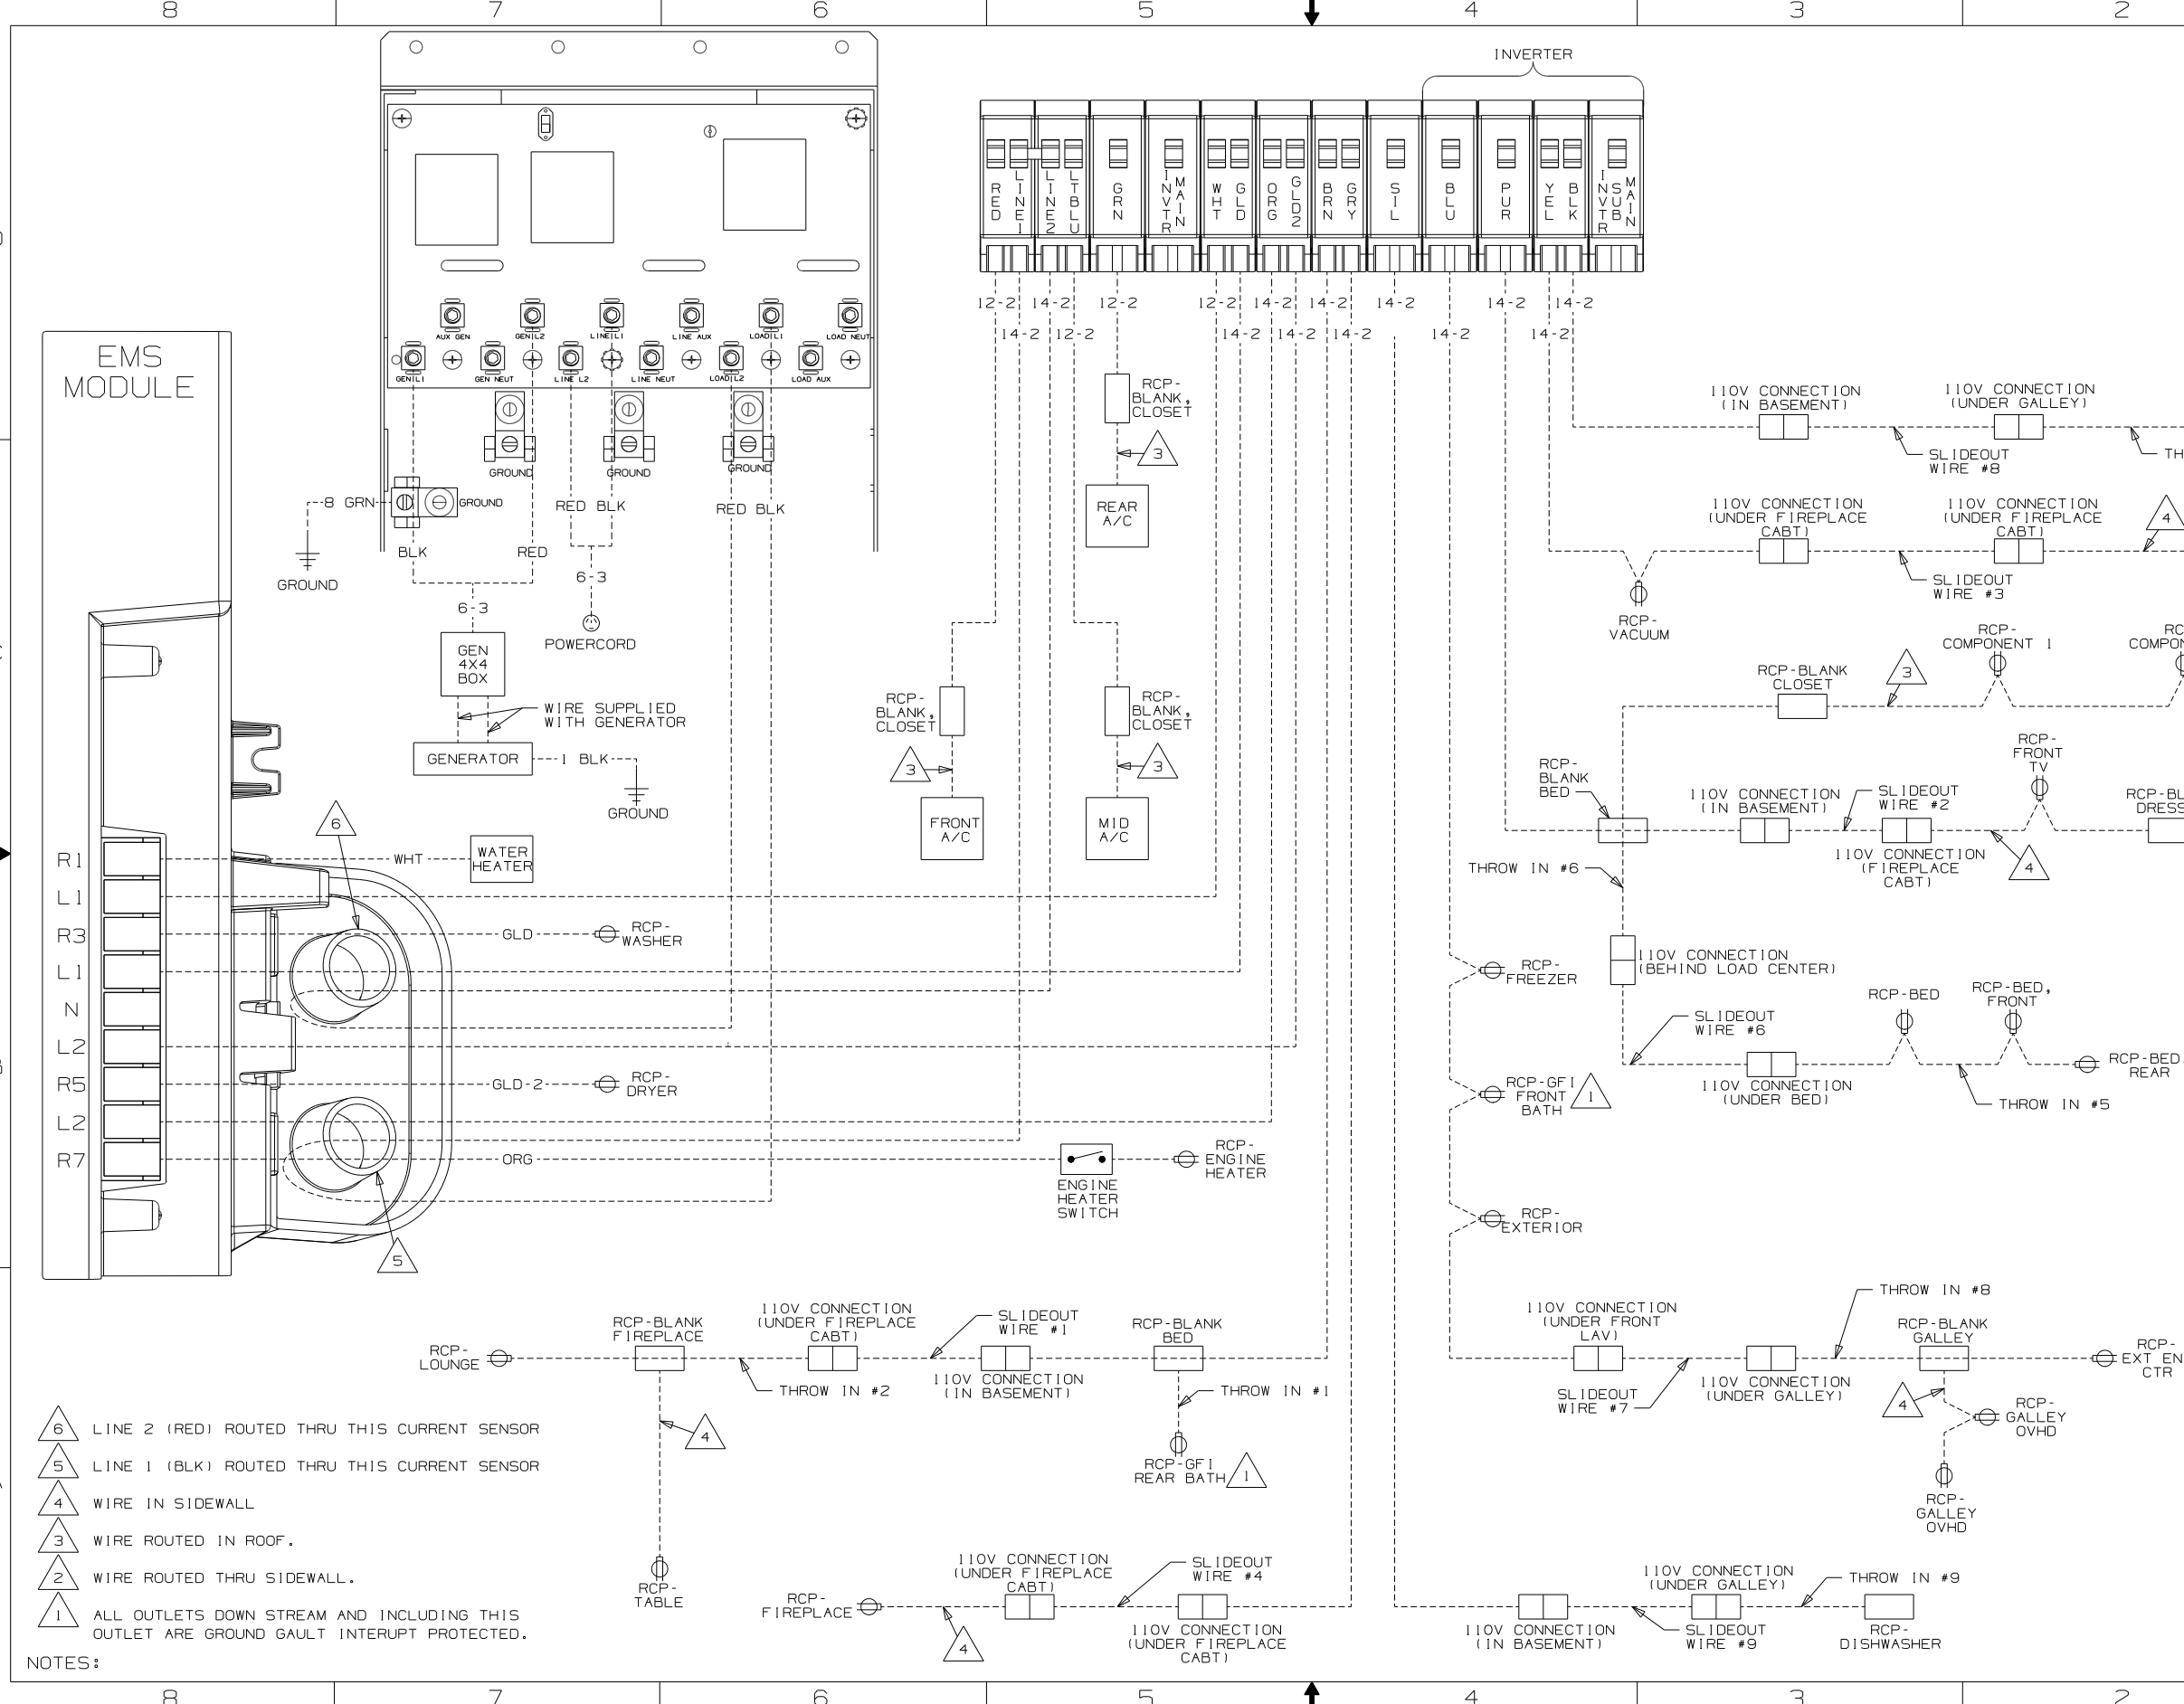
- NOTES:
- 6 LINE 2 (RED) ROUTED THRU THIS CURRENT SENSOR
  - 5 LINE 1 (BLK) ROUTED THRU THIS CURRENT SENSOR
  - 4 WIRE IN SIDEWALL
  - 3 WIRE ROUTED IN ROOF.
  - 2 WIRE ROUTED THRU SIDEWALL.
  - 1 ALL OUTLETS DOWN STREAM AND INCLUDING THIS OUTLET ARE GROUND GAULT INTERRUPT PROTECTED.
