WINNEBAGO

TITLE:  
WIRING DIAGRAM-BODY, 110V

SHEET 1 OF 1PART NO  
175194REV

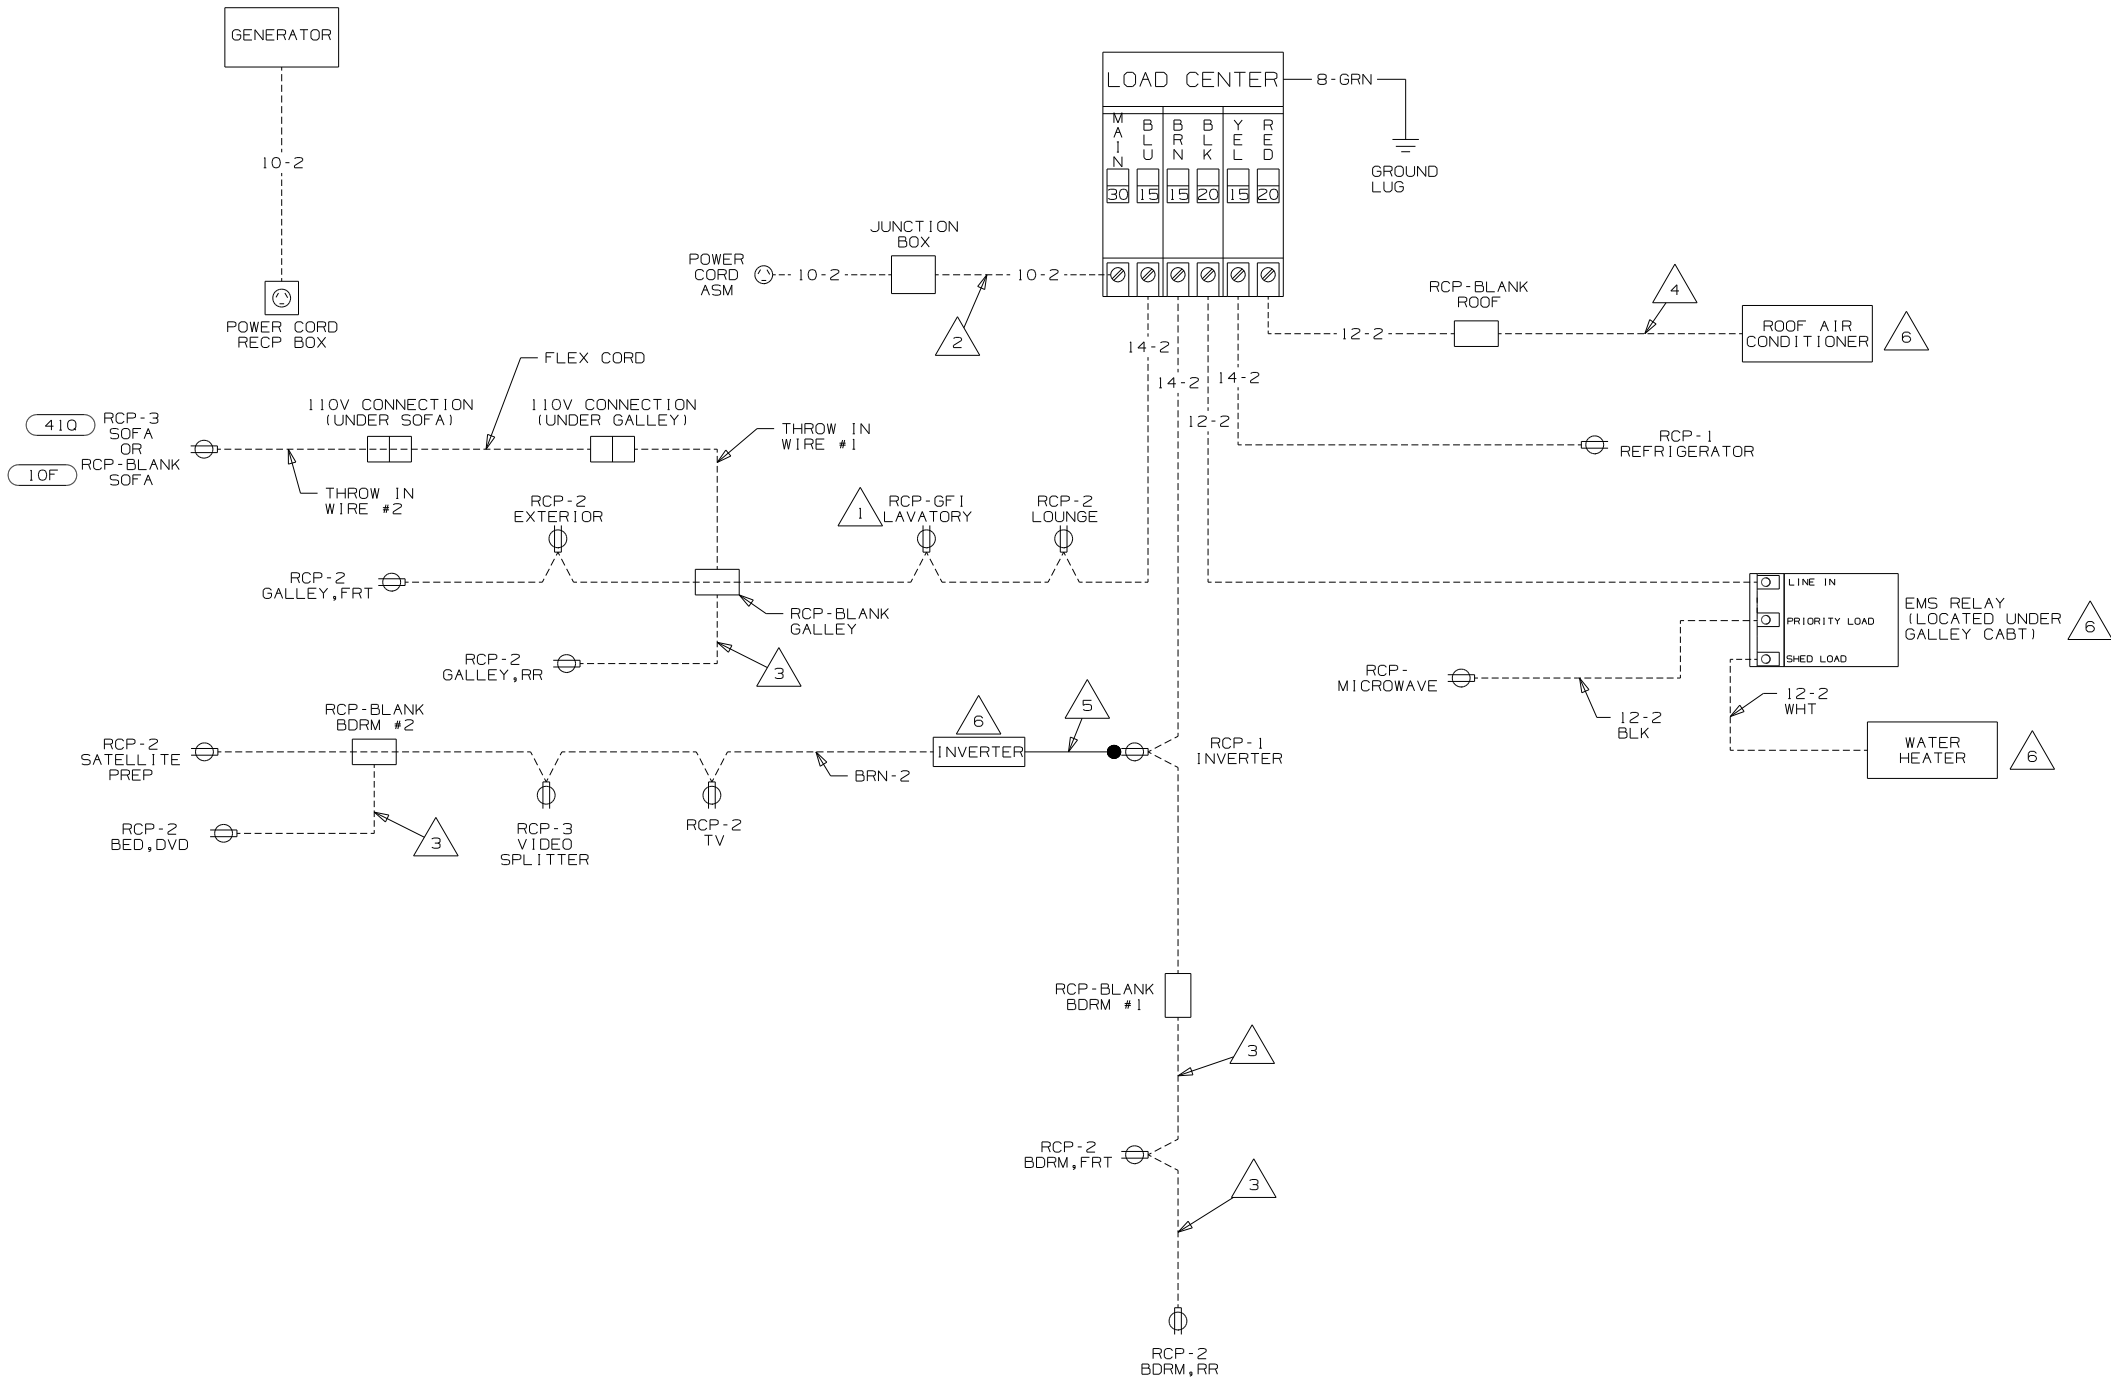
ALL WIRES DOWN STREAM AND INCLUDING THIS OUTLET ARE GROUND FAULT CIRCUIT INTERRUPT PROTECTED.
