WINNEBAGO		COPYRIGHT 2013 WINNEBAGO INDUSTRIES, INC.	
DFT-ORIG	ORIG. DATE	ALL DIMENSIONS ARE IN MILLIMETERS	
CHKR		FIRST USED	
P.E.		93 MOTORHAMES	
M.E.		MATERIAL:	
DSNR		UNSPECIFIED TOLERANCES ARE:	
		WHOLE DIM (X)	:
		ONE-PLACE (X.X)	:
		TWO-PLACE (X.XX)	:
		ANGLE	:
		THIRD ANGLE PROJECTION	
DO NOT SCALE DRAWING		REFER TO ES0018 FOR FASTENER TIGHTENING GUIDELINES	
TITLE: WIRING DIAGRAM-TV COAX			
SHEET 1 OF 2		PART NO	110138
REF:		1	03-Jan-2013

FIRST USED	93 MOTORHAMES
DO NOT SCALE DRAWING	
TITLE: WIRING DIAGRAM-TV COAX	
SHEET 2	PART NO 110138
03-Jan-2013

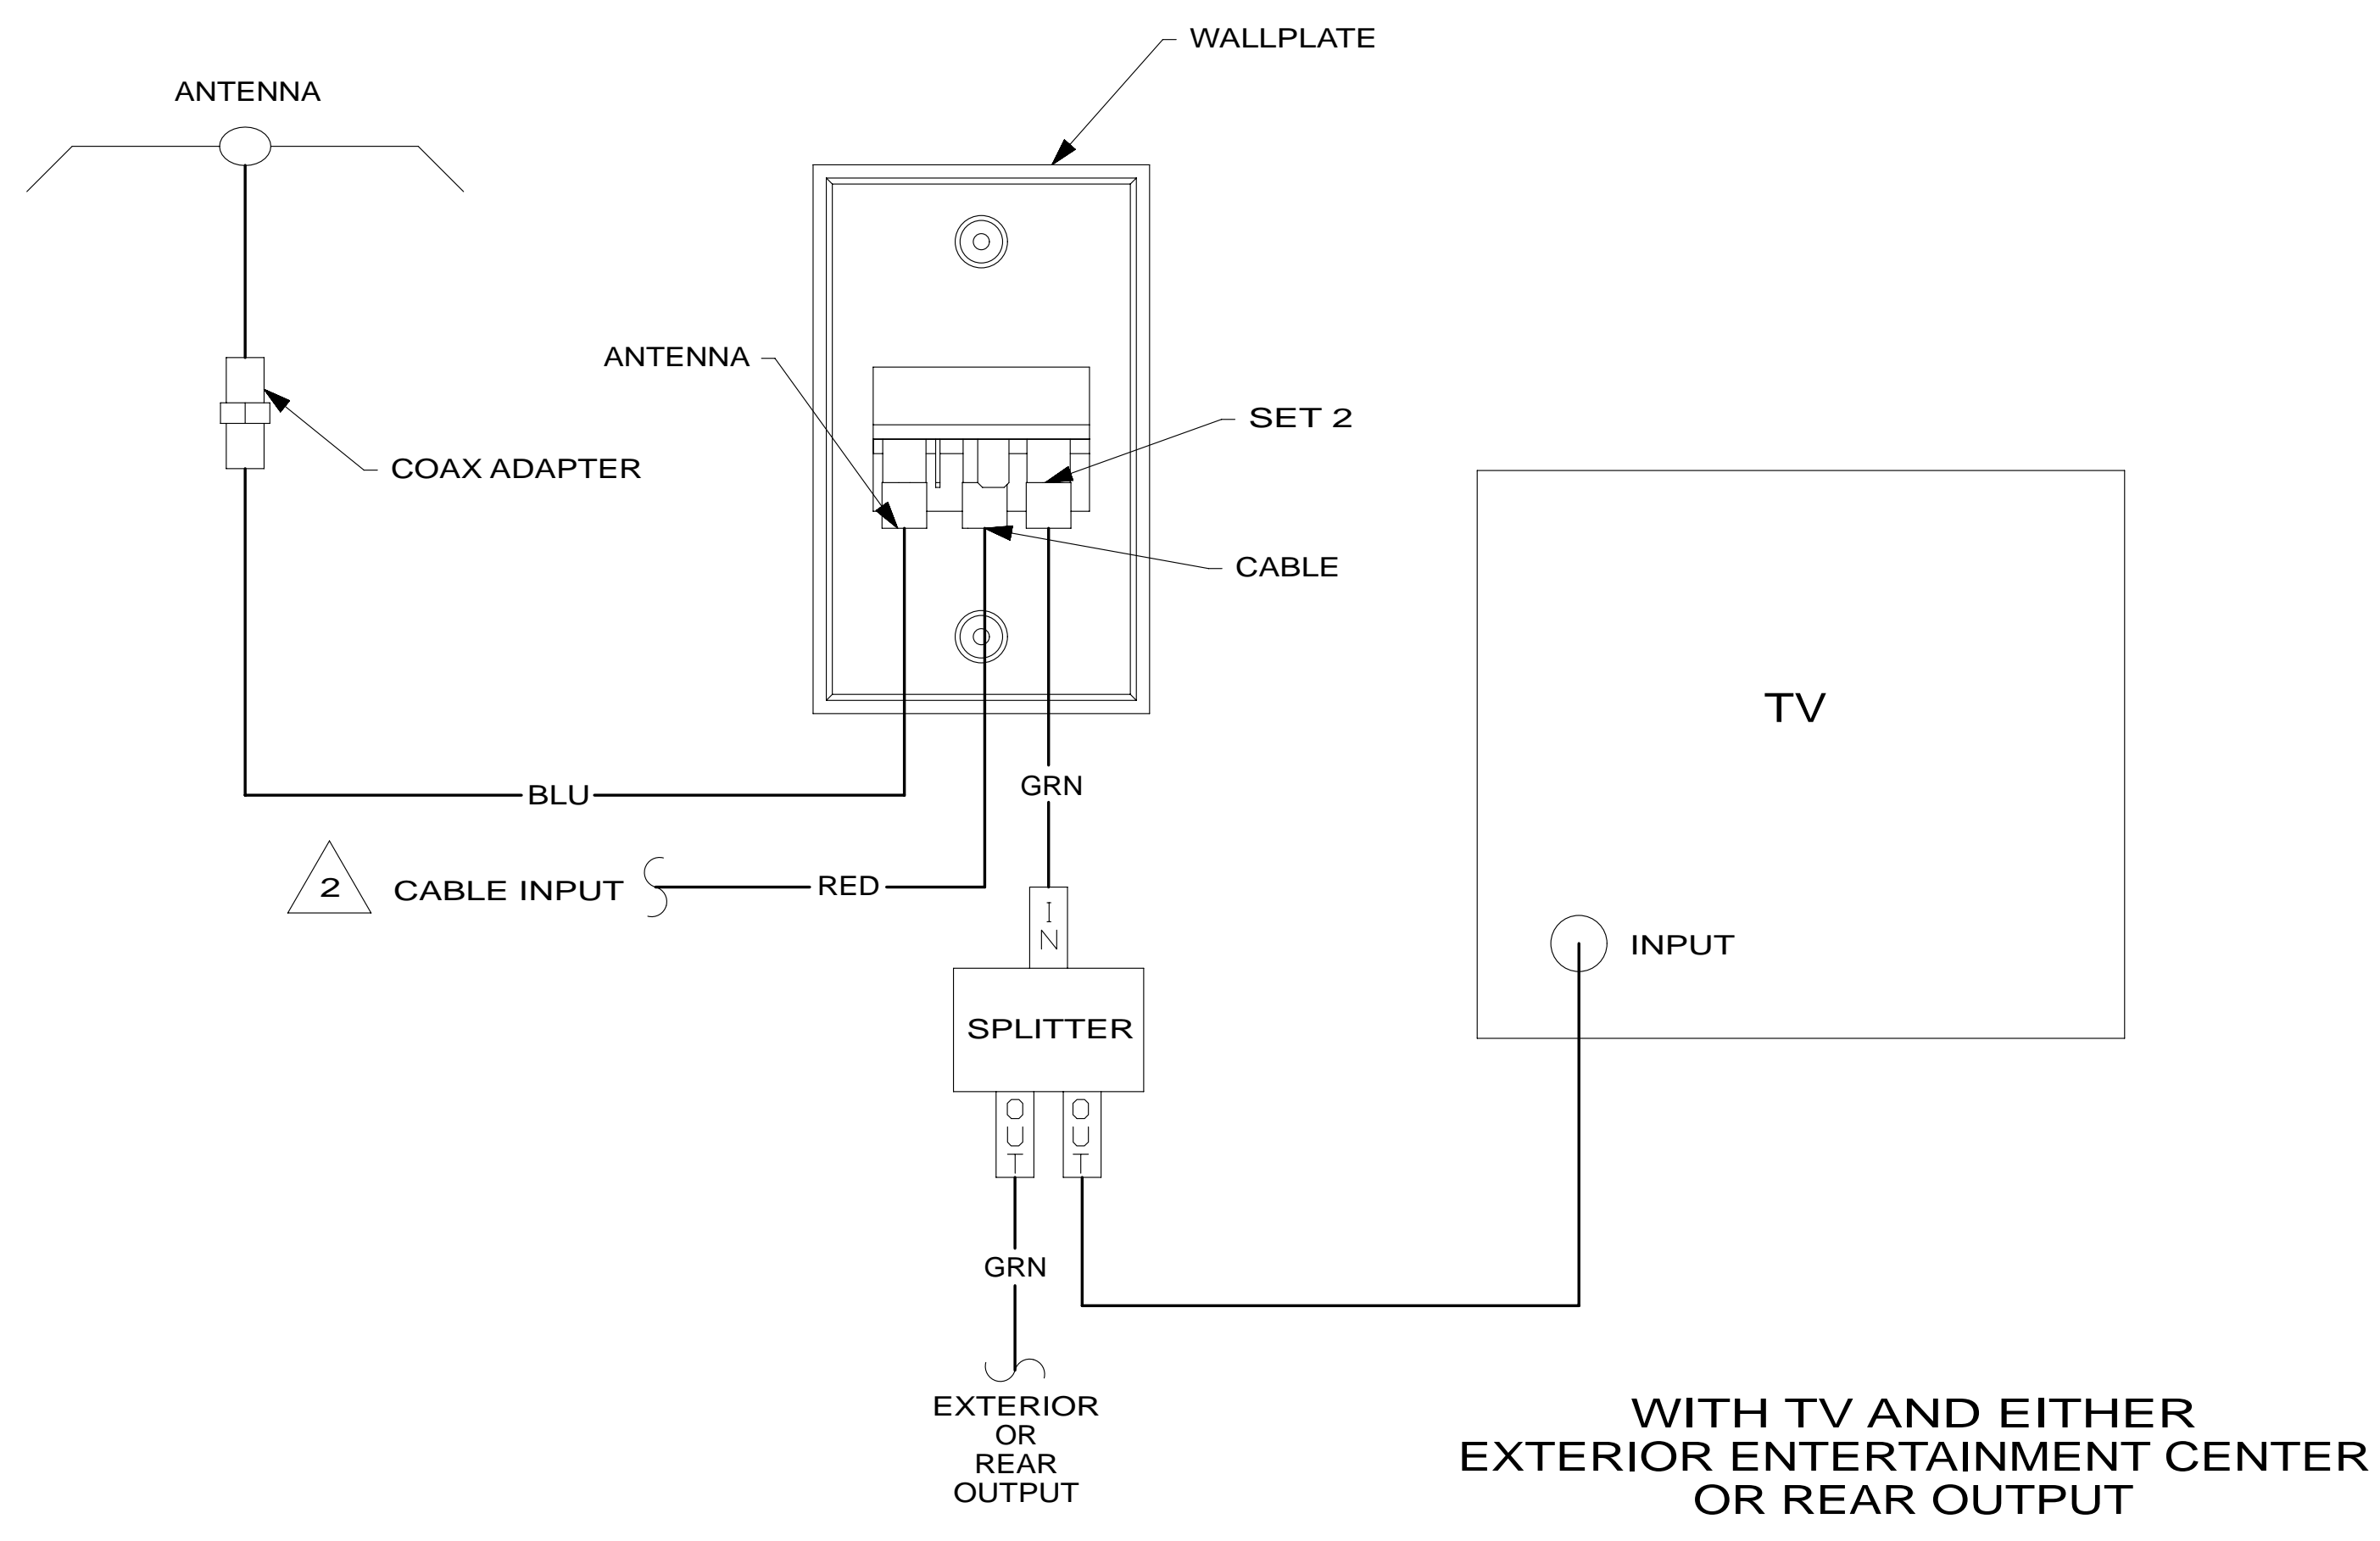
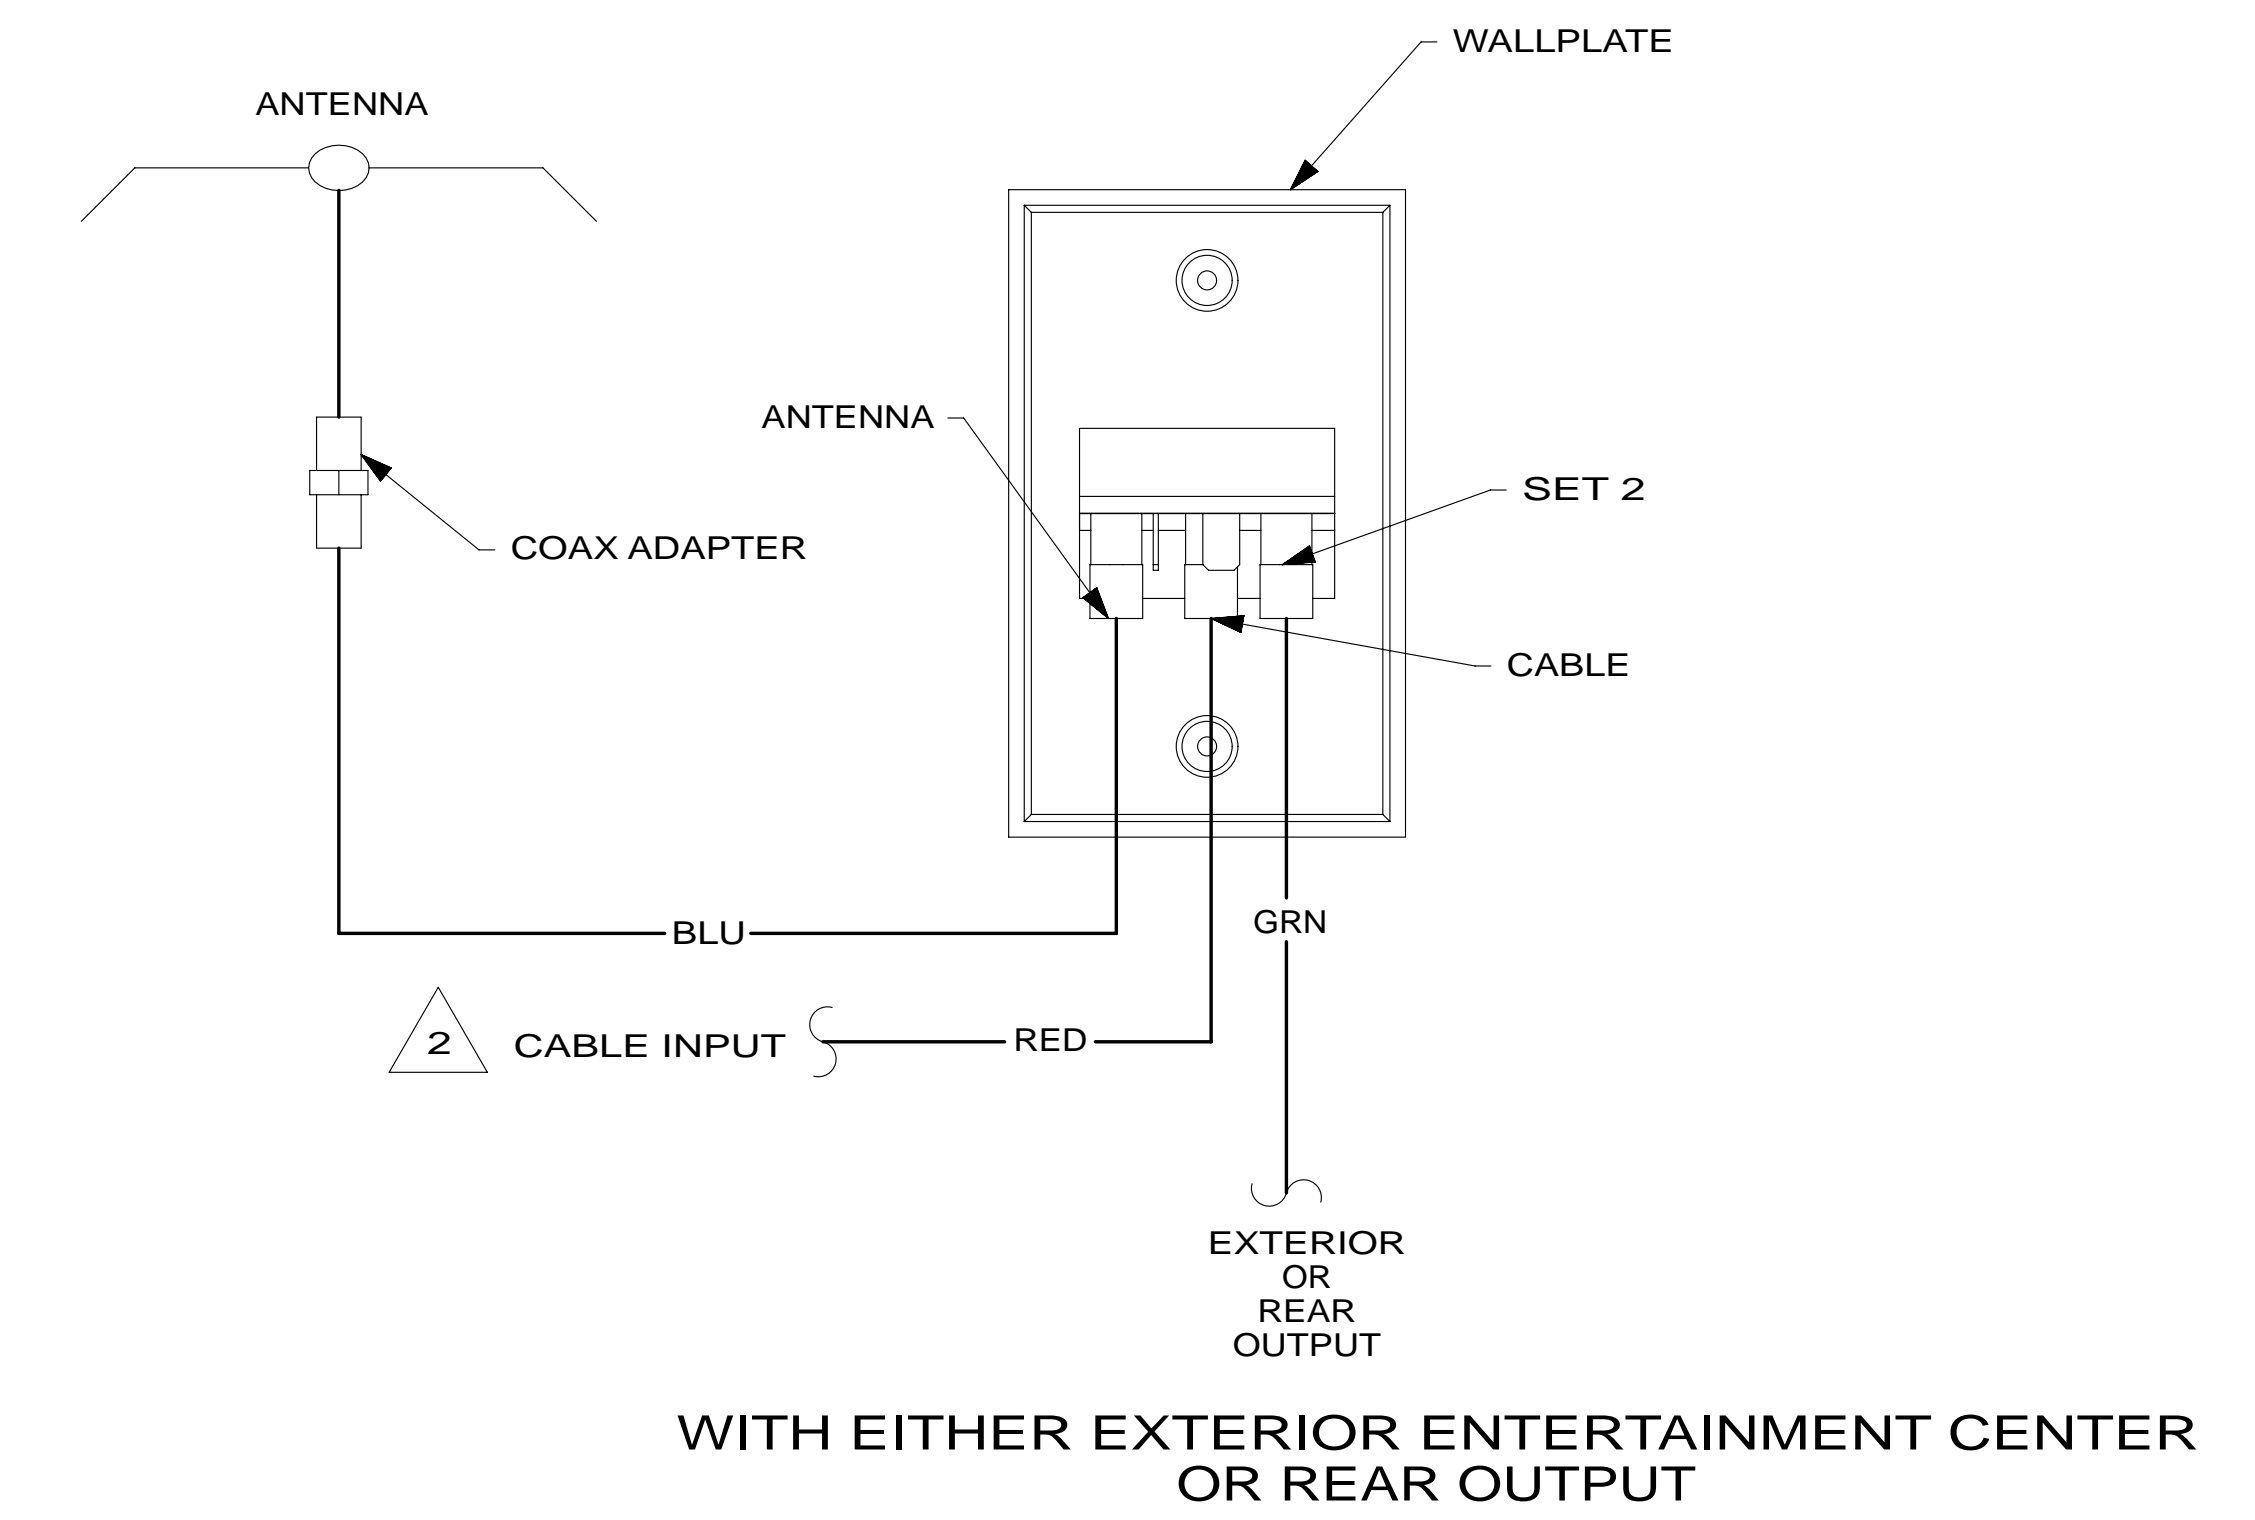
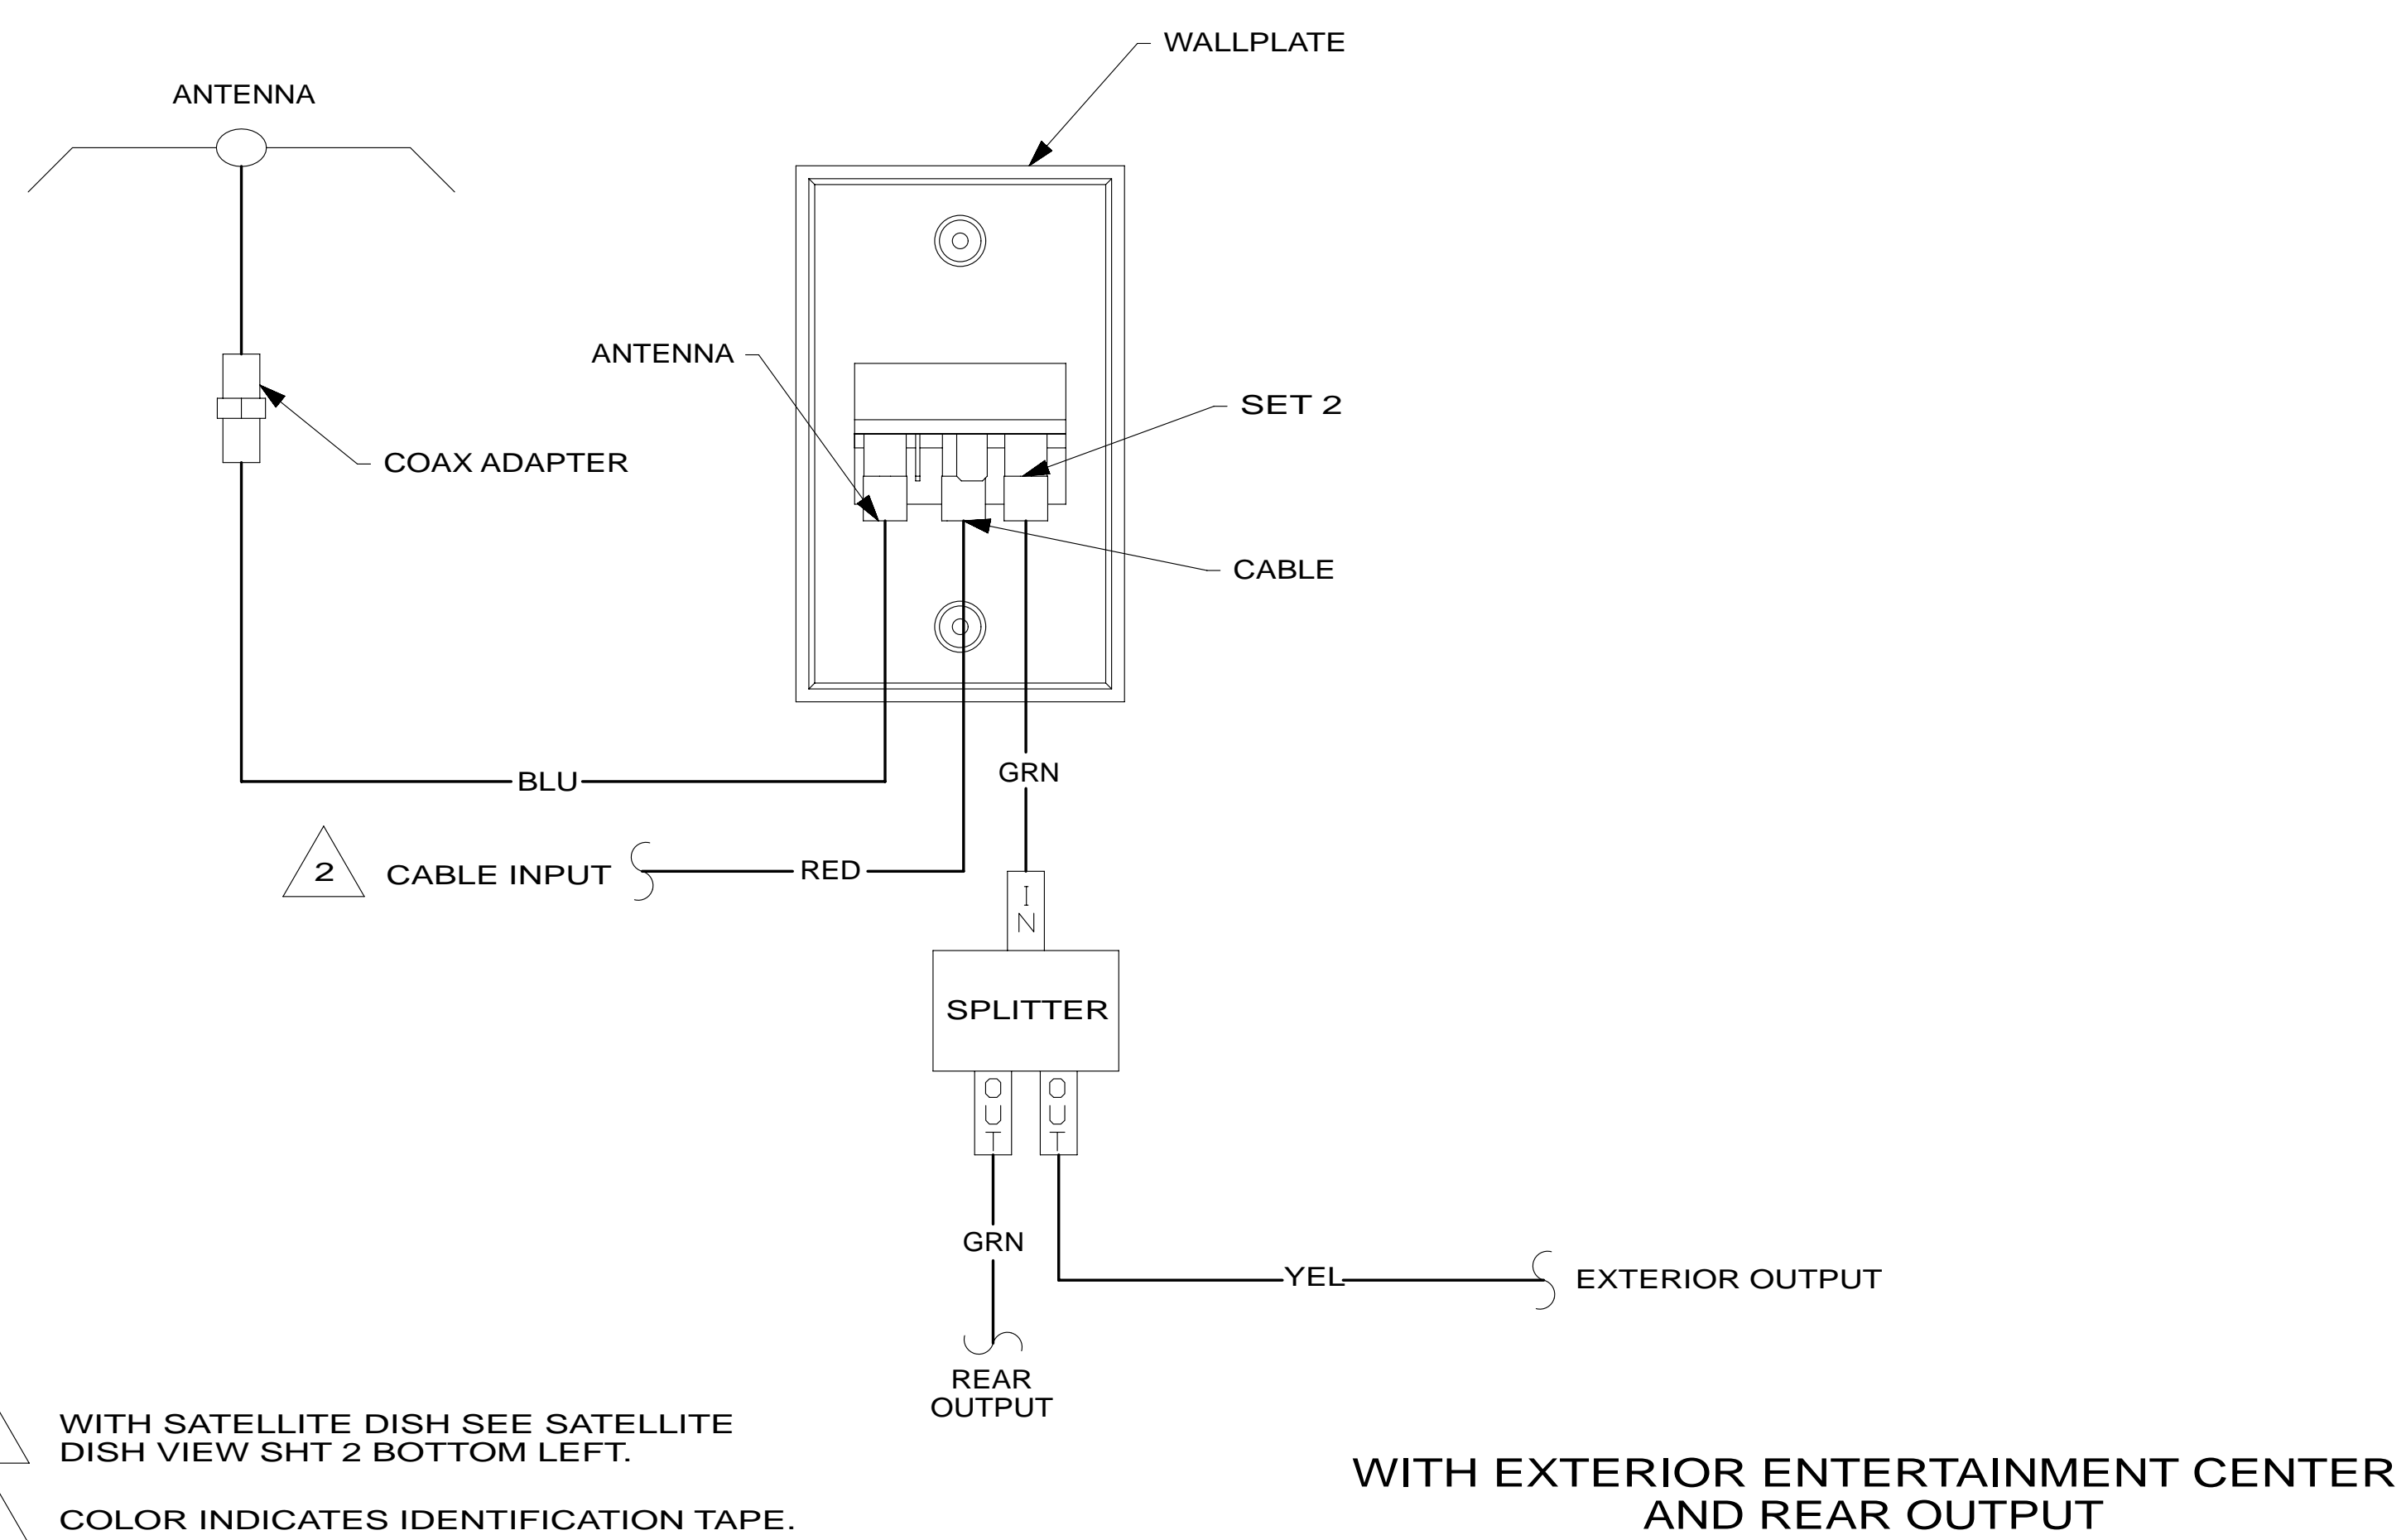
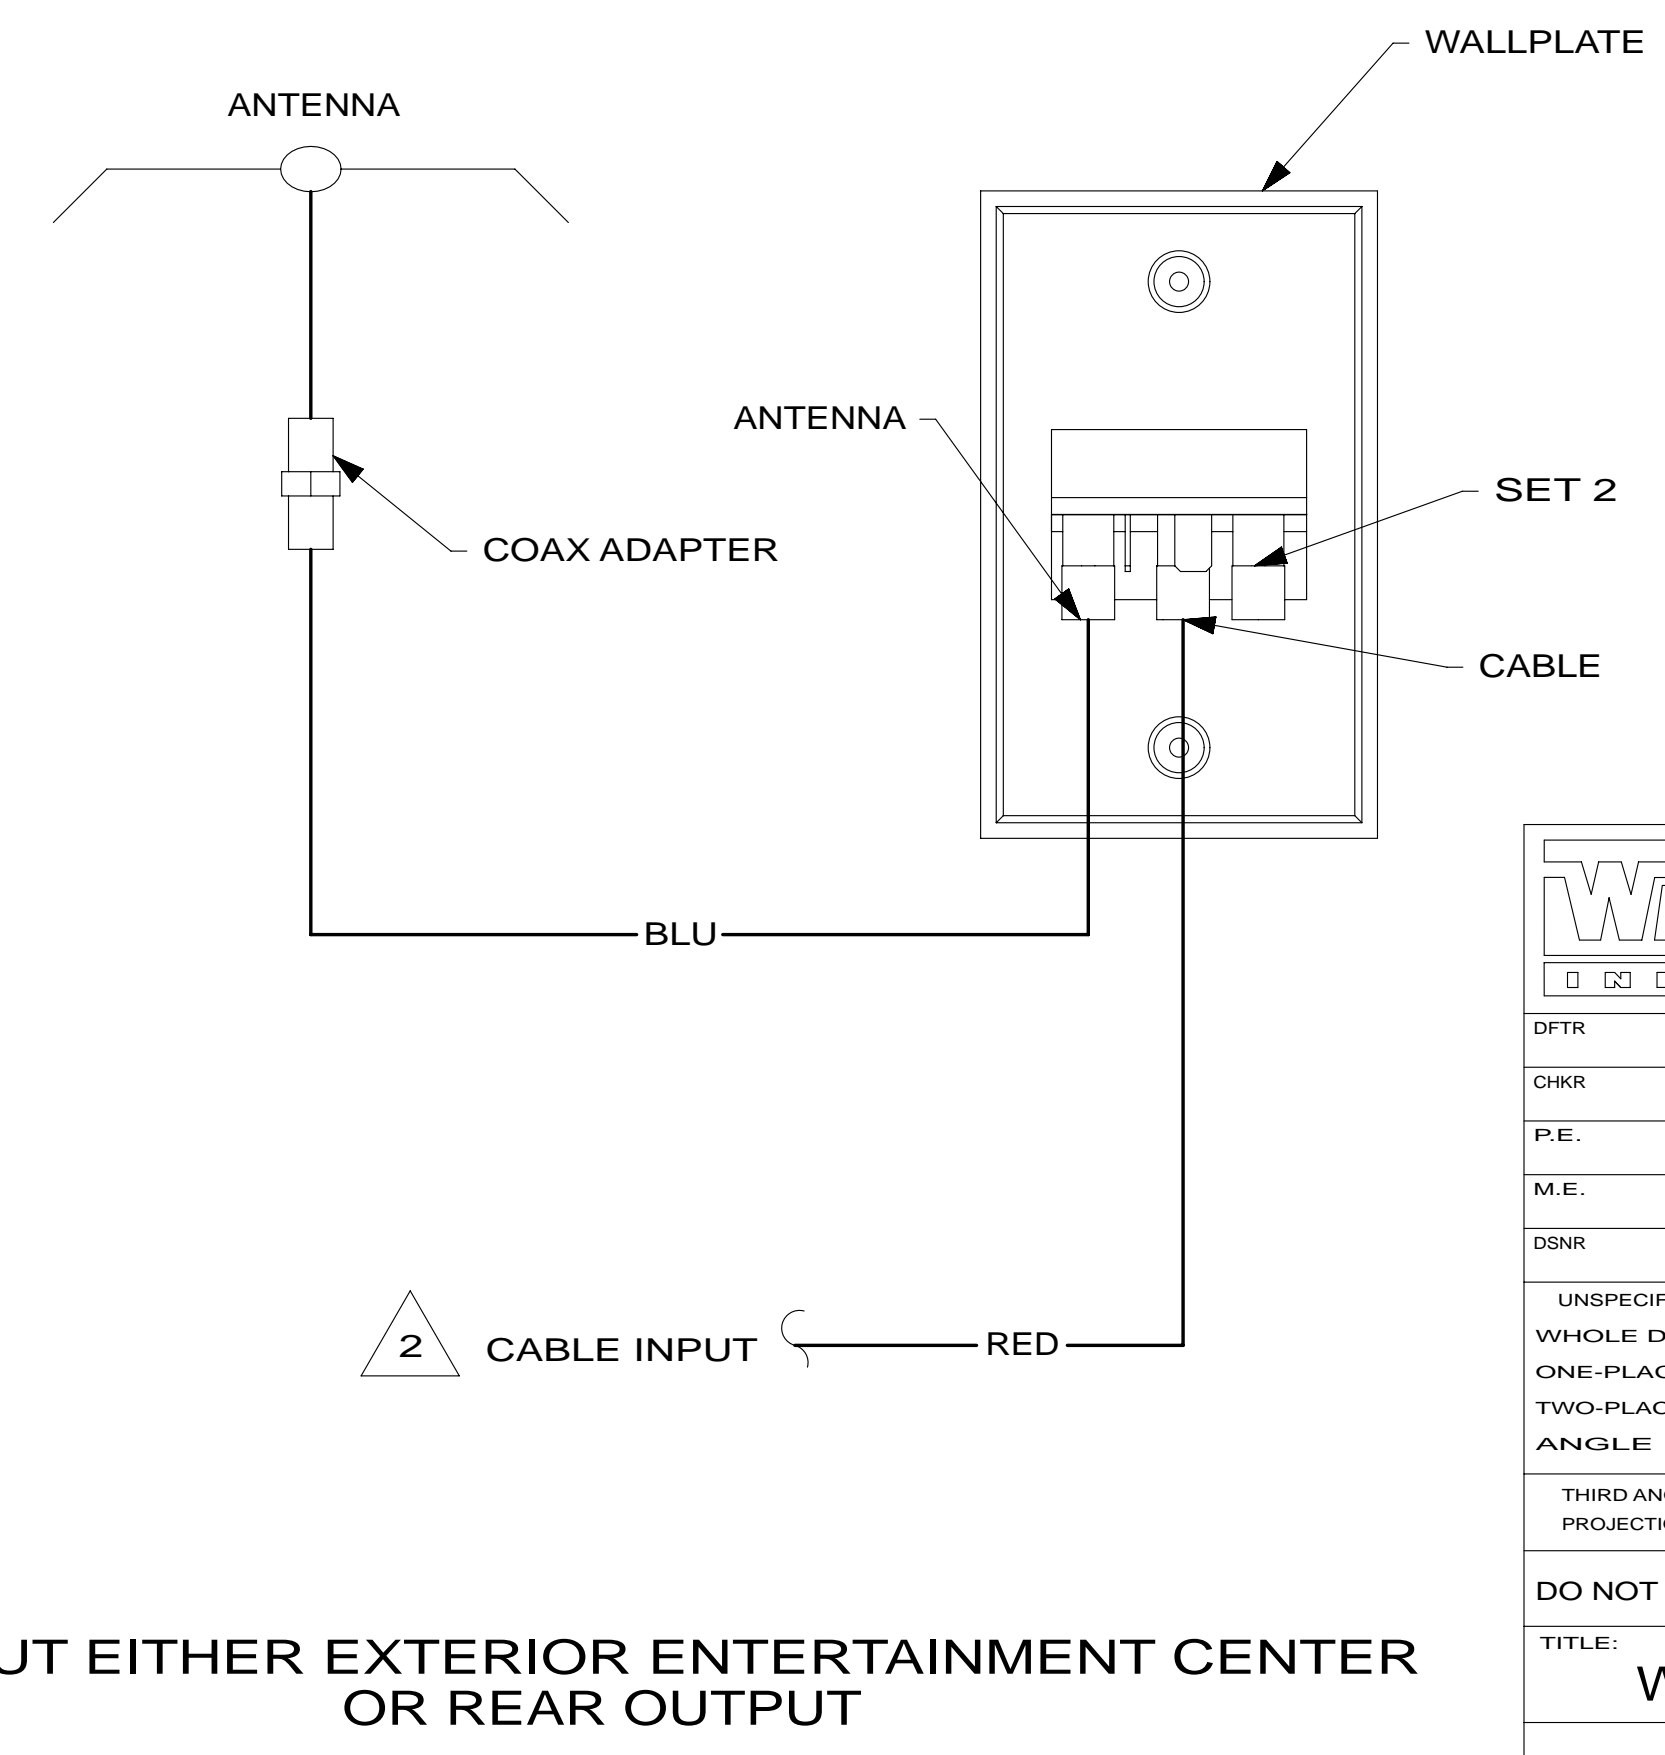
2 WITH SATELLITE DISH SEE SATELLITE DISH VIEW SHT 2 BOTTOM LEFT.

1 COLOR INDICATES IDENTIFICATION TAPE.
