WINNEBAGO		COPYRIGHT 2013 WINNEBAGO INDUSTRIES, INC.	
DFT-ORIG	ORIG. DATE	ALL DIMENSIONS ARE IN MILLIMETERS	
CHKR		FIRST USED	
P.E.		93 MOTORHAMES	
M.E.		MATERIAL:	
DSNR		UNSPECIFIED TOLERANCES ARE:	
		WHOLE DIM (X)	:
		ONE-PLACE (X.X)	:
		TWO-PLACE (X.XX)	:
		ANGLE	:
		THIRD ANGLE PROJECTION	
DO NOT SCALE DRAWING		REFER TO ES0018 FOR FASTENER TIGHTENING GUIDELINES	
TITLE: WIRING DIAGRAM-TV COAX			
SHEET 1 OF 2		PART NO	110138
REF:		1	03-Jan-2013

FIRST USED	93 MOTORHAMES
DO NOT SCALE DRAWING	
TITLE: WIRING DIAGRAM-TV COAX	
SHEET 2	PART NO 110138
03-Jan-2013

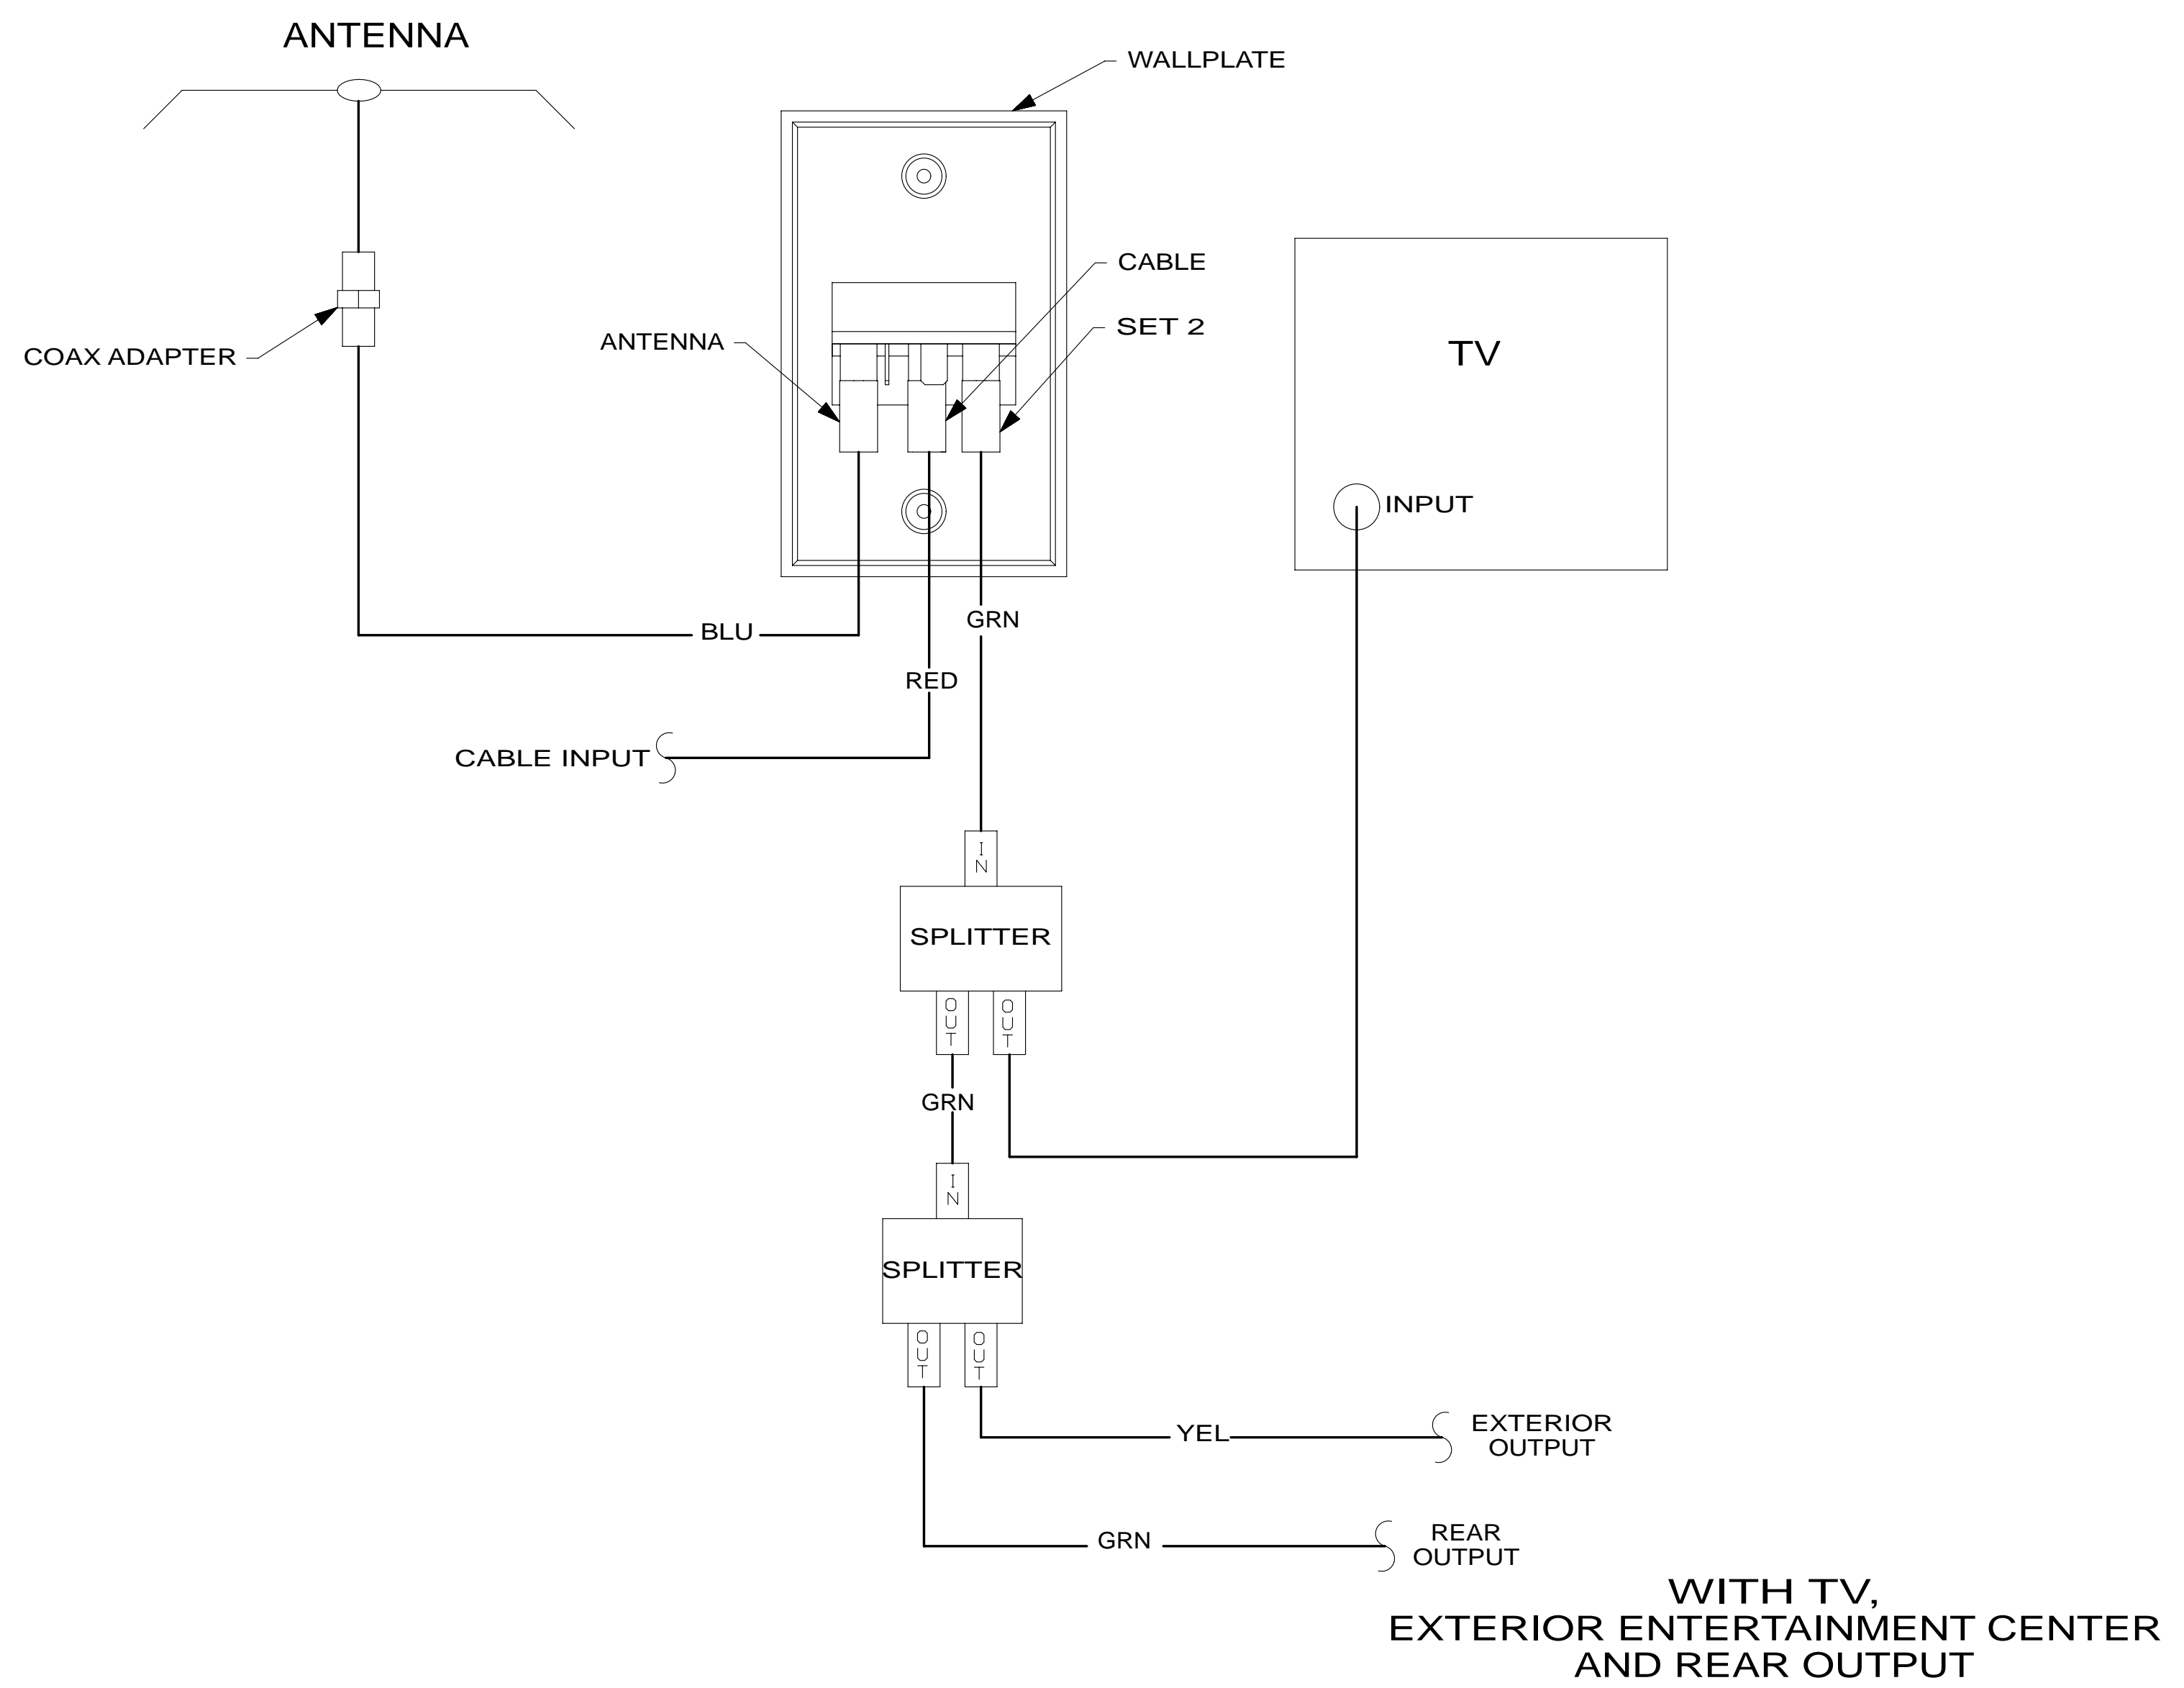
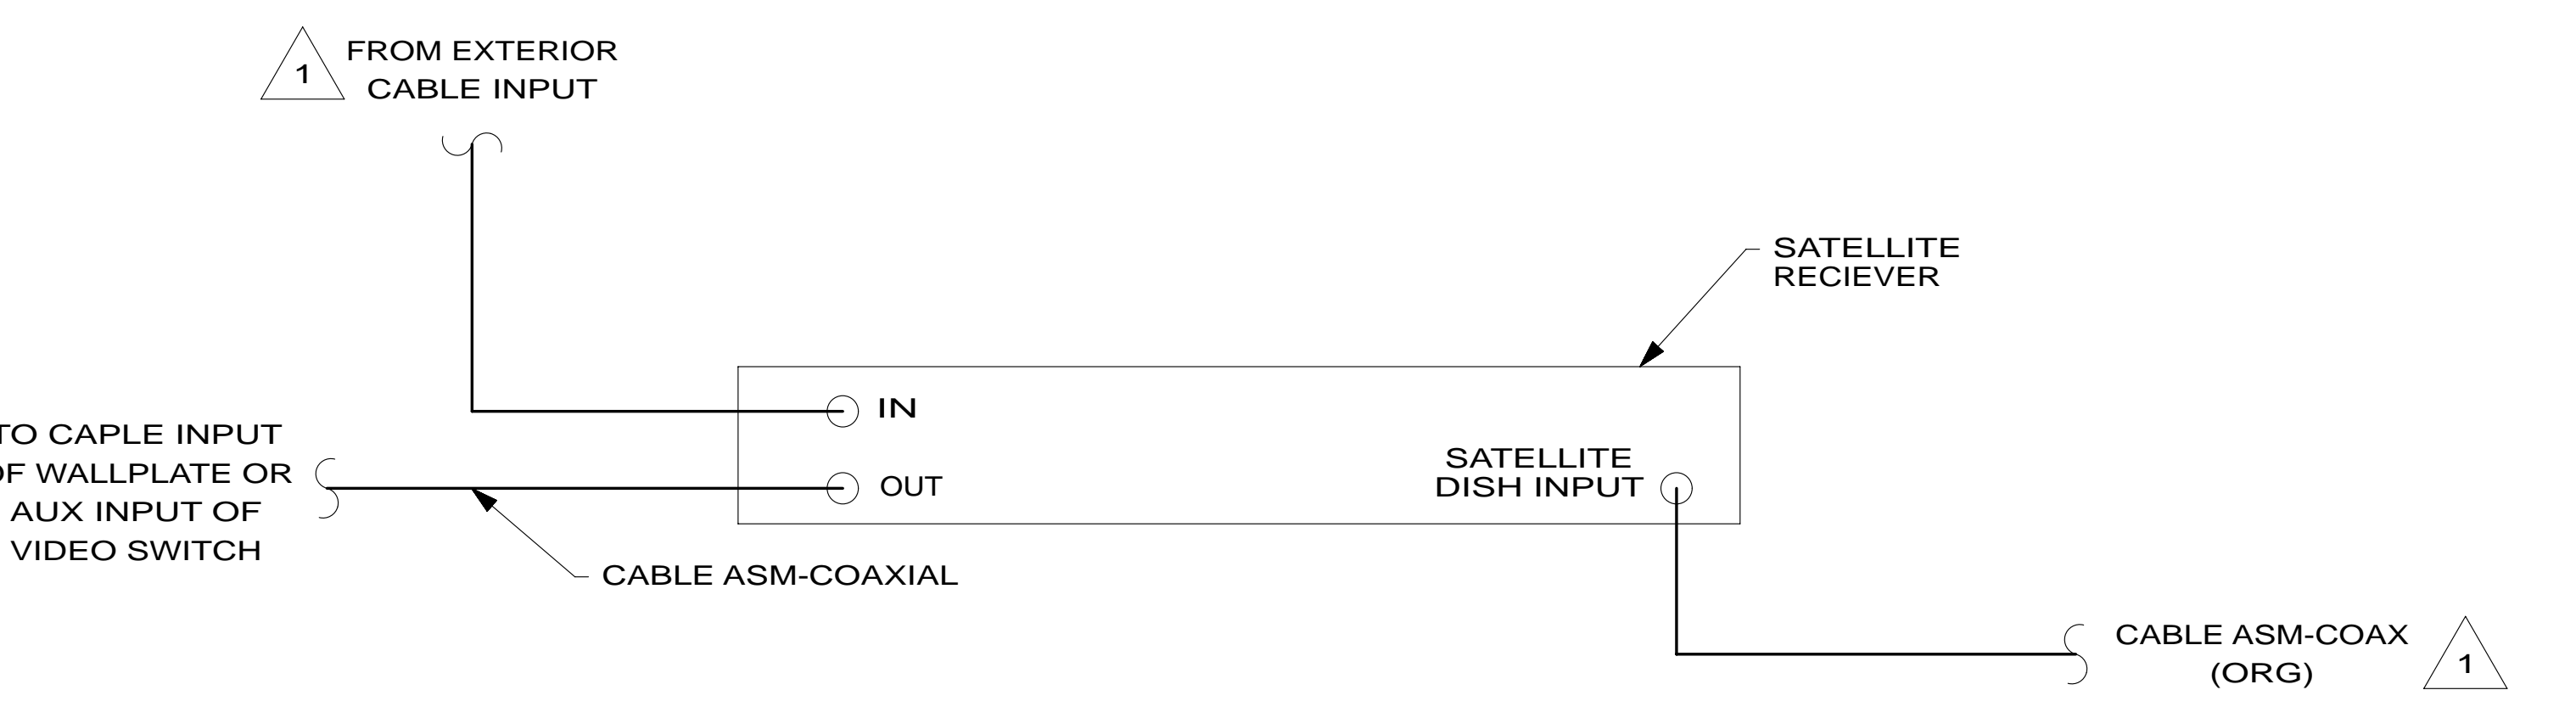
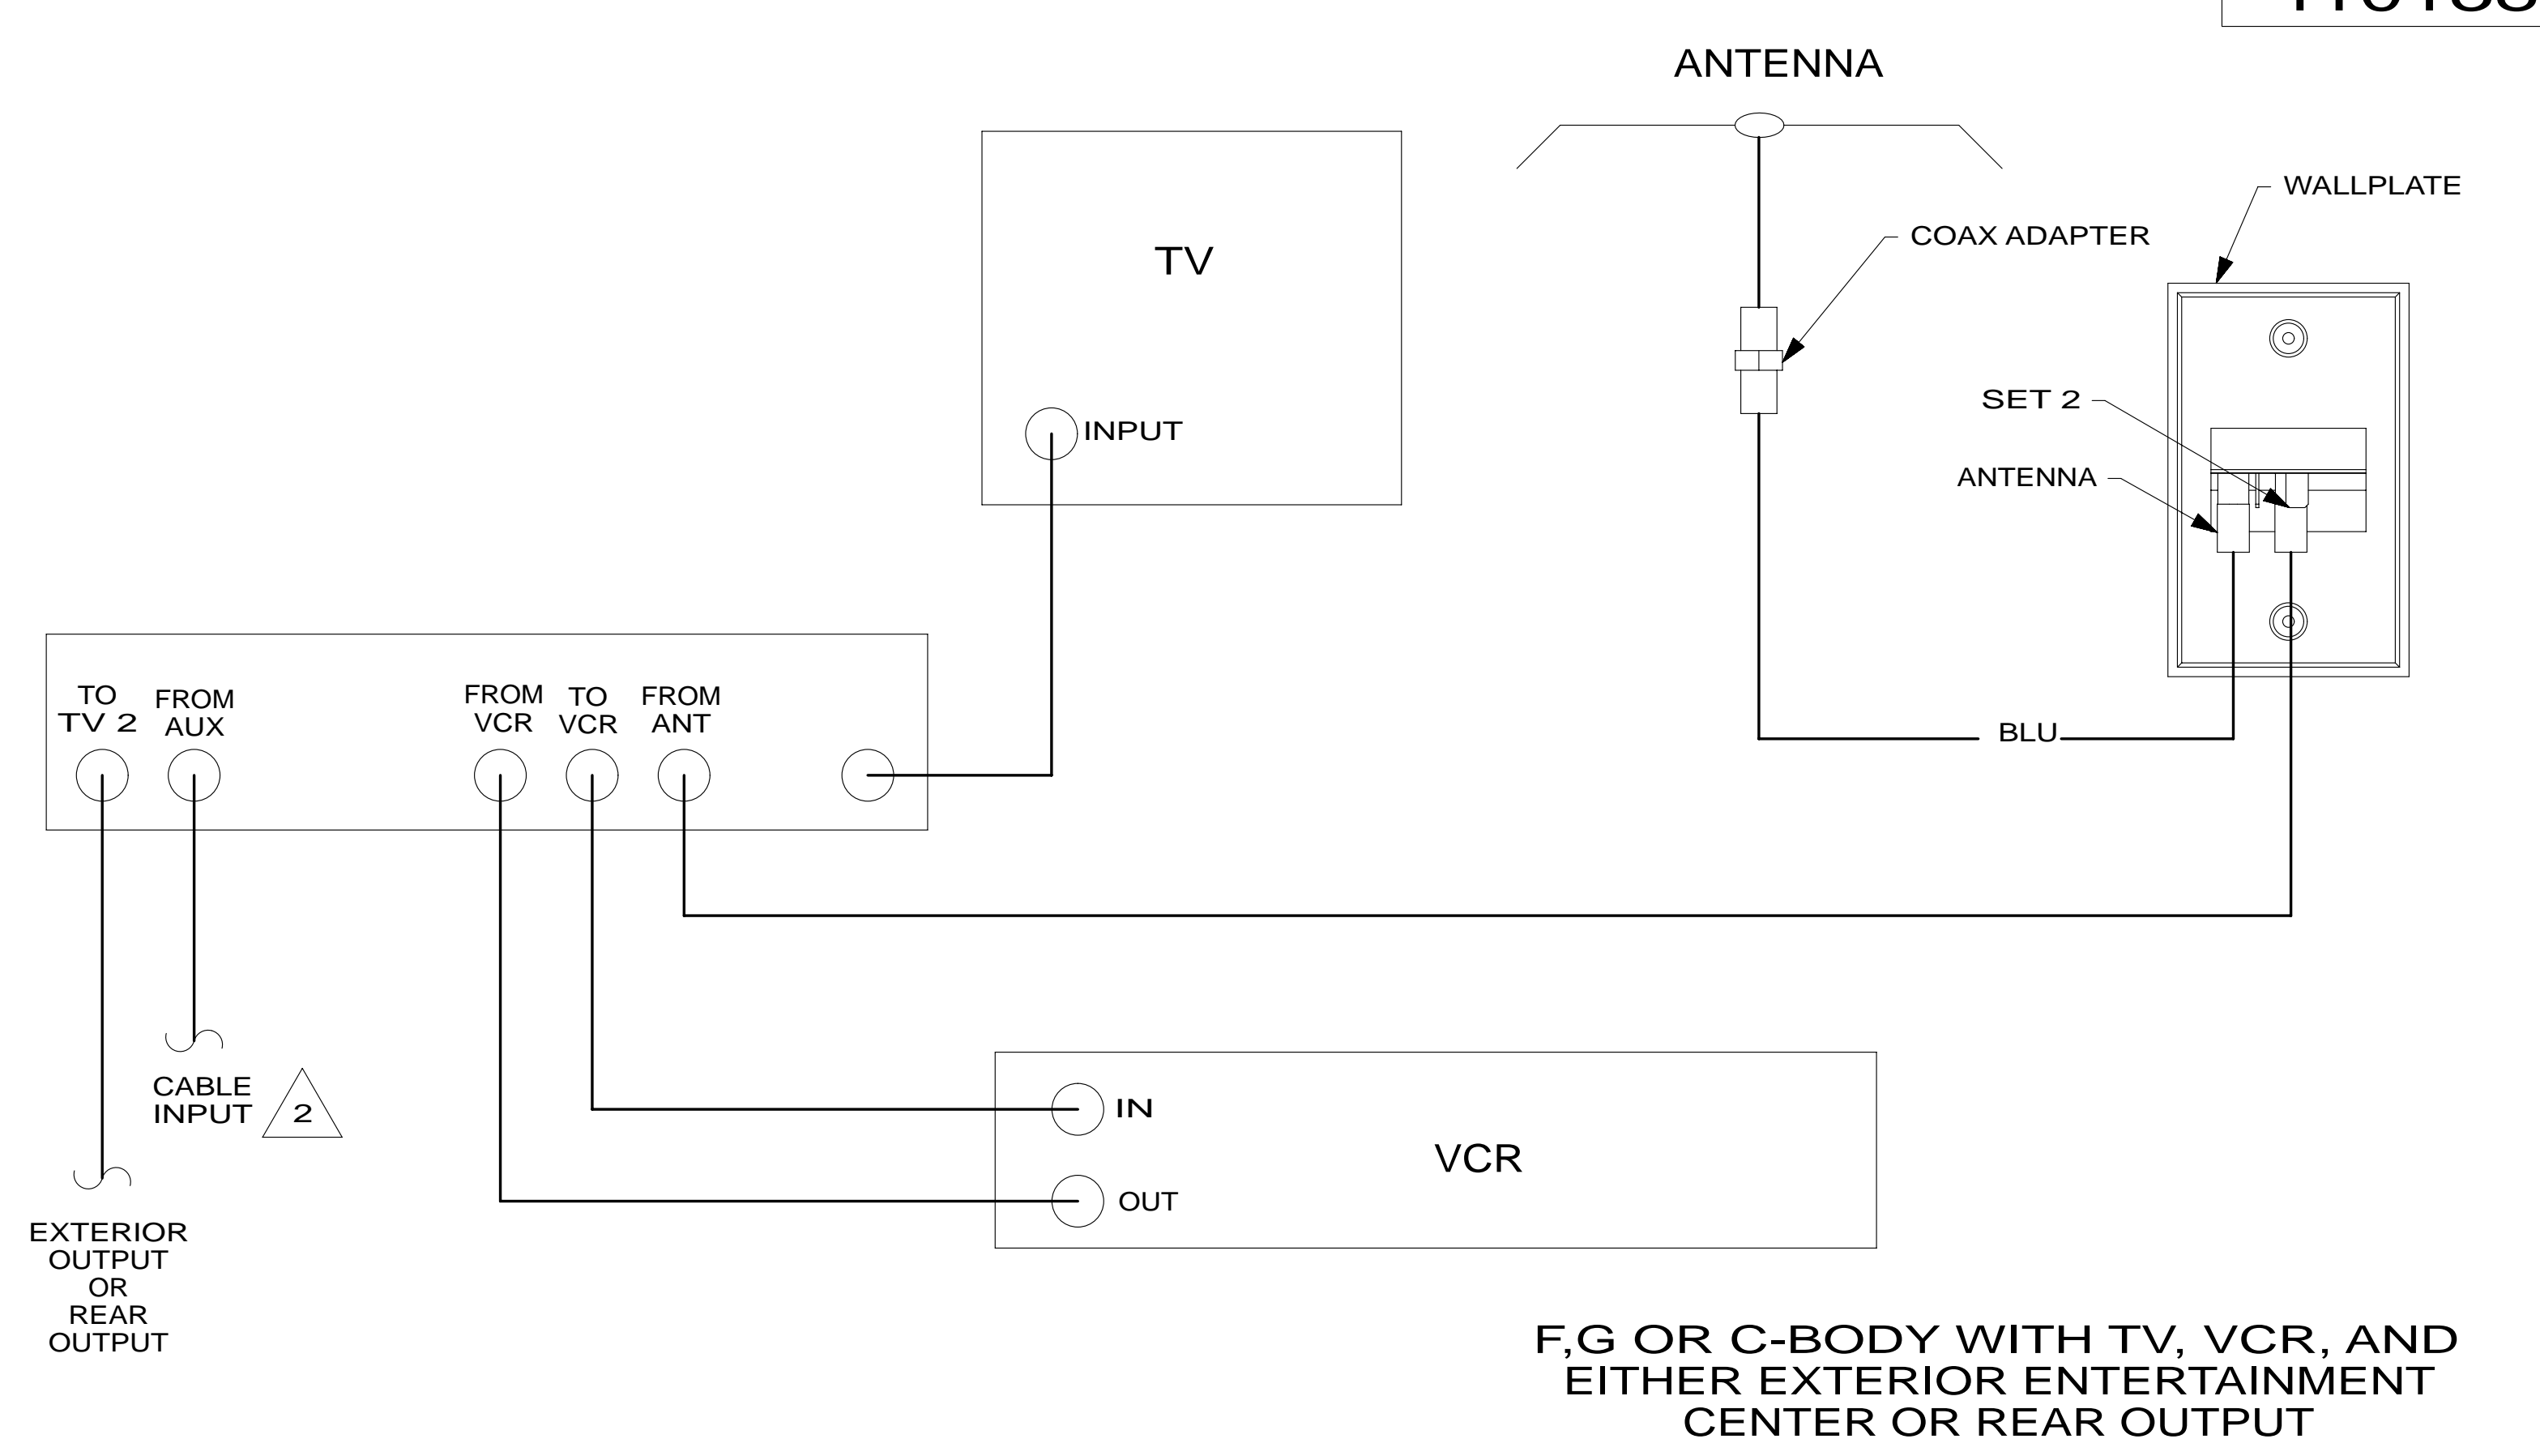
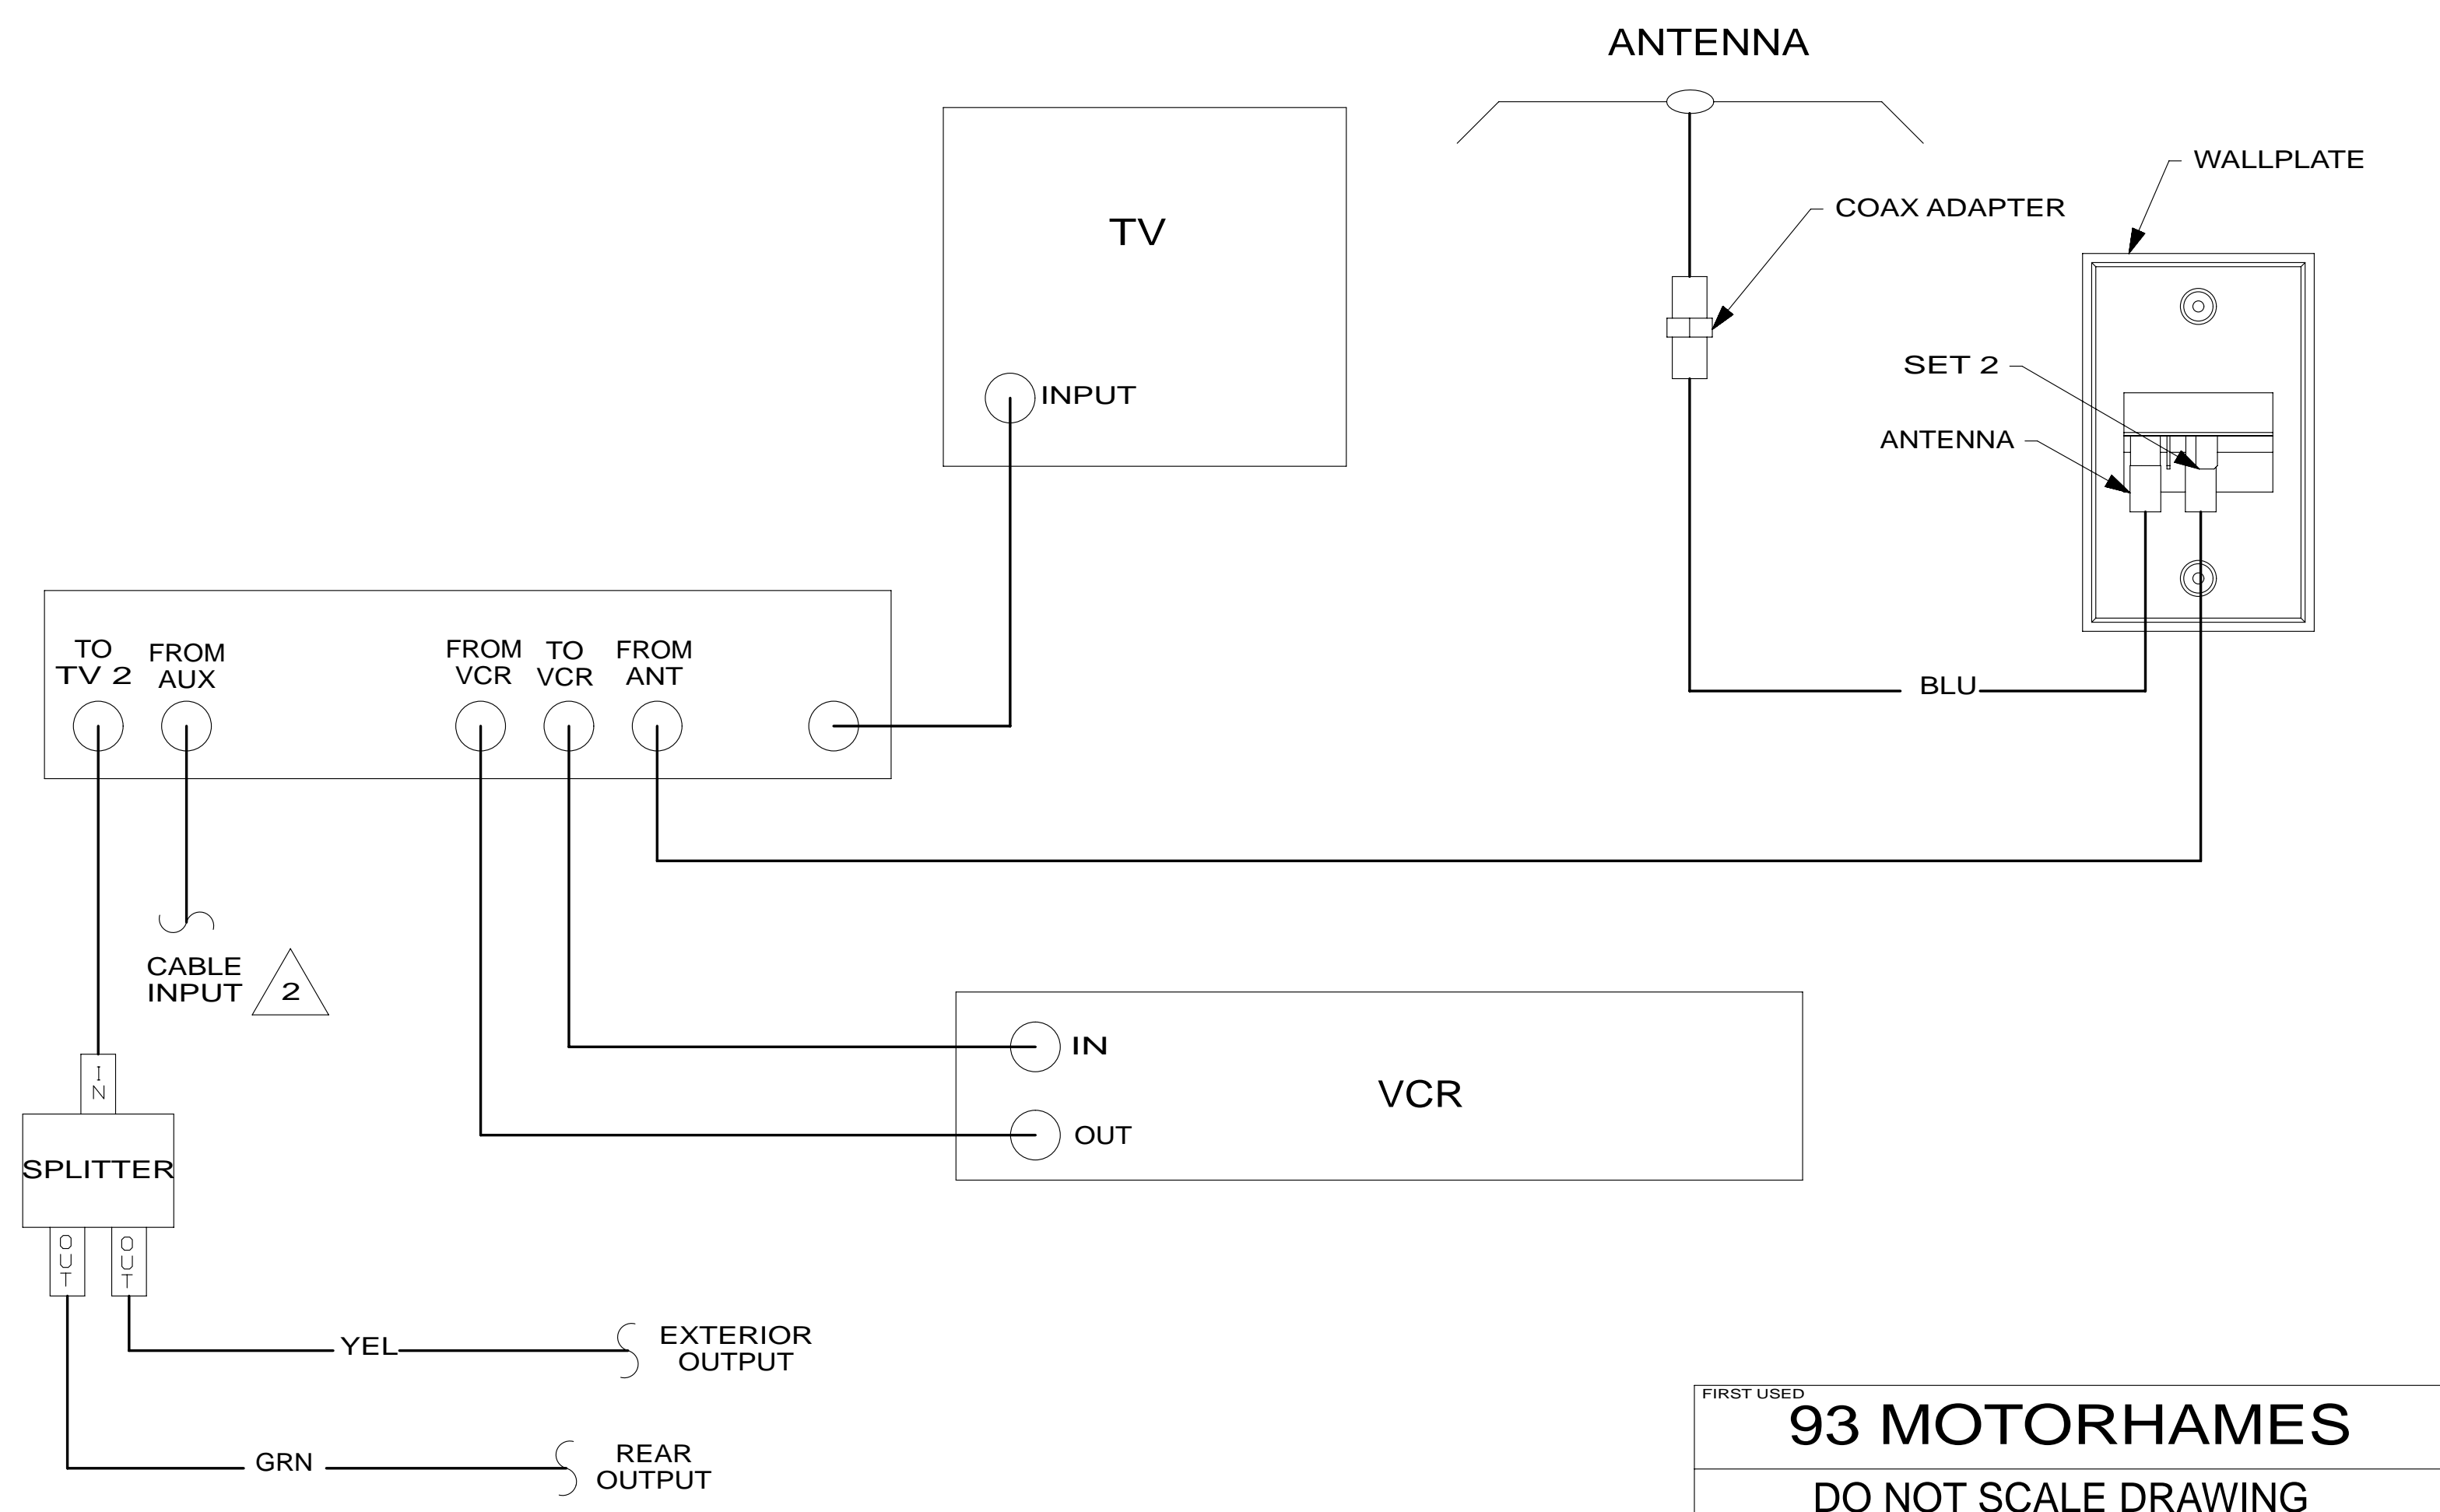
- NOTES:
- 2 WITH SATELLITE DISH SEE SATELLITE DISH VIEW BOTTOM LEFT.
 - 1 CONNECT TV COAX TO JACK ON FRONT OF WALLPLATE.
