WINNEBAGO		90 M-BODY
DATE	UNSPECIFIED TOLERANCES ARE:	MATERIAL
CHRP	ANGLE DIM (IN)	1:1.5
DR	ONE-PLACE (IN.XI)	.
BY	TWO-PLACE (IN.XXX)	.
CHK	ANGLE	.
CDR	THIRD ANGLE PROJECTION	
LABOR NO.	TITLE:	MONITOR INSTL
DIA #	SCALE: NONE	30 MET SCALE DRAWING
ALL DIMENSIONS ARE IN MILLIMETERS	SHEET 1	OF 2
2 REF: 93962	97641

TITLE: MONITOR INSTL	
30 NET SCALE (Drawing)	REV (ing)
SHEET 2 of 2	1 E
97641

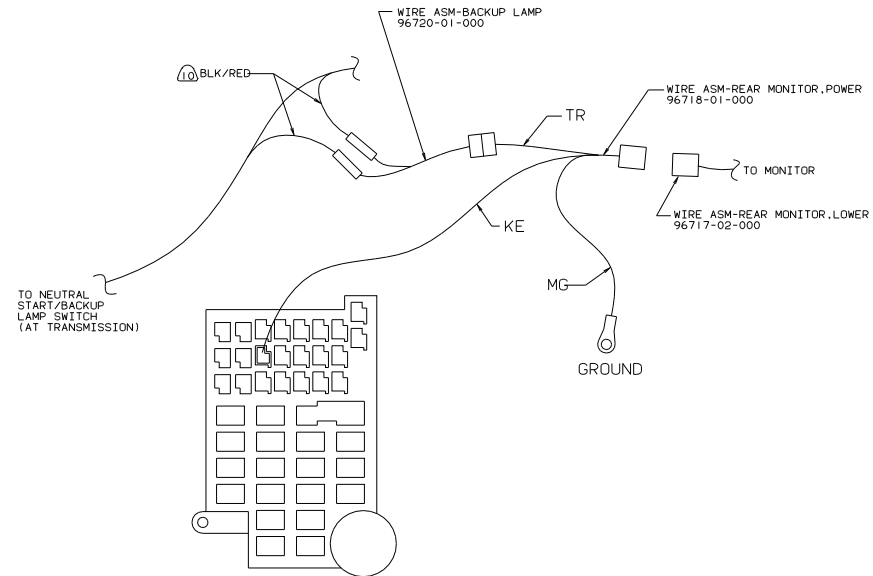
JOHN DEERE
(OSHKOSH)

- (10) CUT WIRE AND RECONNECT AS SHOWN.
- (9) FASTEN PART TO SHROUD USING TAPE 76322-03-000.
- (8) PARTS SUPPLIED WITH CAMERA KIT P/N 93040-01-000.
- 7. INSERTS ARE LOCATED INSIDE OF OVERHEAD CABINETS.
- (6) THESE ARE SCREW LOCATIONS, NOT PRE-DRILLED HOLES.
- (5) MANUFACTURING TO DRILL HOLE THROUGH PLASTIC AND STEEL PLATE.
- (4) FACE OF MONITOR TO BE TOWARDS DRIVER, APPROX 45° OFF CENTER.
- 3. CAP SEAL AROUND RUBBER GROMMET WITH SILICONE P/N 78474-01-CHT.
- 2. CLAMP CABLE WITH WINNEBAGO WIRE ASM ALONG LEFT CHASSIS RAIL THEN UP LEFT HAND SIDE OF REAR CAP.
- (1) PARTS SUPPLIED WITH CAMERA KIT P/N 93040-02-000.
