78J ELECTRICAL SYS 50-AMP

99 M39Y
50 AMP CAN

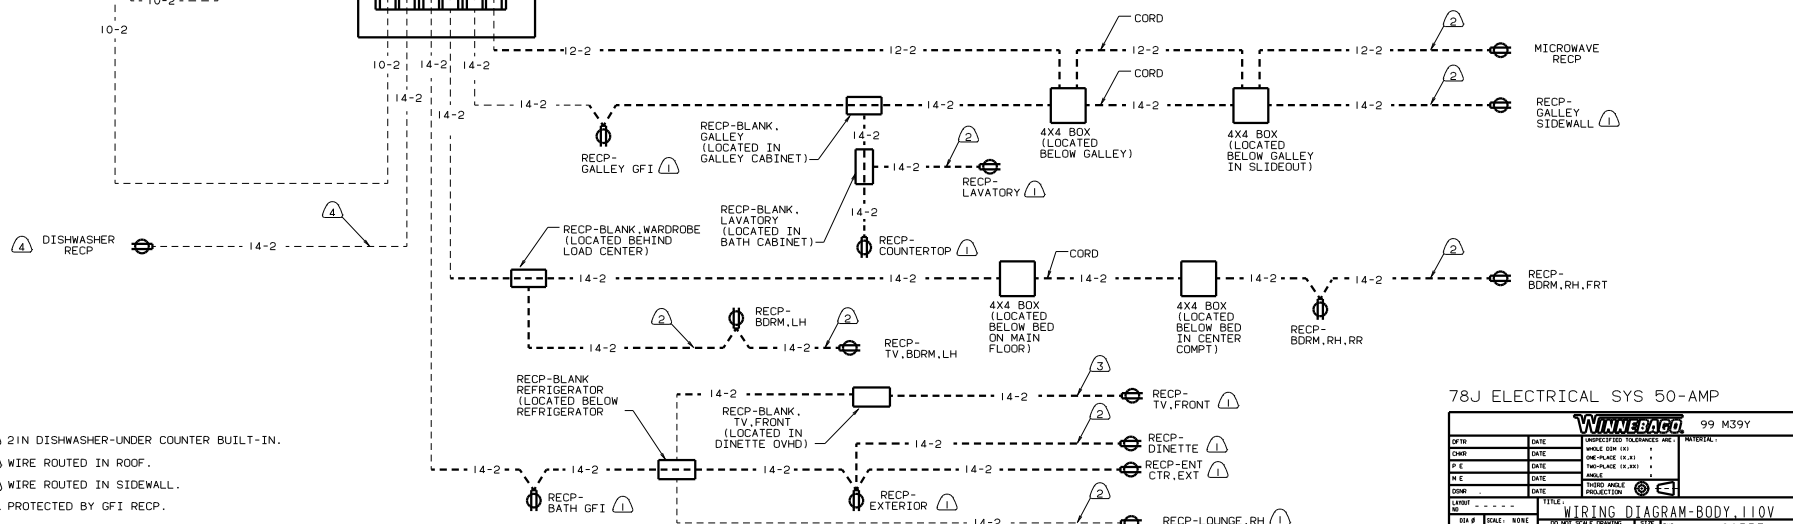
CENTRAL AIR UNIT
 (LOCATED IN RIGHT REAR COMPARTMENT BELOW FLOOR)

INVERTER BREAKER PANEL

- ④ 2IN DISHWASHER-UNDER COUNTER BUILT-IN.
- ③ WIRE ROUTED IN ROOF.
- ② WIRE ROUTED IN SIDEWALL.
- ① PROTECTED BY GFI RECP.
