99 322E
OF IN	DATE	UNSPECIFIED TOLERANCES ARE
CHP	DATE	WHOLE OR 1/16"
DR	DATE	ONE-PLACE (1/32) "
PL	DATE	TWO-PLACE (1/64) "
CON	DATE	THREE-PLACE (1/128) "
TITLE: <b>WIRING DIAGRAM-BODY, 12V</b>		SHEET 1 OF 5
REF: 126214		129065

WIRING DIAGRAM-CHASSIS  
 (WIRE ASM 129122)  
 (FORD CHASSIS) 99 322E

WIRING DIAGRAM-LEFT  
 (WIRE ASM-129127)

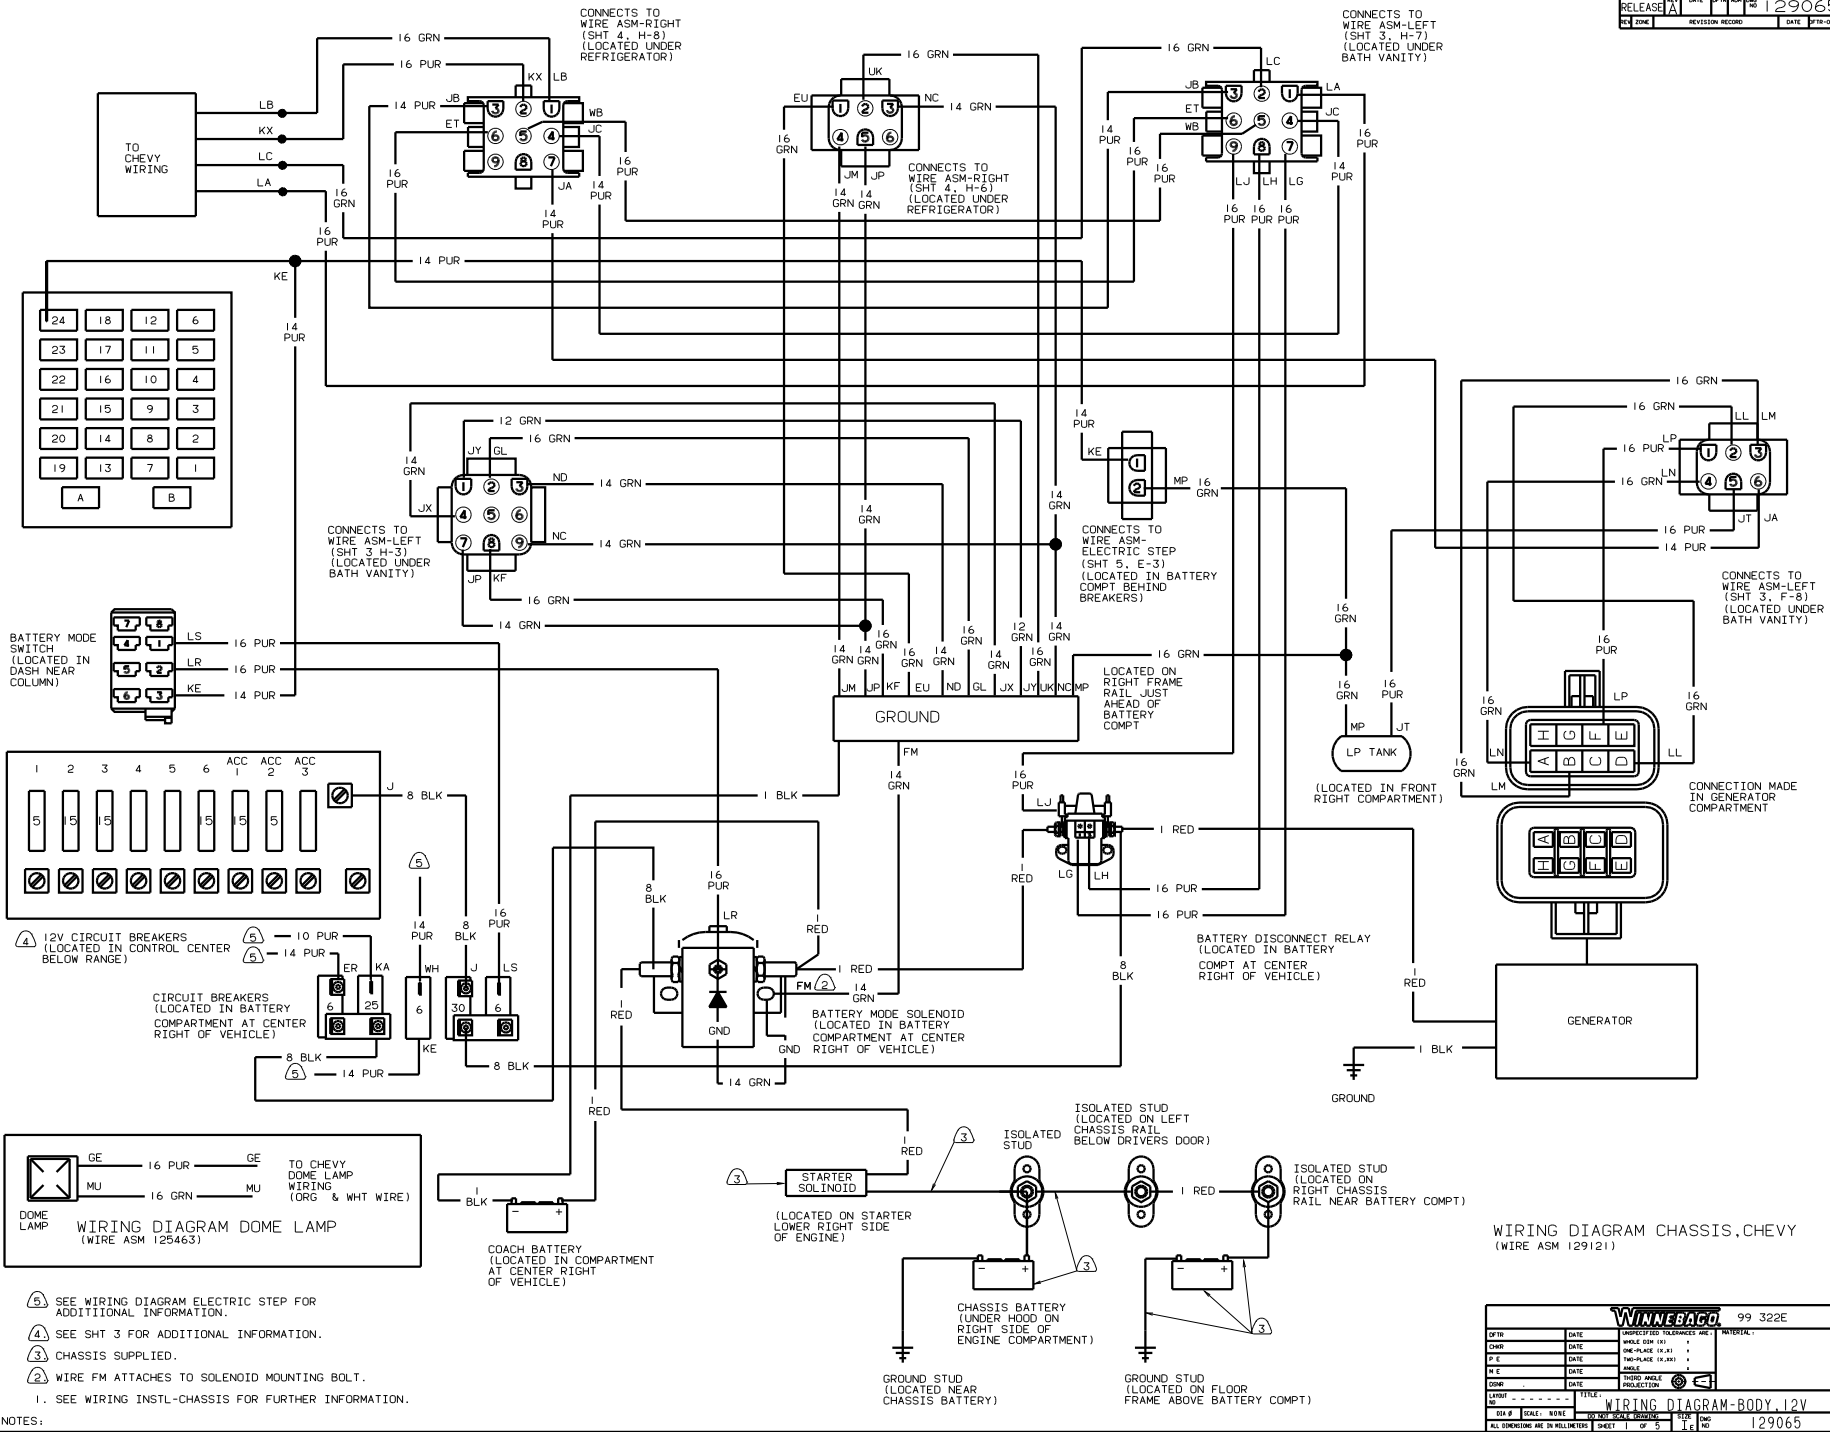
- ③ SEE WIRING DIAGRAM ELECTRIC STEP FOR ADDITIONAL INFORMATION.
- ④ SEE SHT 3 FOR ADDITIONAL INFORMATION.
- ③ CHASSIS SUPPLIED.
- ② WIRE FM ATTACHES TO SOLENOID MOUNTING BOLT.
- 1. SEE WIRING INSTL-CHASSIS FOR FURTHER INFORMATION.

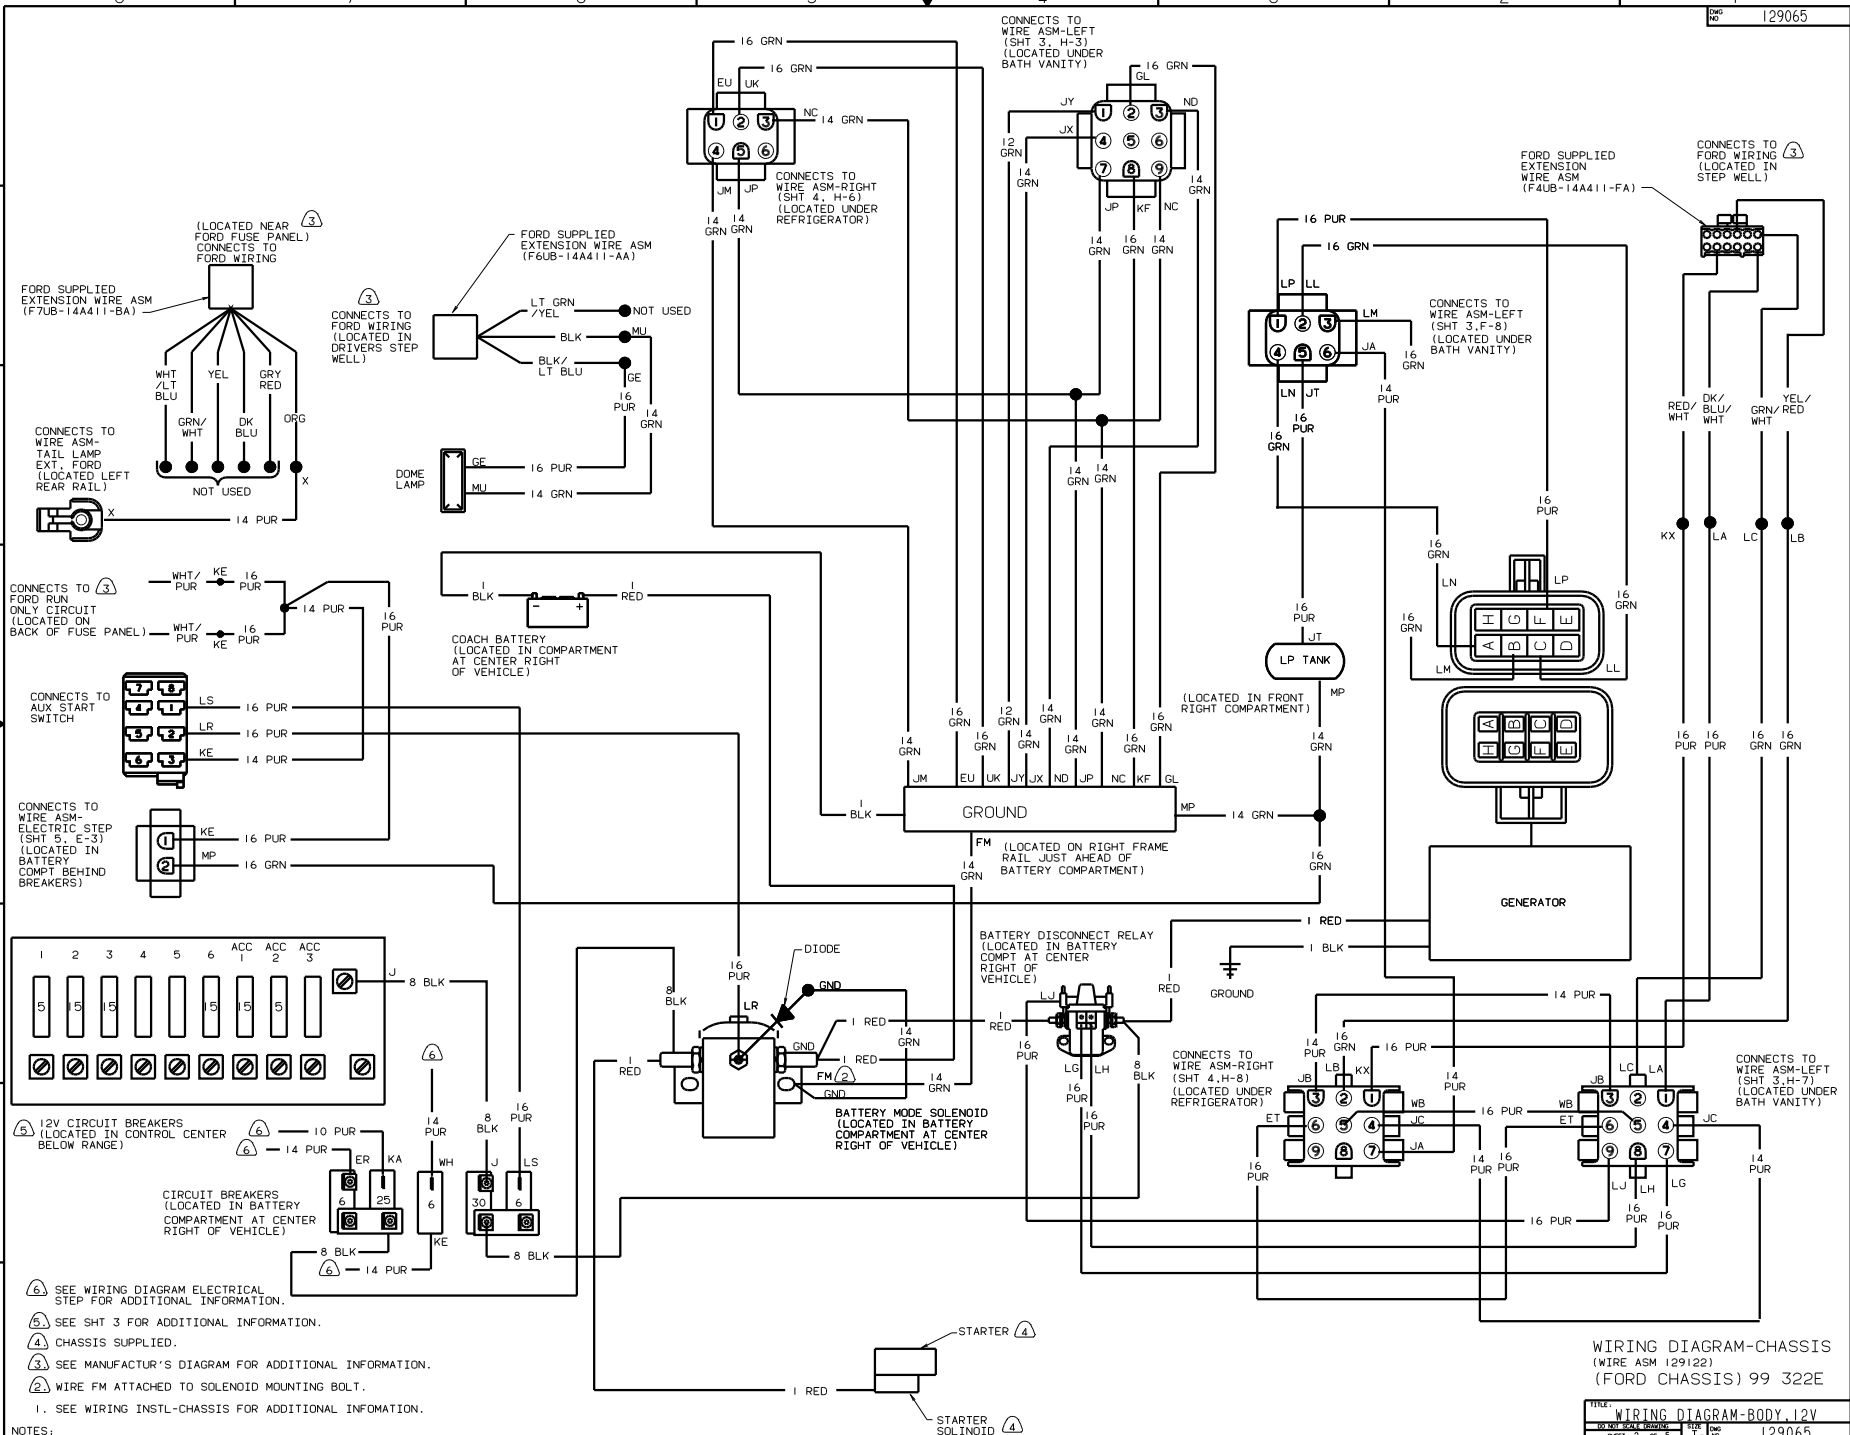
FIG. NO.	129065
NO. OF SHEETS	5
SHEET NO.	2
DATE	1/6
REV.	1

NOTES:  
 1. SEE WIRING INSTL-CHASSIS FOR ADDITIONAL INFORMATION.

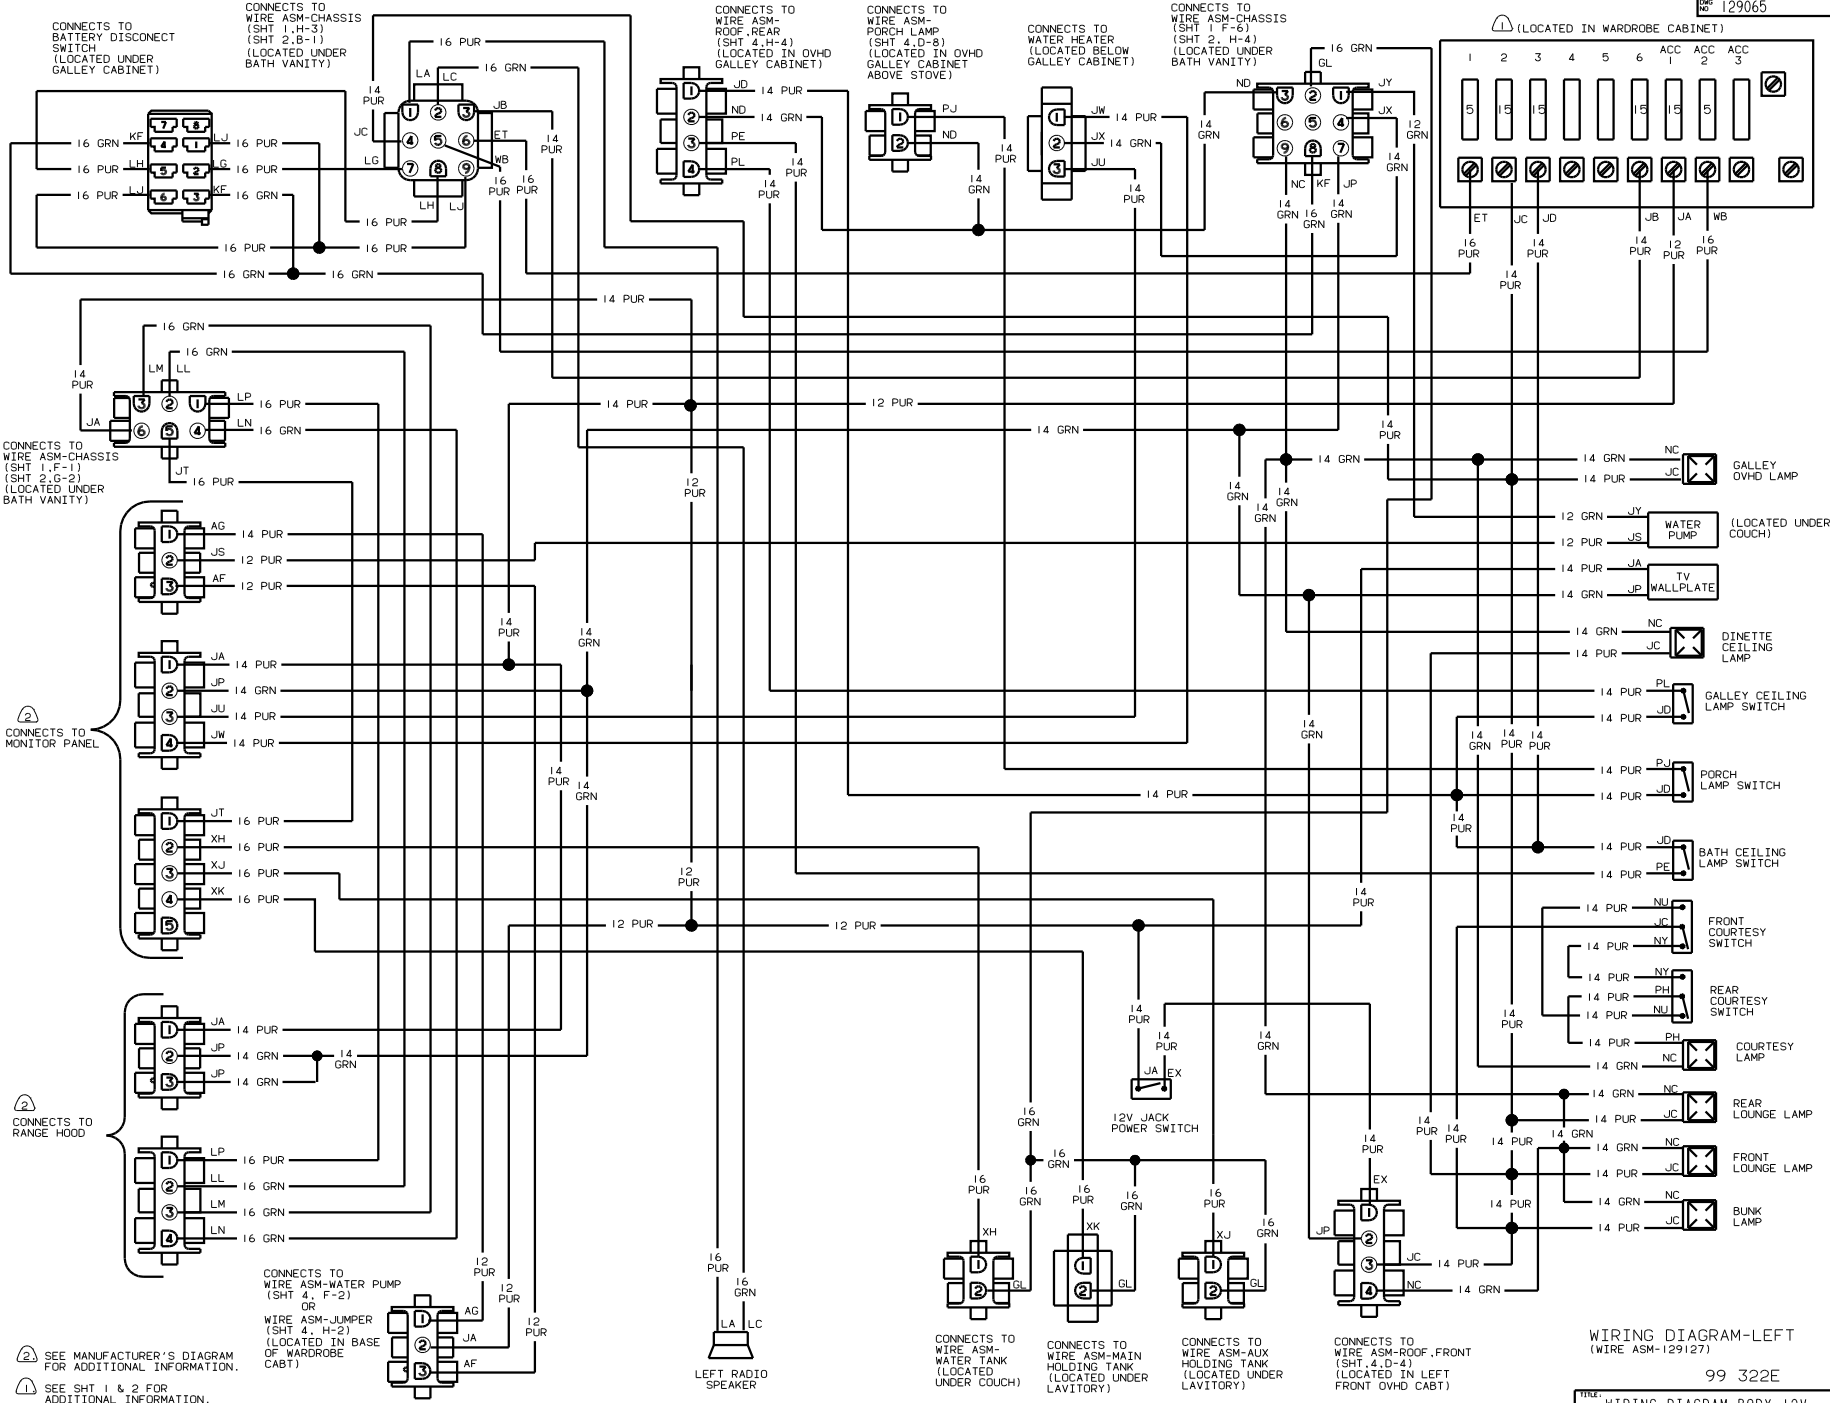
TITLE:	WIRING DIAGRAM-BODY_12V
NO. OF SHEETS DRAWING:	1 of 1
SHEET NO.:	3 of 5
DATE:	129065

NOTES:  
 ① SEE MANUFACTURER'S DIAGRAM FOR ADDITIONAL INFORMATION.  
 ② SEE SHT 1 & 2 FOR ADDITIONAL INFORMATION.

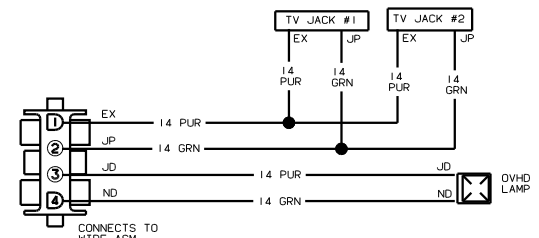
CONNECTS TO  
WIRE ASM-  
ROOF FRONT  
(SHT 4, C-1)  
(LOCATED IN  
OVHD TV CABT)

WIRING DIAGRAM-OVHD,TV  
(WIRE ASM 128775)

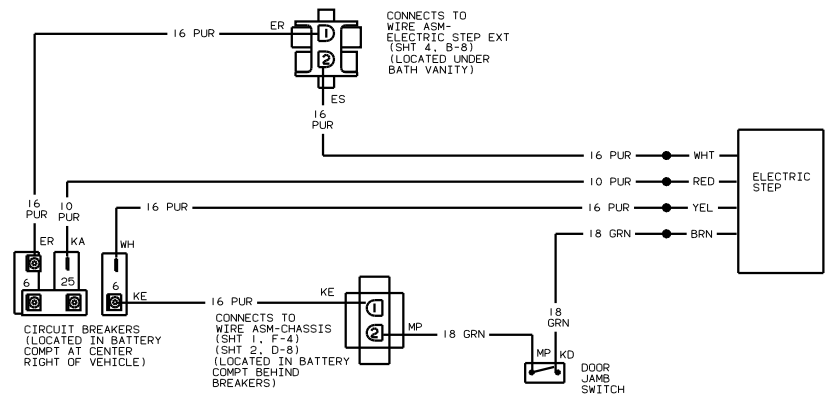
CONNECTS TO  
WIRE ASM-  
ELECTRIC STEP EXT  
(SHT 4, B-8)  
(LOCATED UNDER  
BATH VANITY)

CIRCUIT BREAKERS  
(LOCATED IN BATTERY  
COMPT AT CENTER  
RIGHT OF VEHICLE)

CONNECTS TO  
WIRE ASM-CHASSIS  
(SHT 1, F-4)  
(SHT 2, D-8)  
(LOCATED IN BATTERY  
COMPT BEHIND  
BREAKERS)

WIRING DIAGRAM-ELECTRIC STEP  
(WIRE ASM 129123)  
(W/ELECTRIC STEP)
