WINNEBAGO 99 L-SERIES

WIRING DIAGRAM-AUTO LAMPS

129783

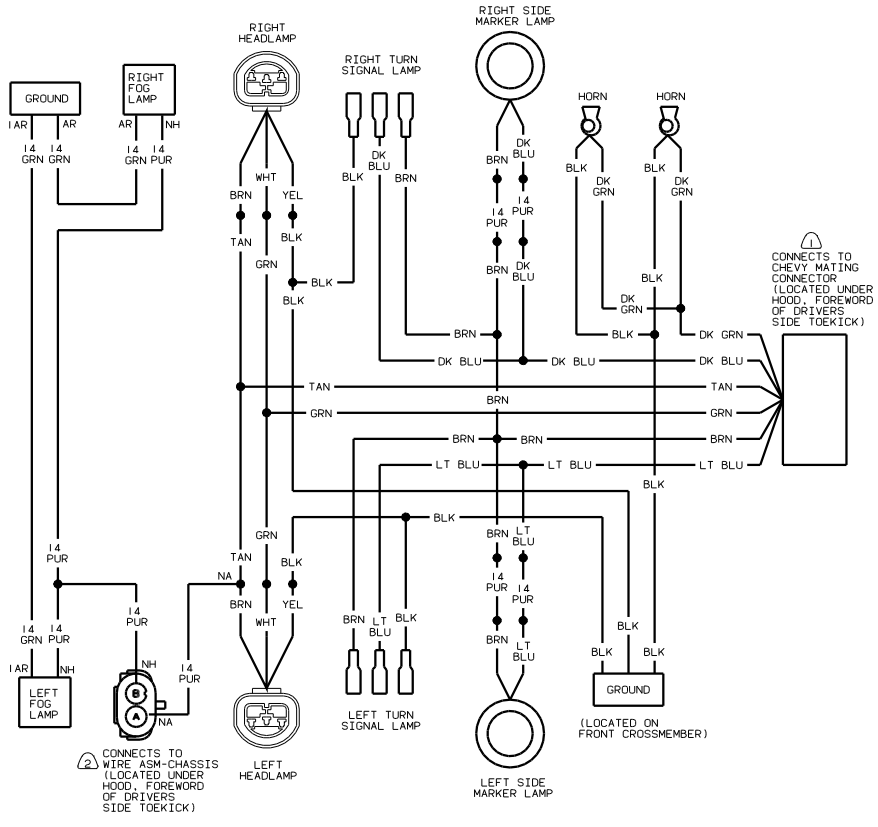
WIRING DIAGRAM-HEADLAMP
(CHEVY CHASSIS)
(WIRE ASM 126816-01)

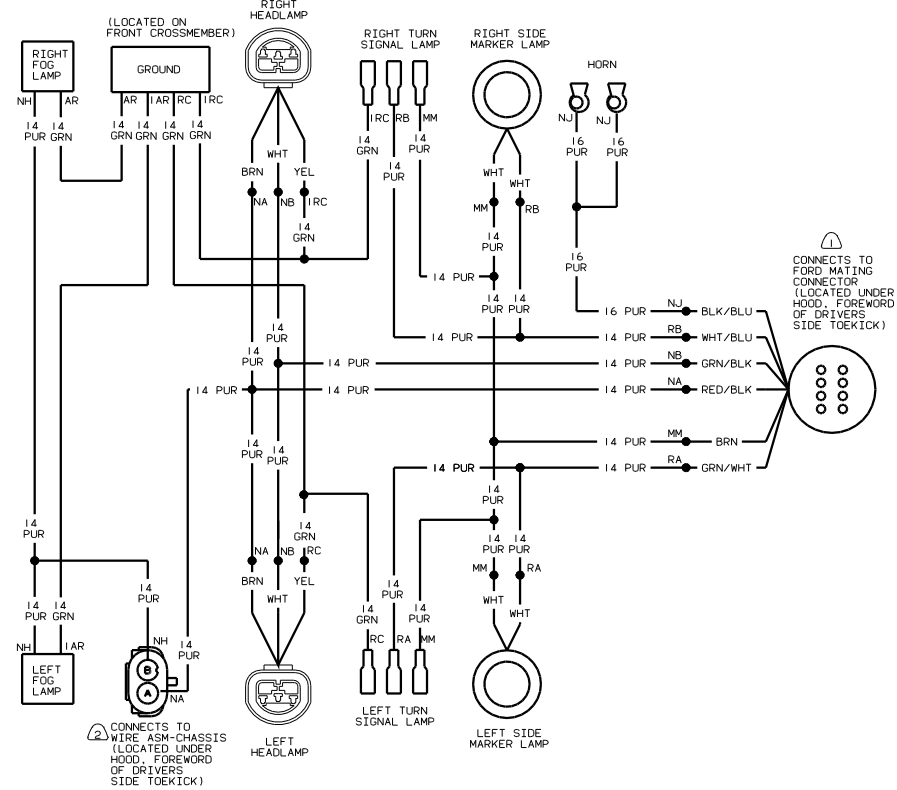
WIRING DIAGRAM-HEADLAMP
(FORD CHASSIS)
(WIRE ASM 126816-02)

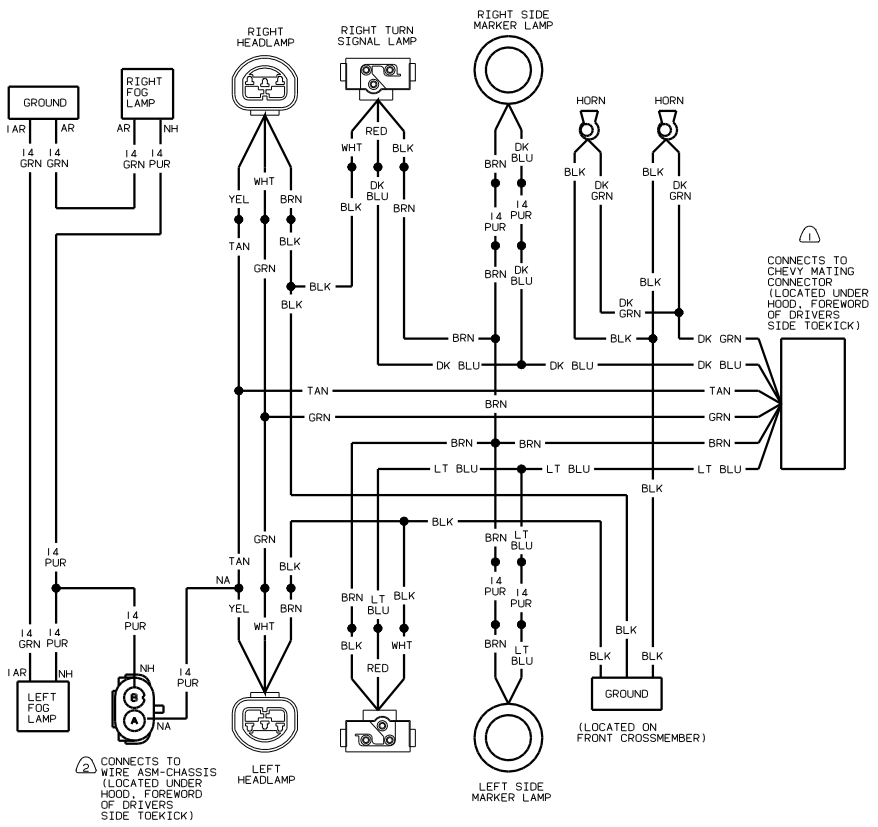
WIRING DIAGRAM-HEADLAMP
(CHEVY CHASSIS)
(WIRE ASM 126865-01)

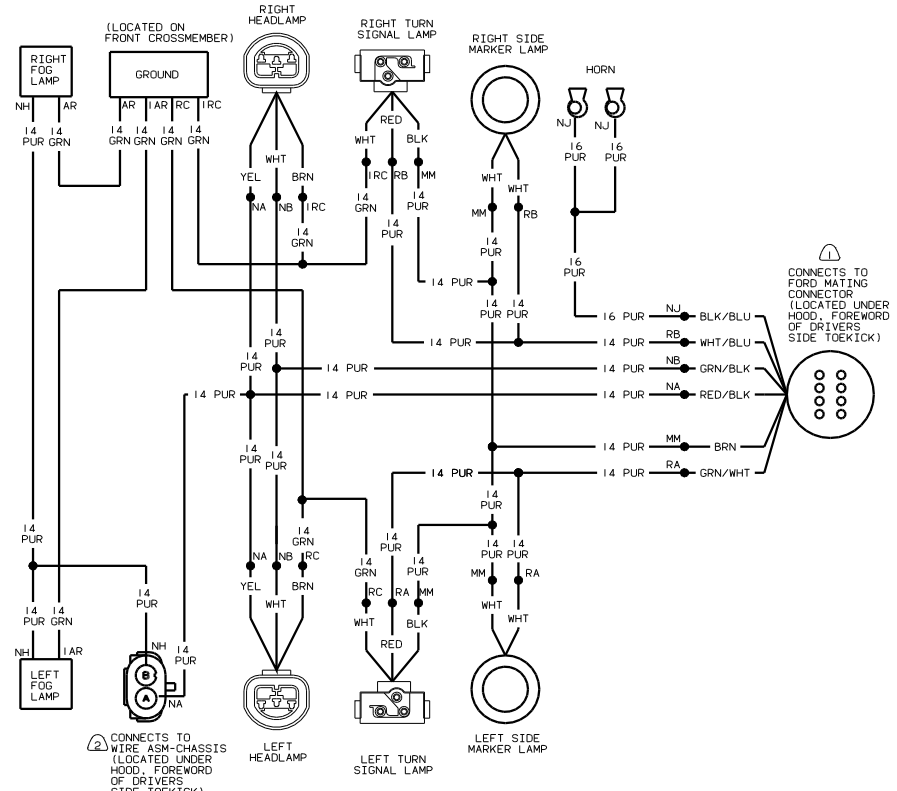
WIRING DIAGRAM-HEADLAMP
(FORD CHASSIS)
(WIRE ASM 126865-02)

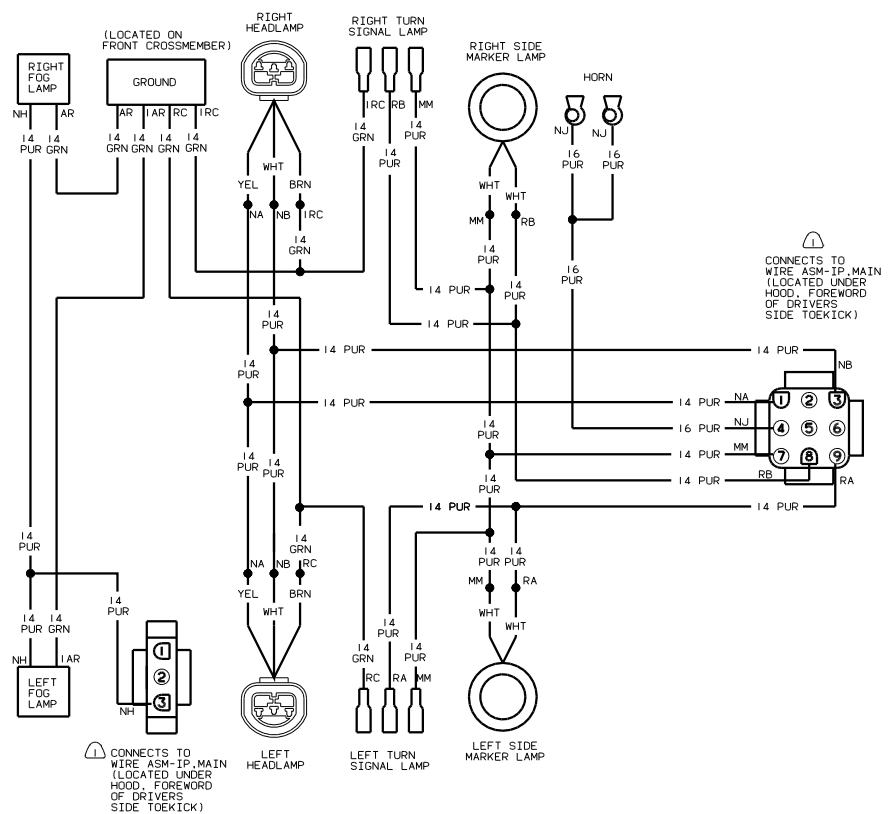
WIRING DIAGRAM-HEADLAMP
 (WINNEBAGO)
 (FREIGHTLINER CHASSIS)
 (WIRE ASM 126816-03)

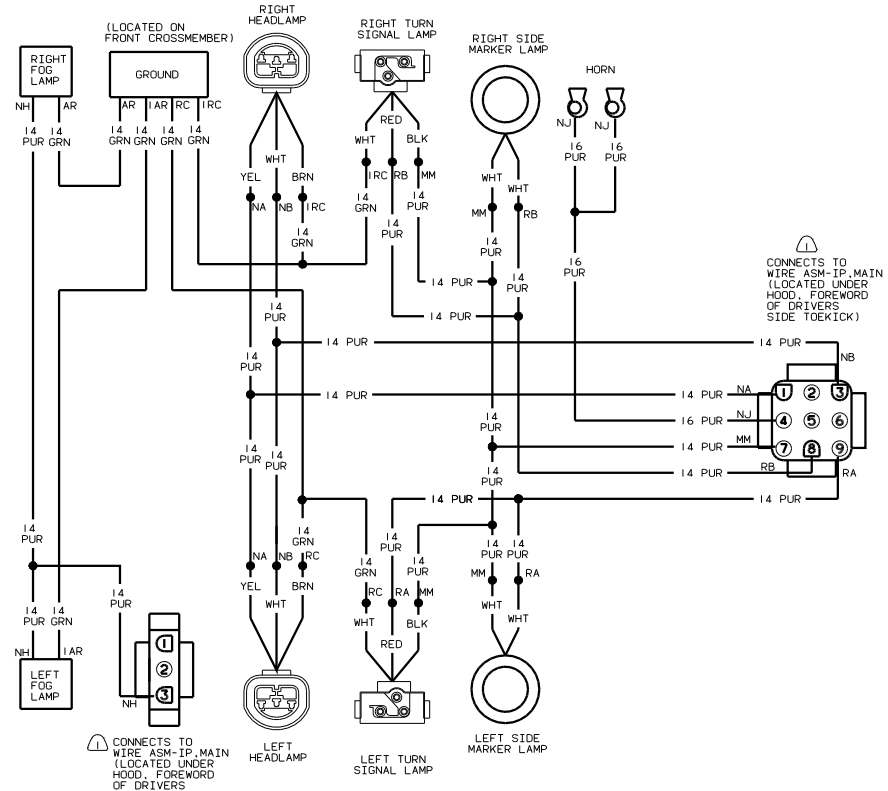
WIRING DIAGRAM-HEADLAMP
 (ITASCA)
 (FREIGHTLINER CHASSIS)
 (WIRE ASM 126865-03)

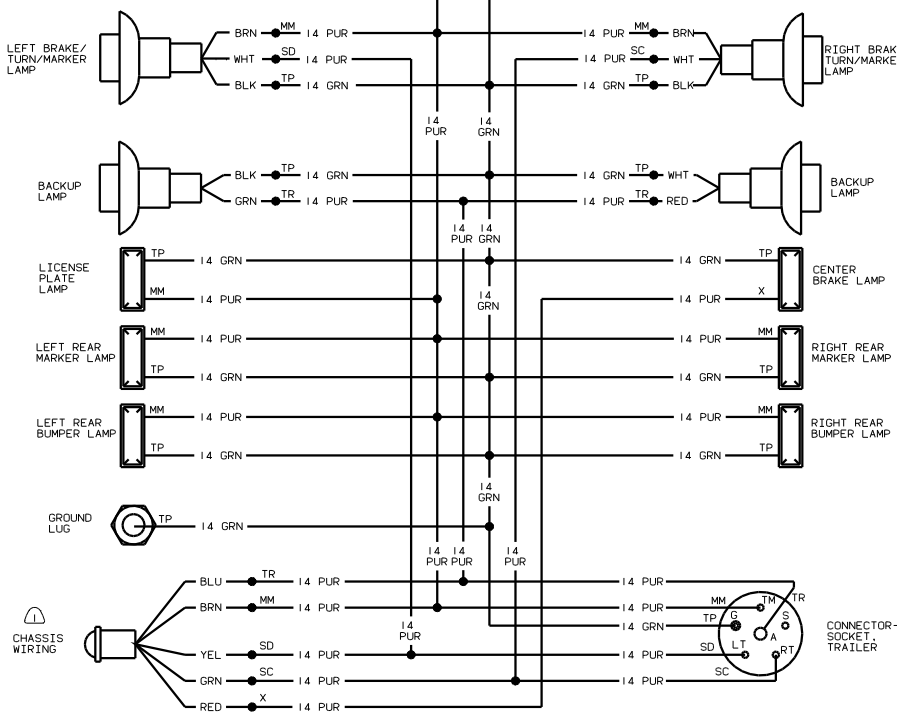
WIRING DIAGRAM-BACKWALL
(FREIGHTLINER CHASSIS)
(WIRE ASM-129777-04-000)

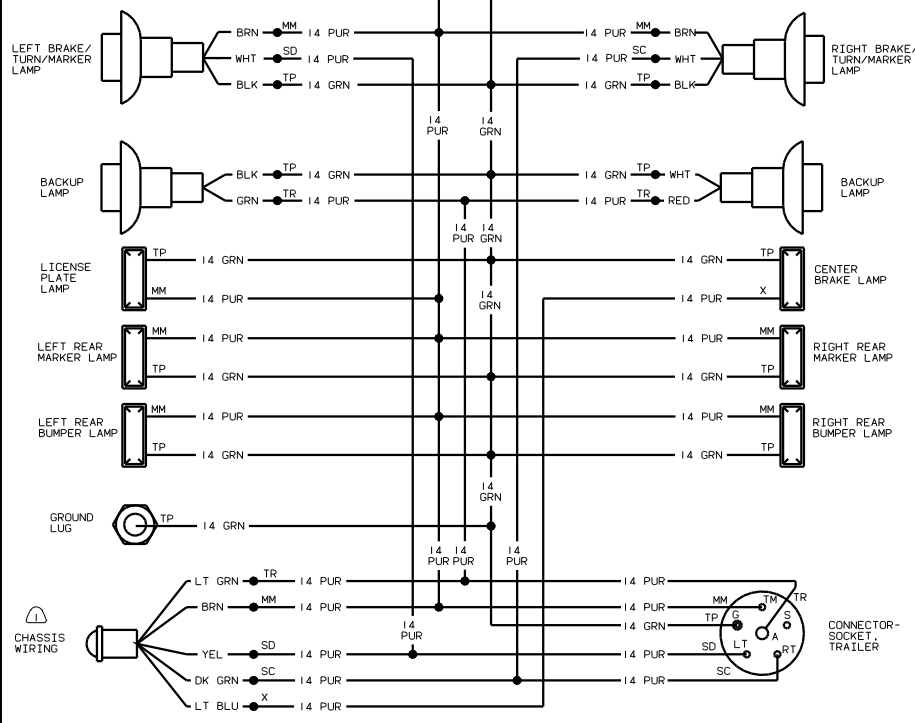
WIRING DIAGRAM-BACKWALL
(GM CHASSIS)
(WIRE ASM-129777-01-000)
