OF IN		DATE	UNDESIGNED TOLERANCES ARE	MATERIAL
CHP	DATE	WHOLE OR 1/2	ONE-PLACE (1/2, 1/4)	
D/E	DATE	HIGH-PLACE (1/2, 1/4)	ANGLE	
D/E	DATE	INDIC. W/ANGLE PROJECTION		
COMB	DATE			
LAUNCH	DATE	TITLE	WINNEBAGO 99 222FD	
REV #	SCALE	NOTE	WIRING DIAGRAM-BODY 110V	
ALL DIMENSIONS ARE IN MILLIMETERS	SHEET	1 OF 1	FIG. NO.	130492

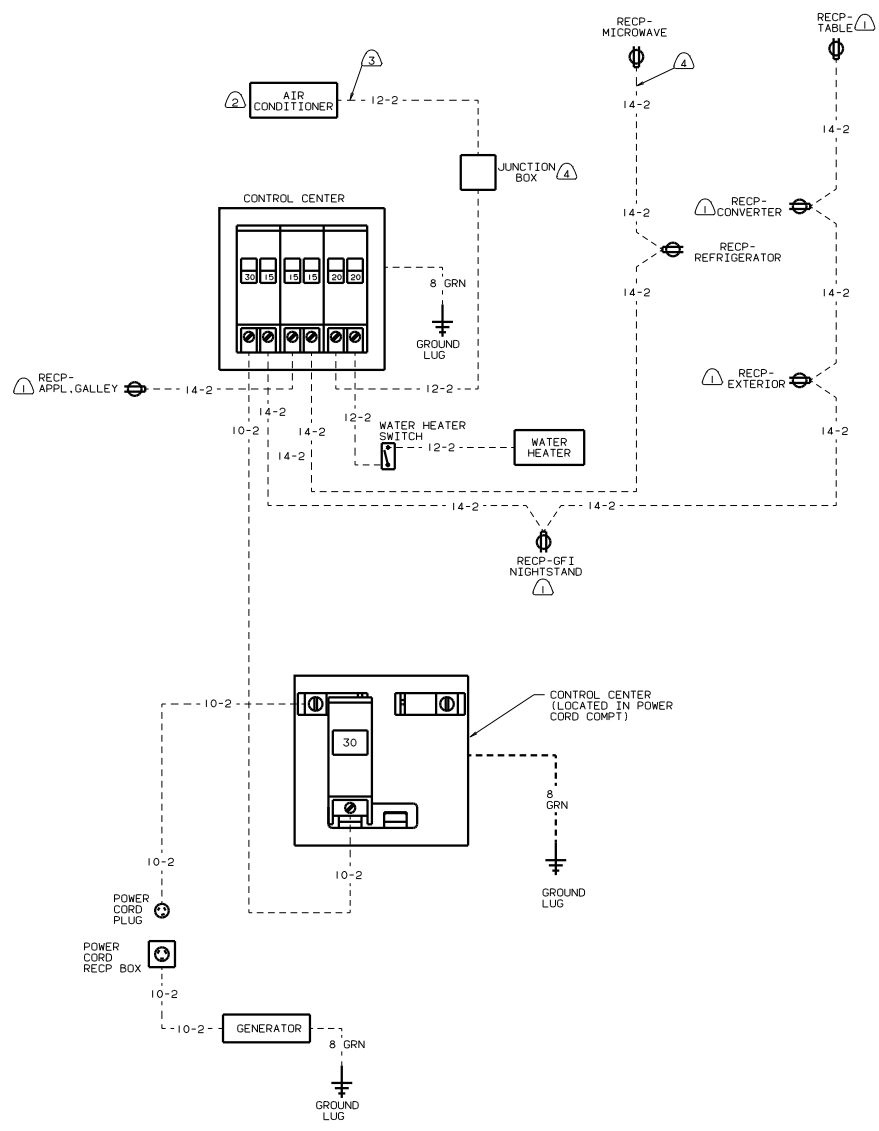
(CAN 110V WIRING)
 (DOUBLE BED) (TWIN BED)

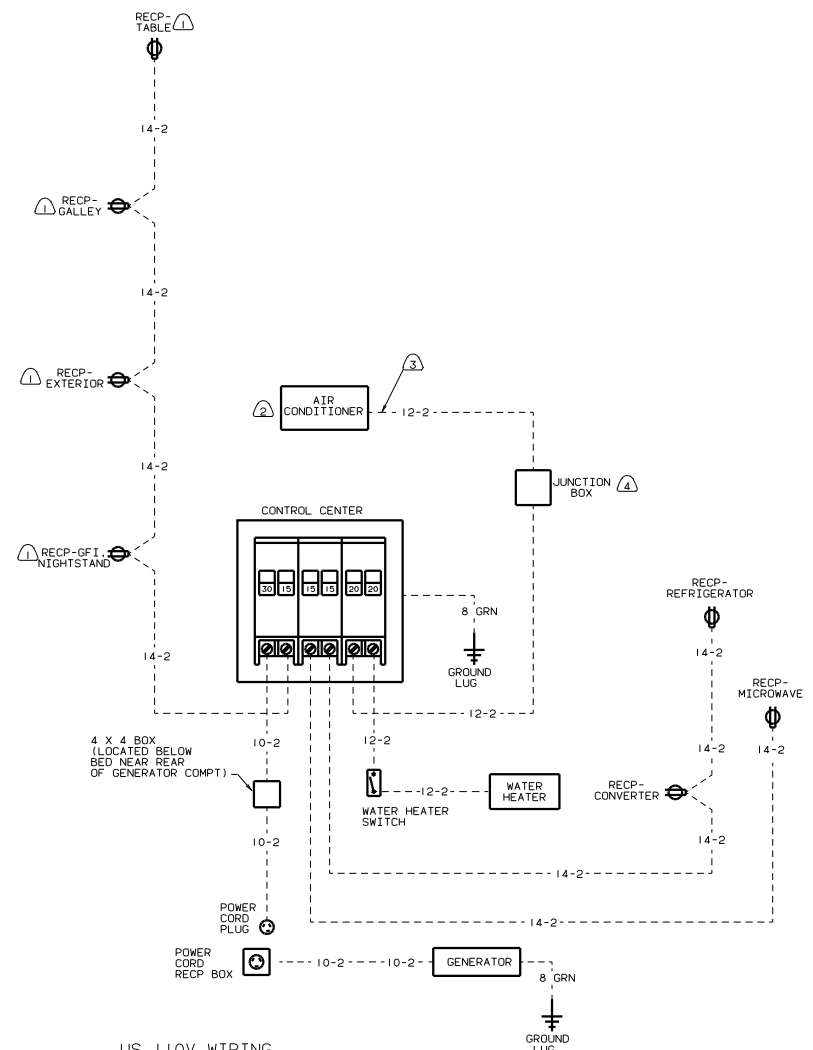
US 110V WIRING
 (DOUBLE BED) (TWIN BED)

- ④ NOT USED WITH 29K A/C. ROOF TWO 13,500.
- ③ WIRE ROUTED THRU ROOF.
- ② WITH AIR CONDITIONER.
- ① PROTECTED BY GFI RECP.
