WINNEBAGO 00 327P

DRAWING NO. XX-XXXX TITLE: WIRING DIAGRAM-BODY 110V  
 SHEET 1 OF 1  
 ALL DIMENSIONS ARE IN MILLIMETERS  
 SCALE: 1" = 1'-0"  
 DATE: 11/1/85  
 DRAWN BY: J.E.H.  
 CHECKED BY: J.E.H.  
 PROJECT NO: 133785

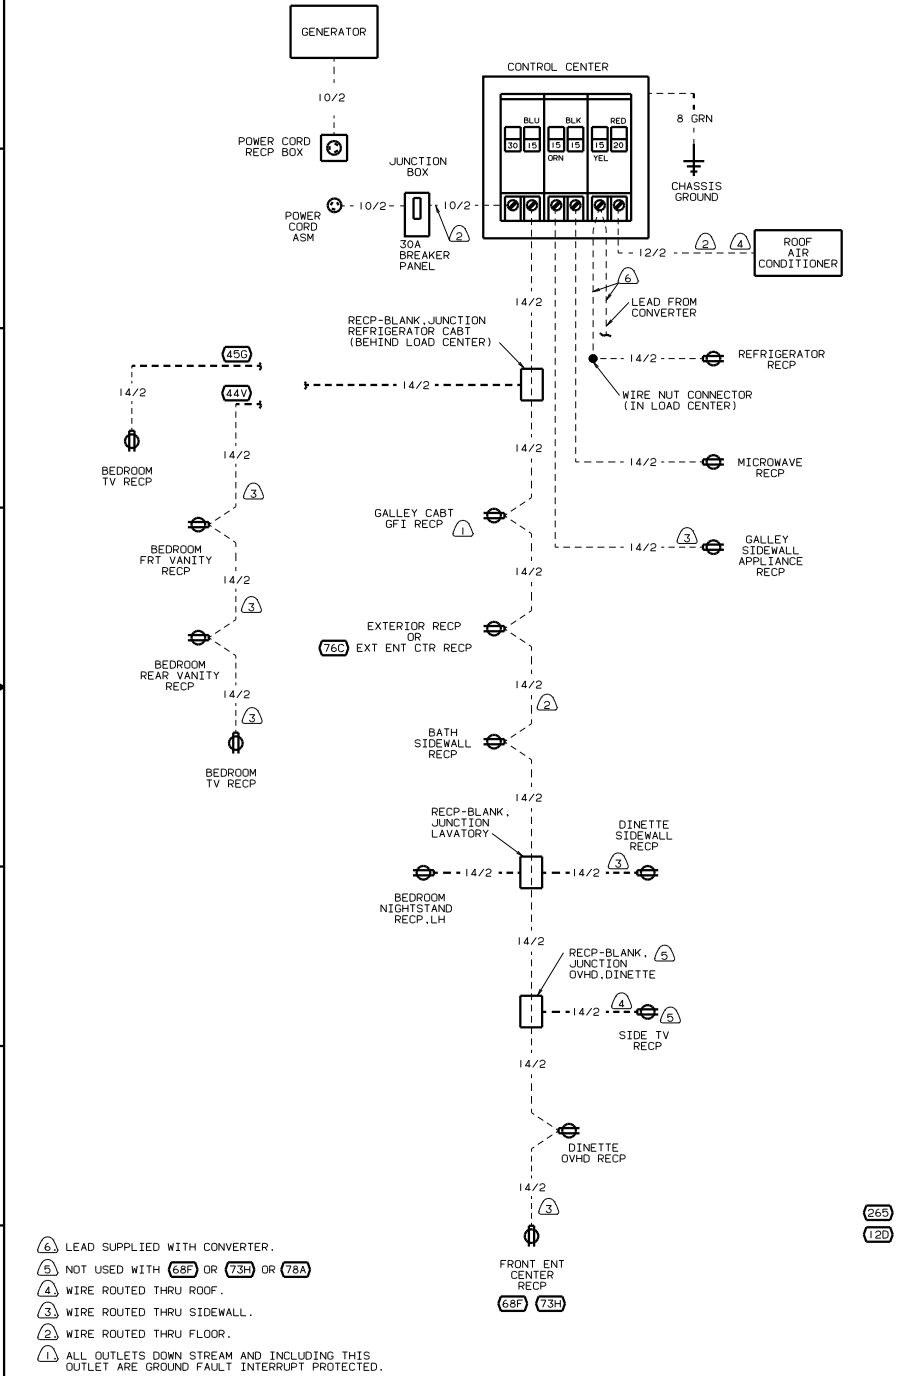
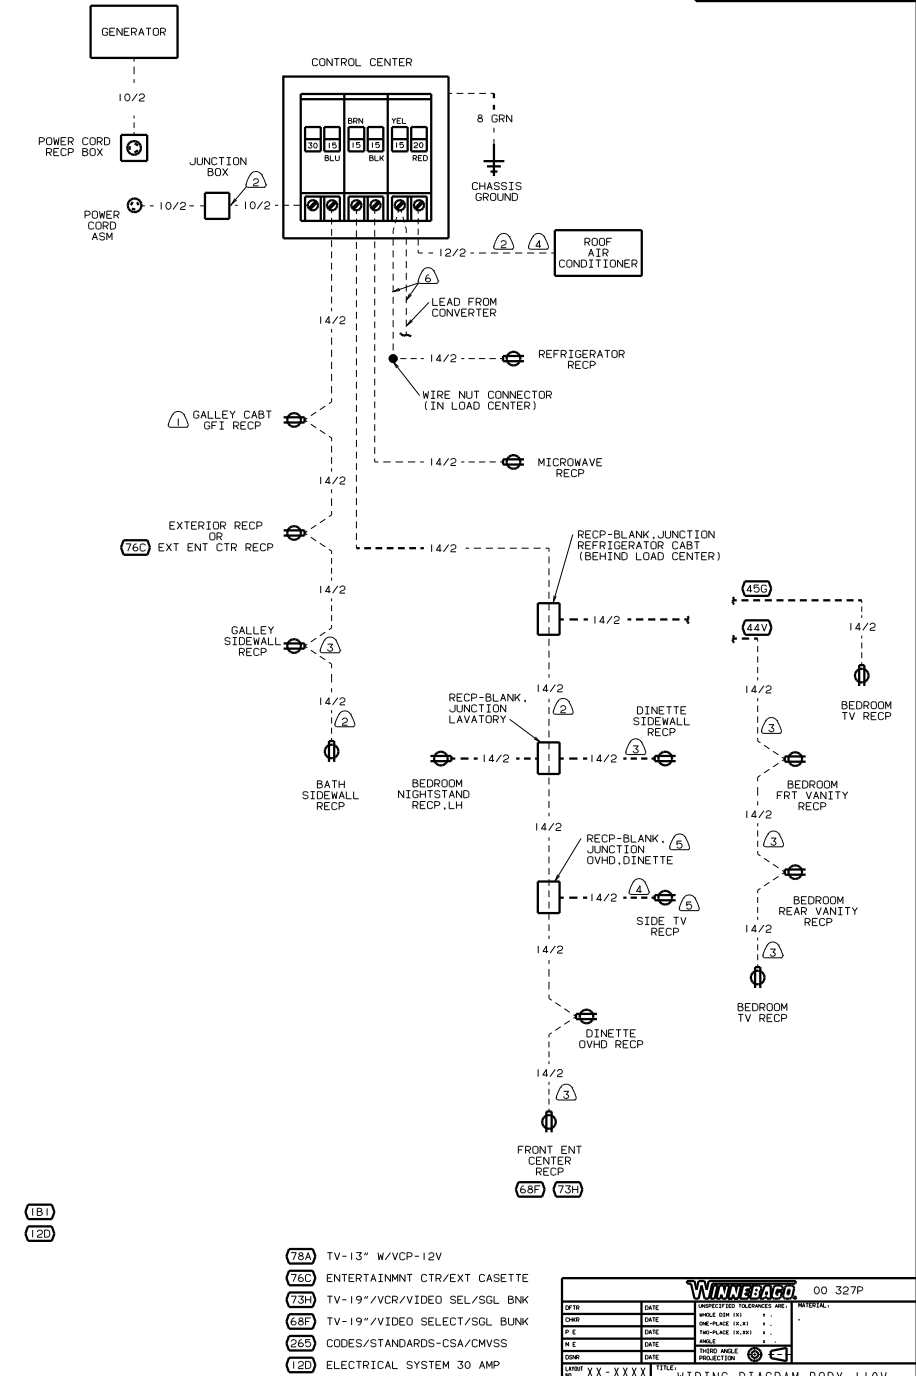
- NOTES:
- ① LEAD SUPPLIED WITH CONVERTER.
  - ② NOT USED WITH (68F) OR (73H) OR (78A)
  - ③ WIRE ROUTED THRU ROOF.
  - ④ WIRE ROUTED THRU SIDEWALL.
  - ⑤ WIRE ROUTED THRU FLOOR.
  - ⑥ ALL OUTLETS DOWN STREAM AND INCLUDING THIS OUTLET ARE GROUND FAULT INTERRUPT PROTECTED.
