WIRING DIAGRAM CHASSIS
 WIRE ASM 136618-01

WIRING DIAGRAM-BODY 12V

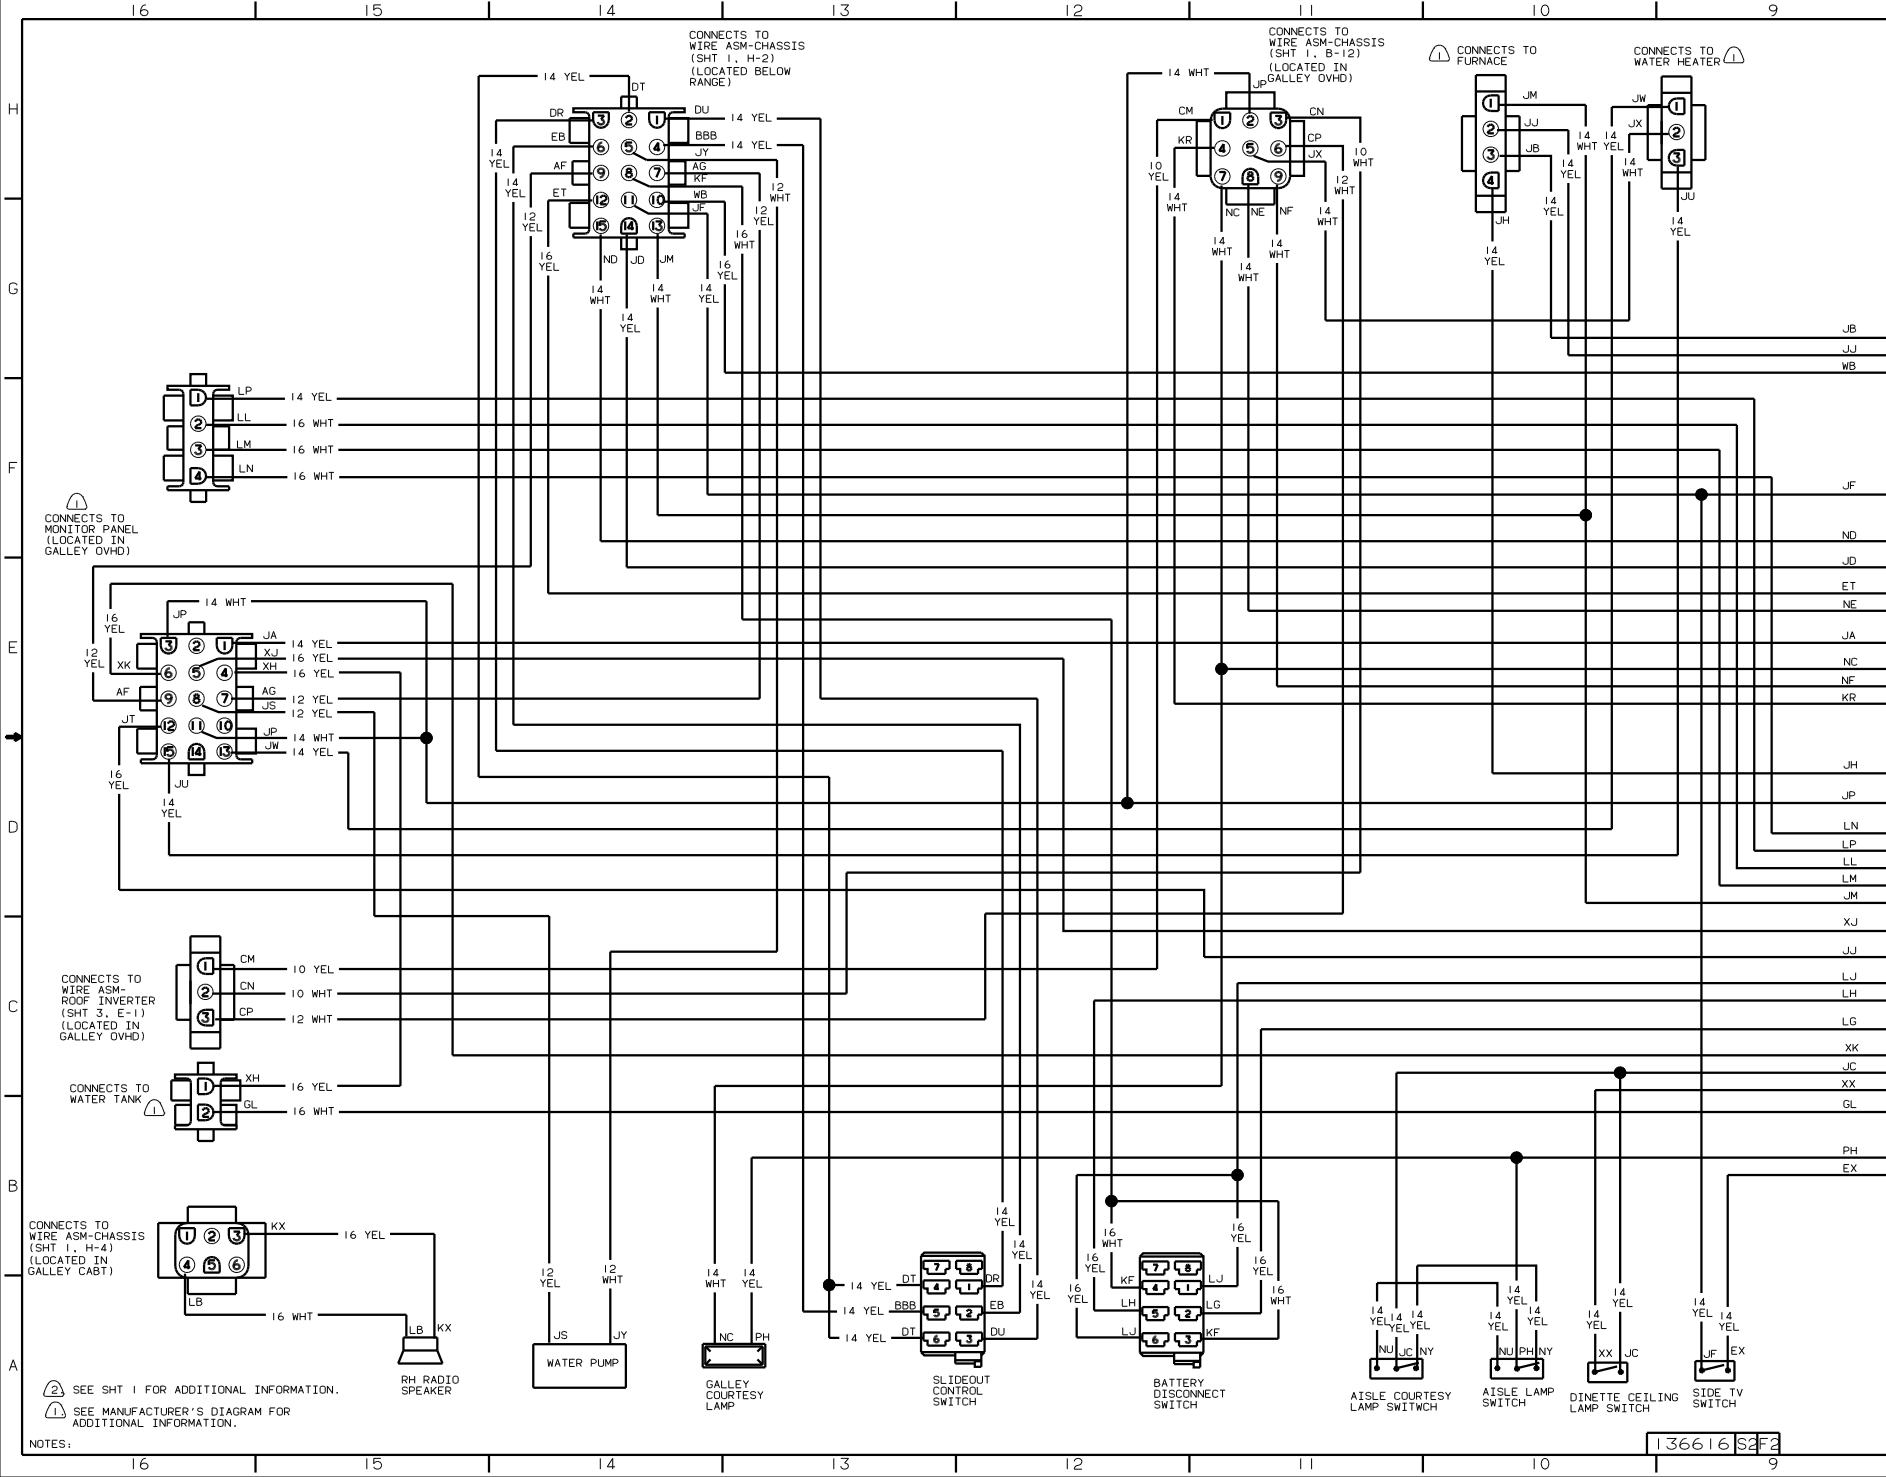
CONNECTS TO MONITOR PANEL (LOCATED IN GALLEY OVHD)

CONNECTS TO WIRE ASM-ROOF INVERTER (SHT 3, E-1) (LOCATED IN GALLEY OVHD)

CONNECTS TO WATER TANK

CONNECTS TO WIRE ASM-CHASSIS (SHT 1, H-4) (LOCATED IN GALLEY CABT)

CONNECTS TO WIRE ASM-CHASSIS (SHT 1, H-2) (LOCATED BELOW RANGE)

CONNECTS TO WIRE ASM-CHASSIS (SHT 1, B-12) (LOCATED IN GALLEY OVHD)

CONNECTS TO FURNACE

CONNECTS TO WATER HEATER

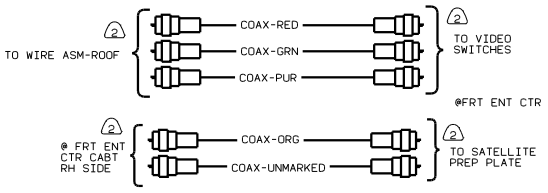
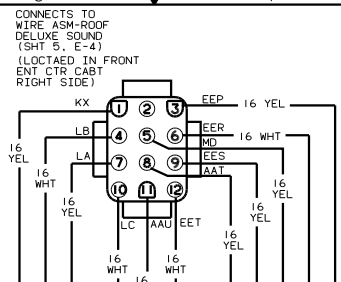
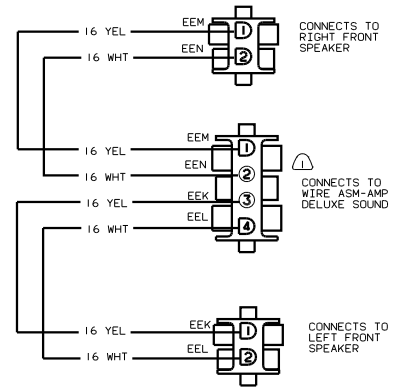
WIRING DIAGRAM TV FRONT (WIRE ASM 135478-02)

FRONT ENTERTAINMENT CENTER W/DELUXE SOUND

CONNECTS TO WIRE ASM-ROOF (SHT 3, E-1) (LOCATED IN FRONT ENT CTR CABT RIGHT SIDE)

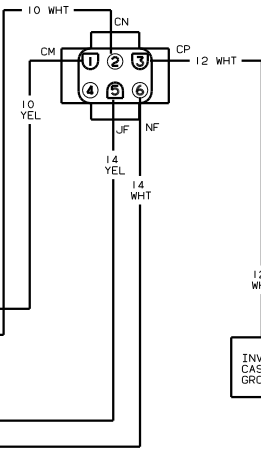
WIRING DIAGRAM TV FRONT
(WIRE ASM 135478-01)

CONNECTS TO WIRE ASM-CHASSIS (SHT 1, H-14) (LOCATED AT CHASSIS BREAKER PANEL)

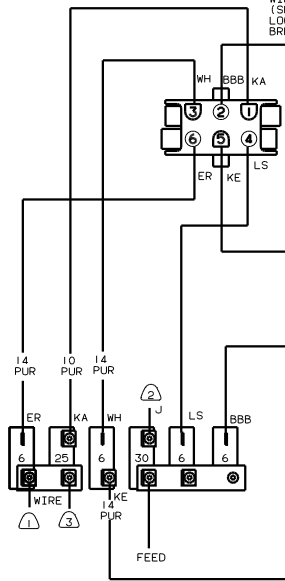
WIRING DIAGRAM, PANEL, BREAKERS
(WIRE ASM 131799-01)

CIRCUIT BREAKERS (LOCATED IN BATTERY COMPARTMENT AT CENTER RIGHT OF VEHICLE)

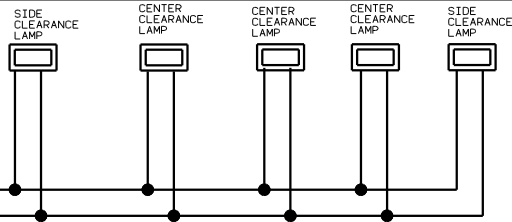
WIRING DIAGRAM CLEARANCE LAMPS
(WIRE ASM 132085-02)

CONNECTS TO WIRE ASM-ROOF (SHT 3, A-2) (LOCATED REAR OF COACH)
