02 P36L/LD/G/CD

TITLE	
WIRING INSL-CHASSIS	
DO NOT SCALE DRAWING	REV NO 137991
SHEET 2 OF 2	IF NO

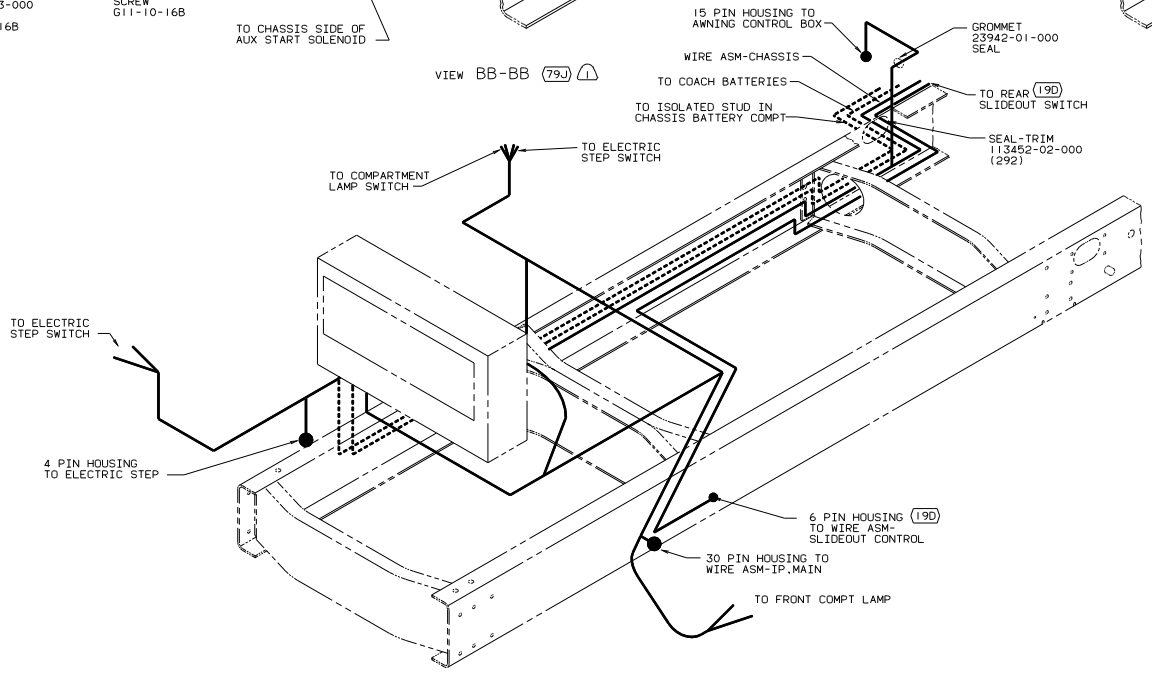
DETAIL BA

- (19D) SLIDEOUT ROOM REAR LEFTHAND
- (79J) INVERTER/CHARGER-1,500 WATT BATTERY-TWO
- (22W) BATTERY-TWO
