02 P36L/LD/G/CD

TITLE		WIRING INSL-CHASSIS	
DO NOT SCALE DRAWING	REV	NO	137991
SHEET 2	OF 2	IF NO

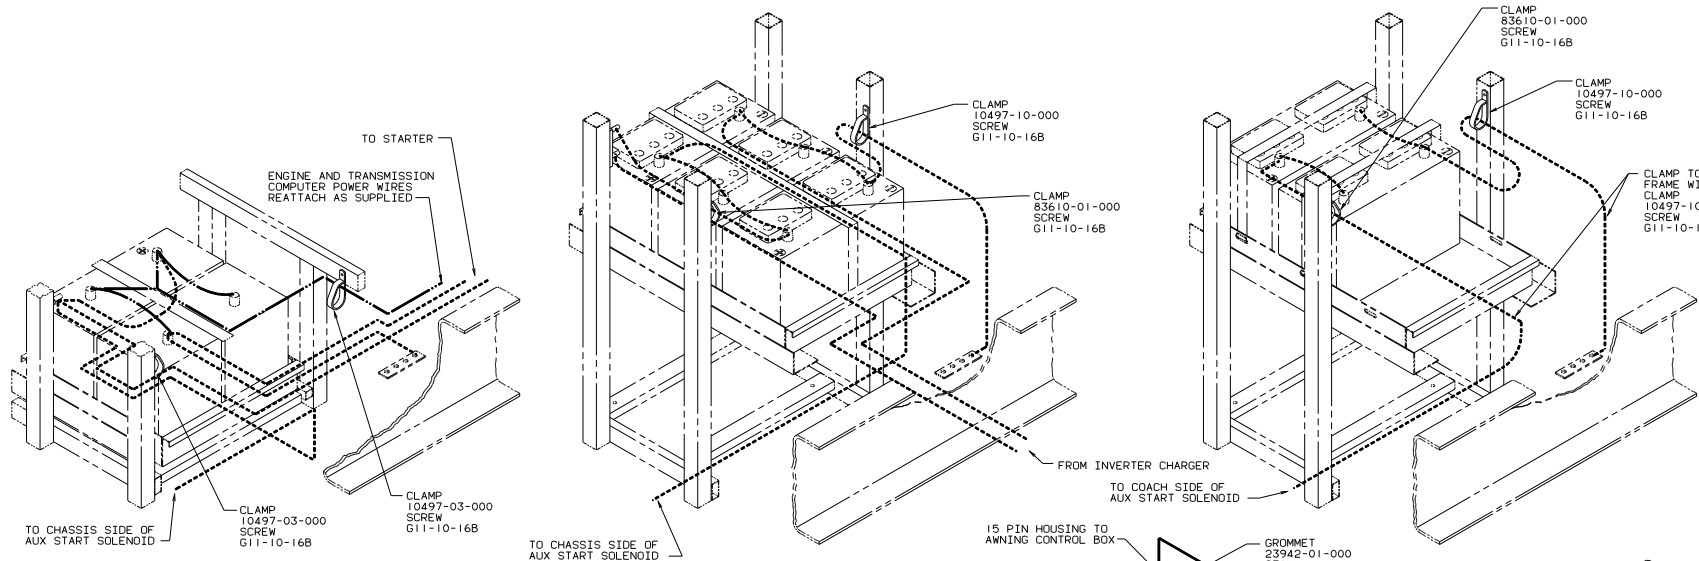
VIEW BB-BB (A)

VIEW BB-BB (79J) (A)

VIEW BB-BB (22J) (A)

(A) CLAMP WIRES TO TUBES WITH ENOUGH SLACK TO PULL BATTERY TRAY OUT 20 INCHES.

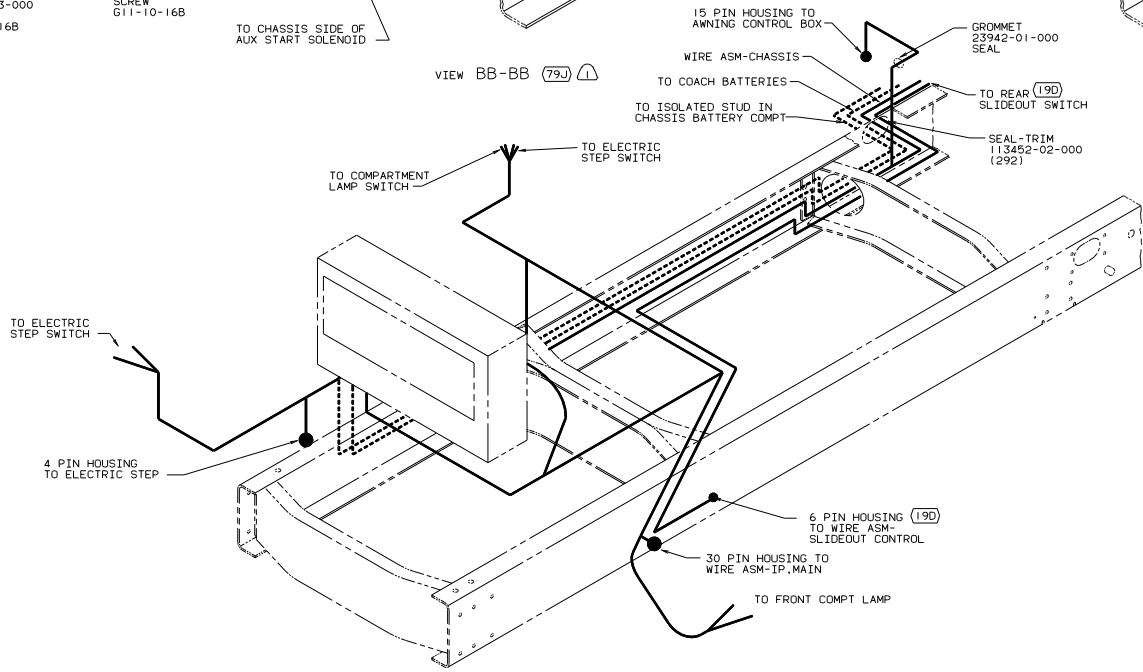
DETAIL BA

- (19D) SLIDEOUT ROOM REAR LEFTHAND
- (79J) INVERTER/CHARGER-1,500 WATT BATTERY-TWO
- (22W) BATTERY-TWO
