74J REARVIEW MONITOR SYSTEM

MONITOR INSTL 08/29/0345349

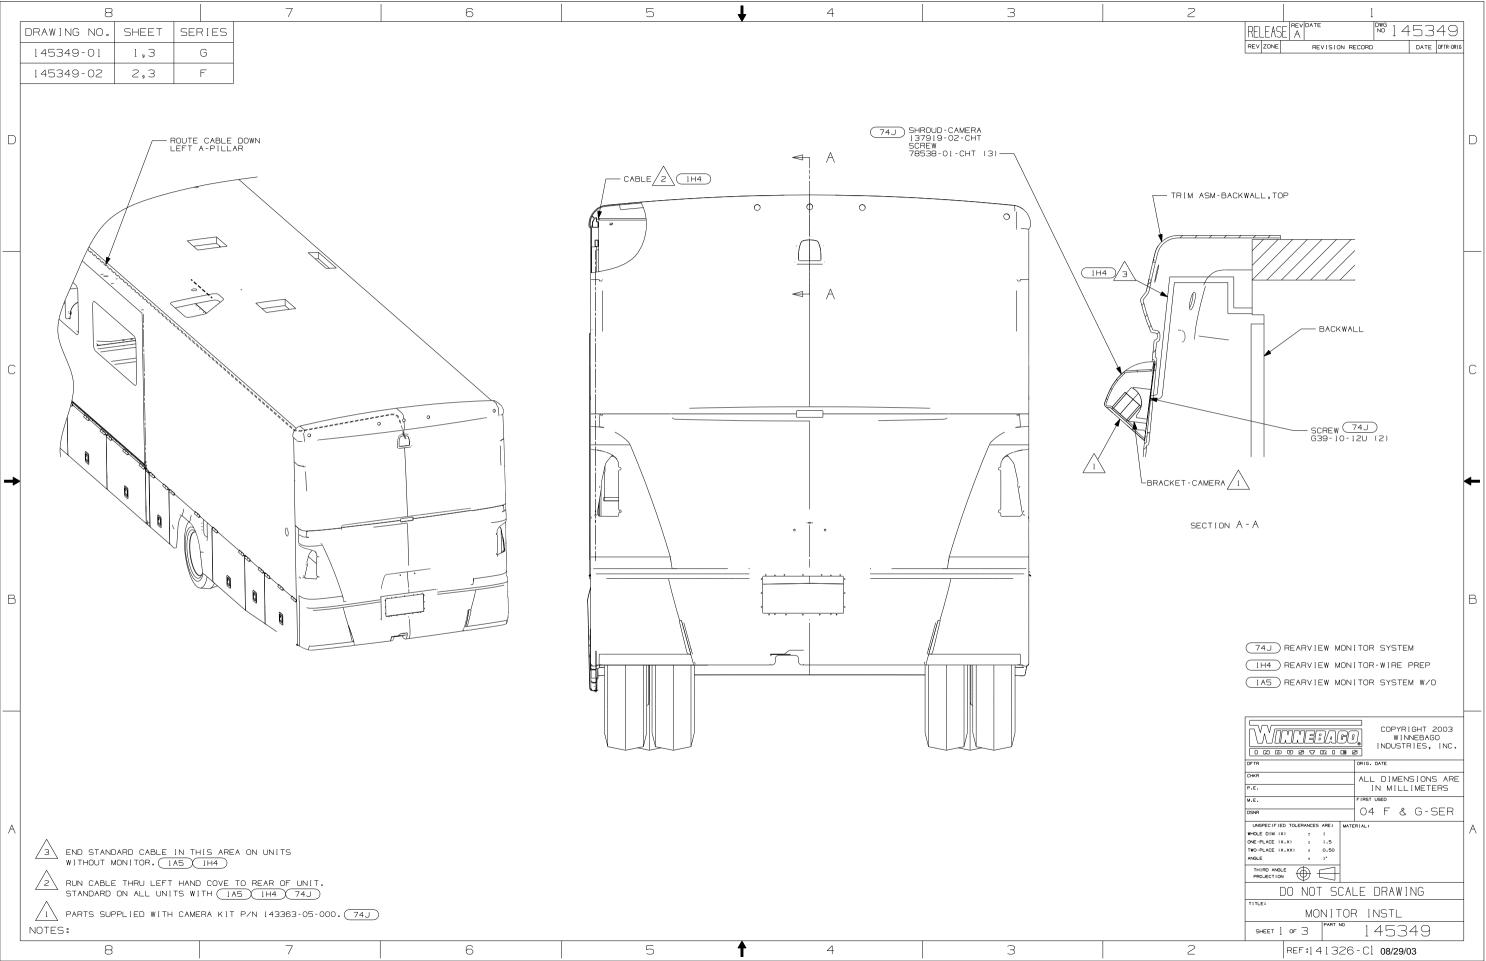
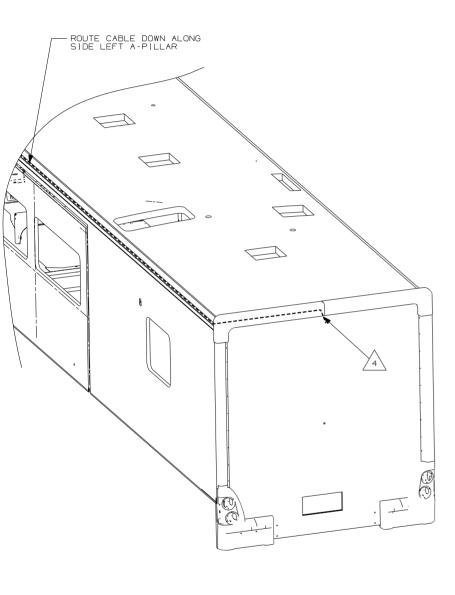
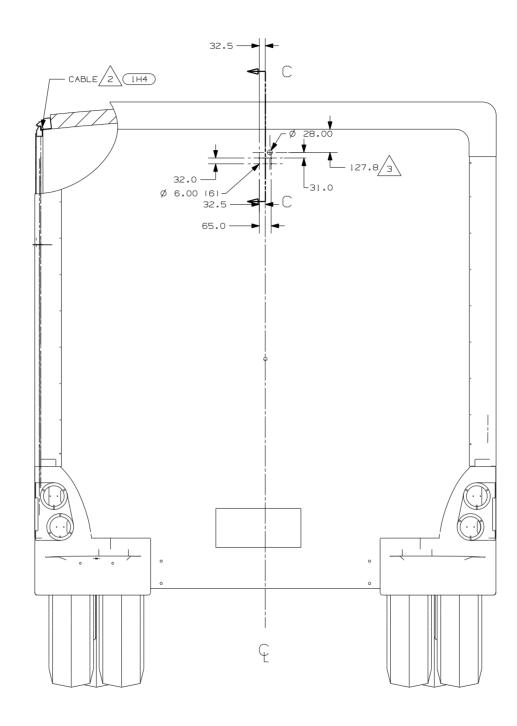
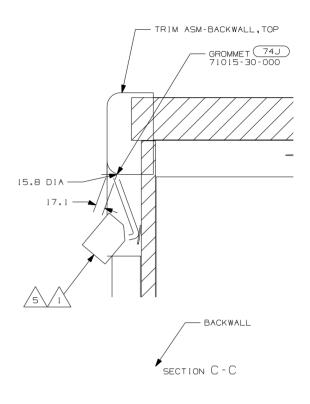
/5\ PARTS SUPPLIED WITH CAMERA KIT P/N 93040-09-000. 74J WINNEBAGO END CABLE IN THIS AREA ON UNITS W/O MONITOR.

MEASURED FROM BOTTOM BACKWALL TRIM.

RUN CABLE THRU LEFT HAND COVE TO REAR OF UNIT. STANDARD ON ALL UNITS WITH 1A5 1H4 74J

PARTS SUPPLIED WITH CAMERA KIT P/N 143363-05-000. 74J ITASCA
