WINNEBAGO		COPYRIGHT 2002 WINNEBAGO INDUSTRIES, INC.	
DFTR	ORIG. DATE	ALL DIMENSIONS ARE IN MILLIMETERS	
CHKR		FIRST USED	
P.E.		04 222HD	
M.E.		UNSPECIFIED TOLERANCES ARE:	
DSNR		MATERIAL:	
		WHOLE DIM (X)	:
		ONE-PLACE (X.X)	:
		TWO-PLACE (X.XX)	:
		ANGLE	:
		THIRD ANGLE PROJECTION	:
DO NOT SCALE DRAWING			
TITLE: WIRING DIAGRAM-BODY, 110V			
SHEET 1 OF 1	PART NO	144799	
REF:141285 A 05/21/03

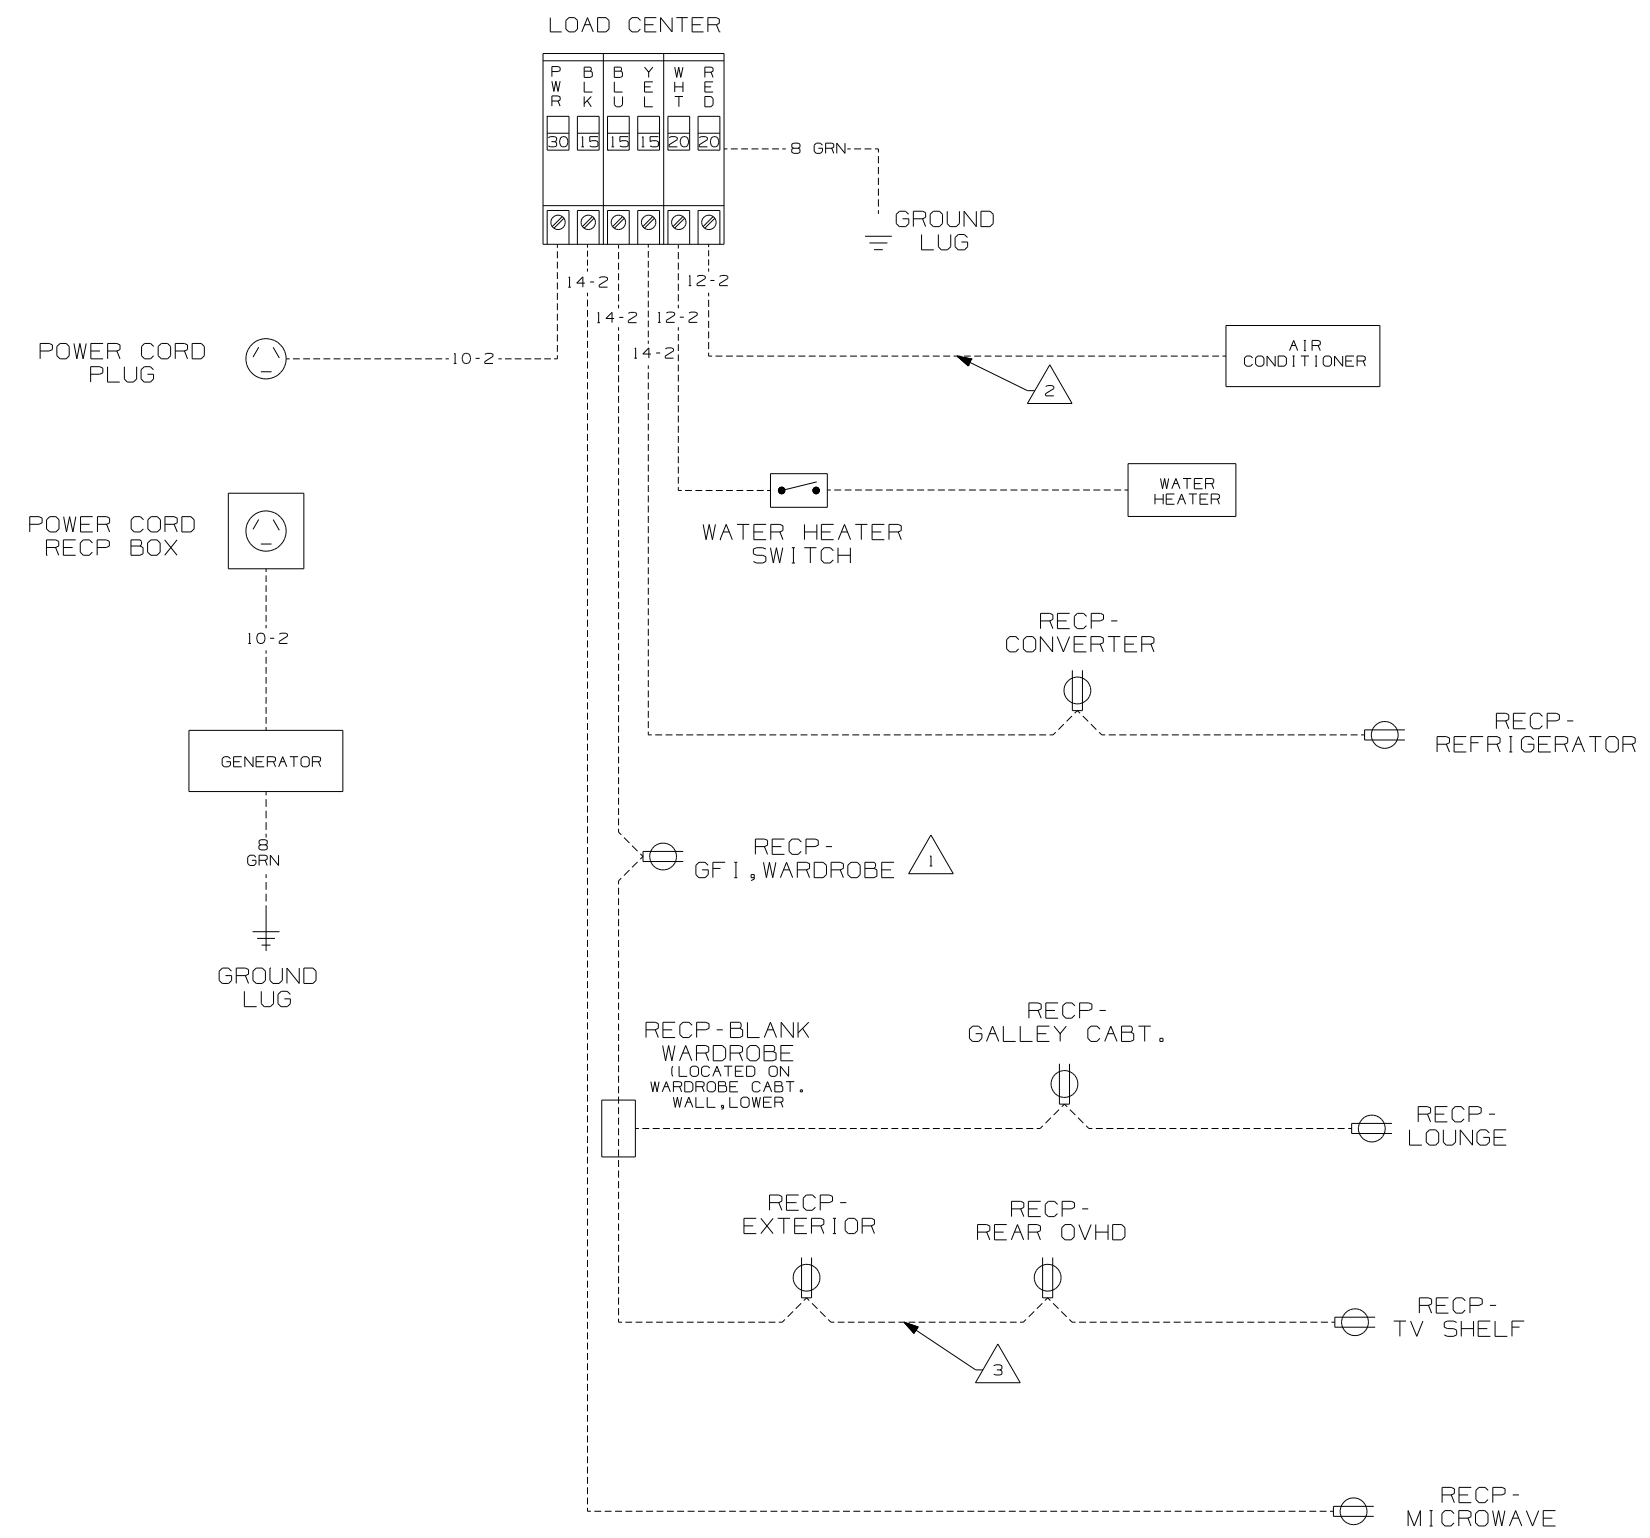
- NOTES:
- 3 WIRE ROUTED THRU SIDEWALL.
 - 2 WIRE ROUTED THRU ROOF.
 - 1 THIS OUTLET AND ALL OUTLETS DOWN STREAM ARE GROUND FAULT CIRCUIT INTERRUPT PROTECTED.
