WIRING DIAGRAM COACH (WIRE ASM 144740)

COPYRIGHT 2003 WINNEBAGO INDUSTRIES, INC. WINNEBAGO 04 2220D	
DATE	UNSPECIFIED TOLERANCES ARE:
DATE	WHOLE DIM (X.X)
DATE	ONE-PLACE (X.XX)
DATE	TWO-PLACE (X.XXX)
DATE	ANGLE
DATE	THIRD ANGLE PROJECTION
DATE	TITLE: WIRING DIAGRAM-BODY, 12V
LAYOUT NO	DIA # SCALE: NOTE
DO NOT SCALE DRAWING	SIZE: 11 X 17
ALL DIMENSIONS ARE IN MILLIMETERS	SHEET 1 OF 2
	NO 144705

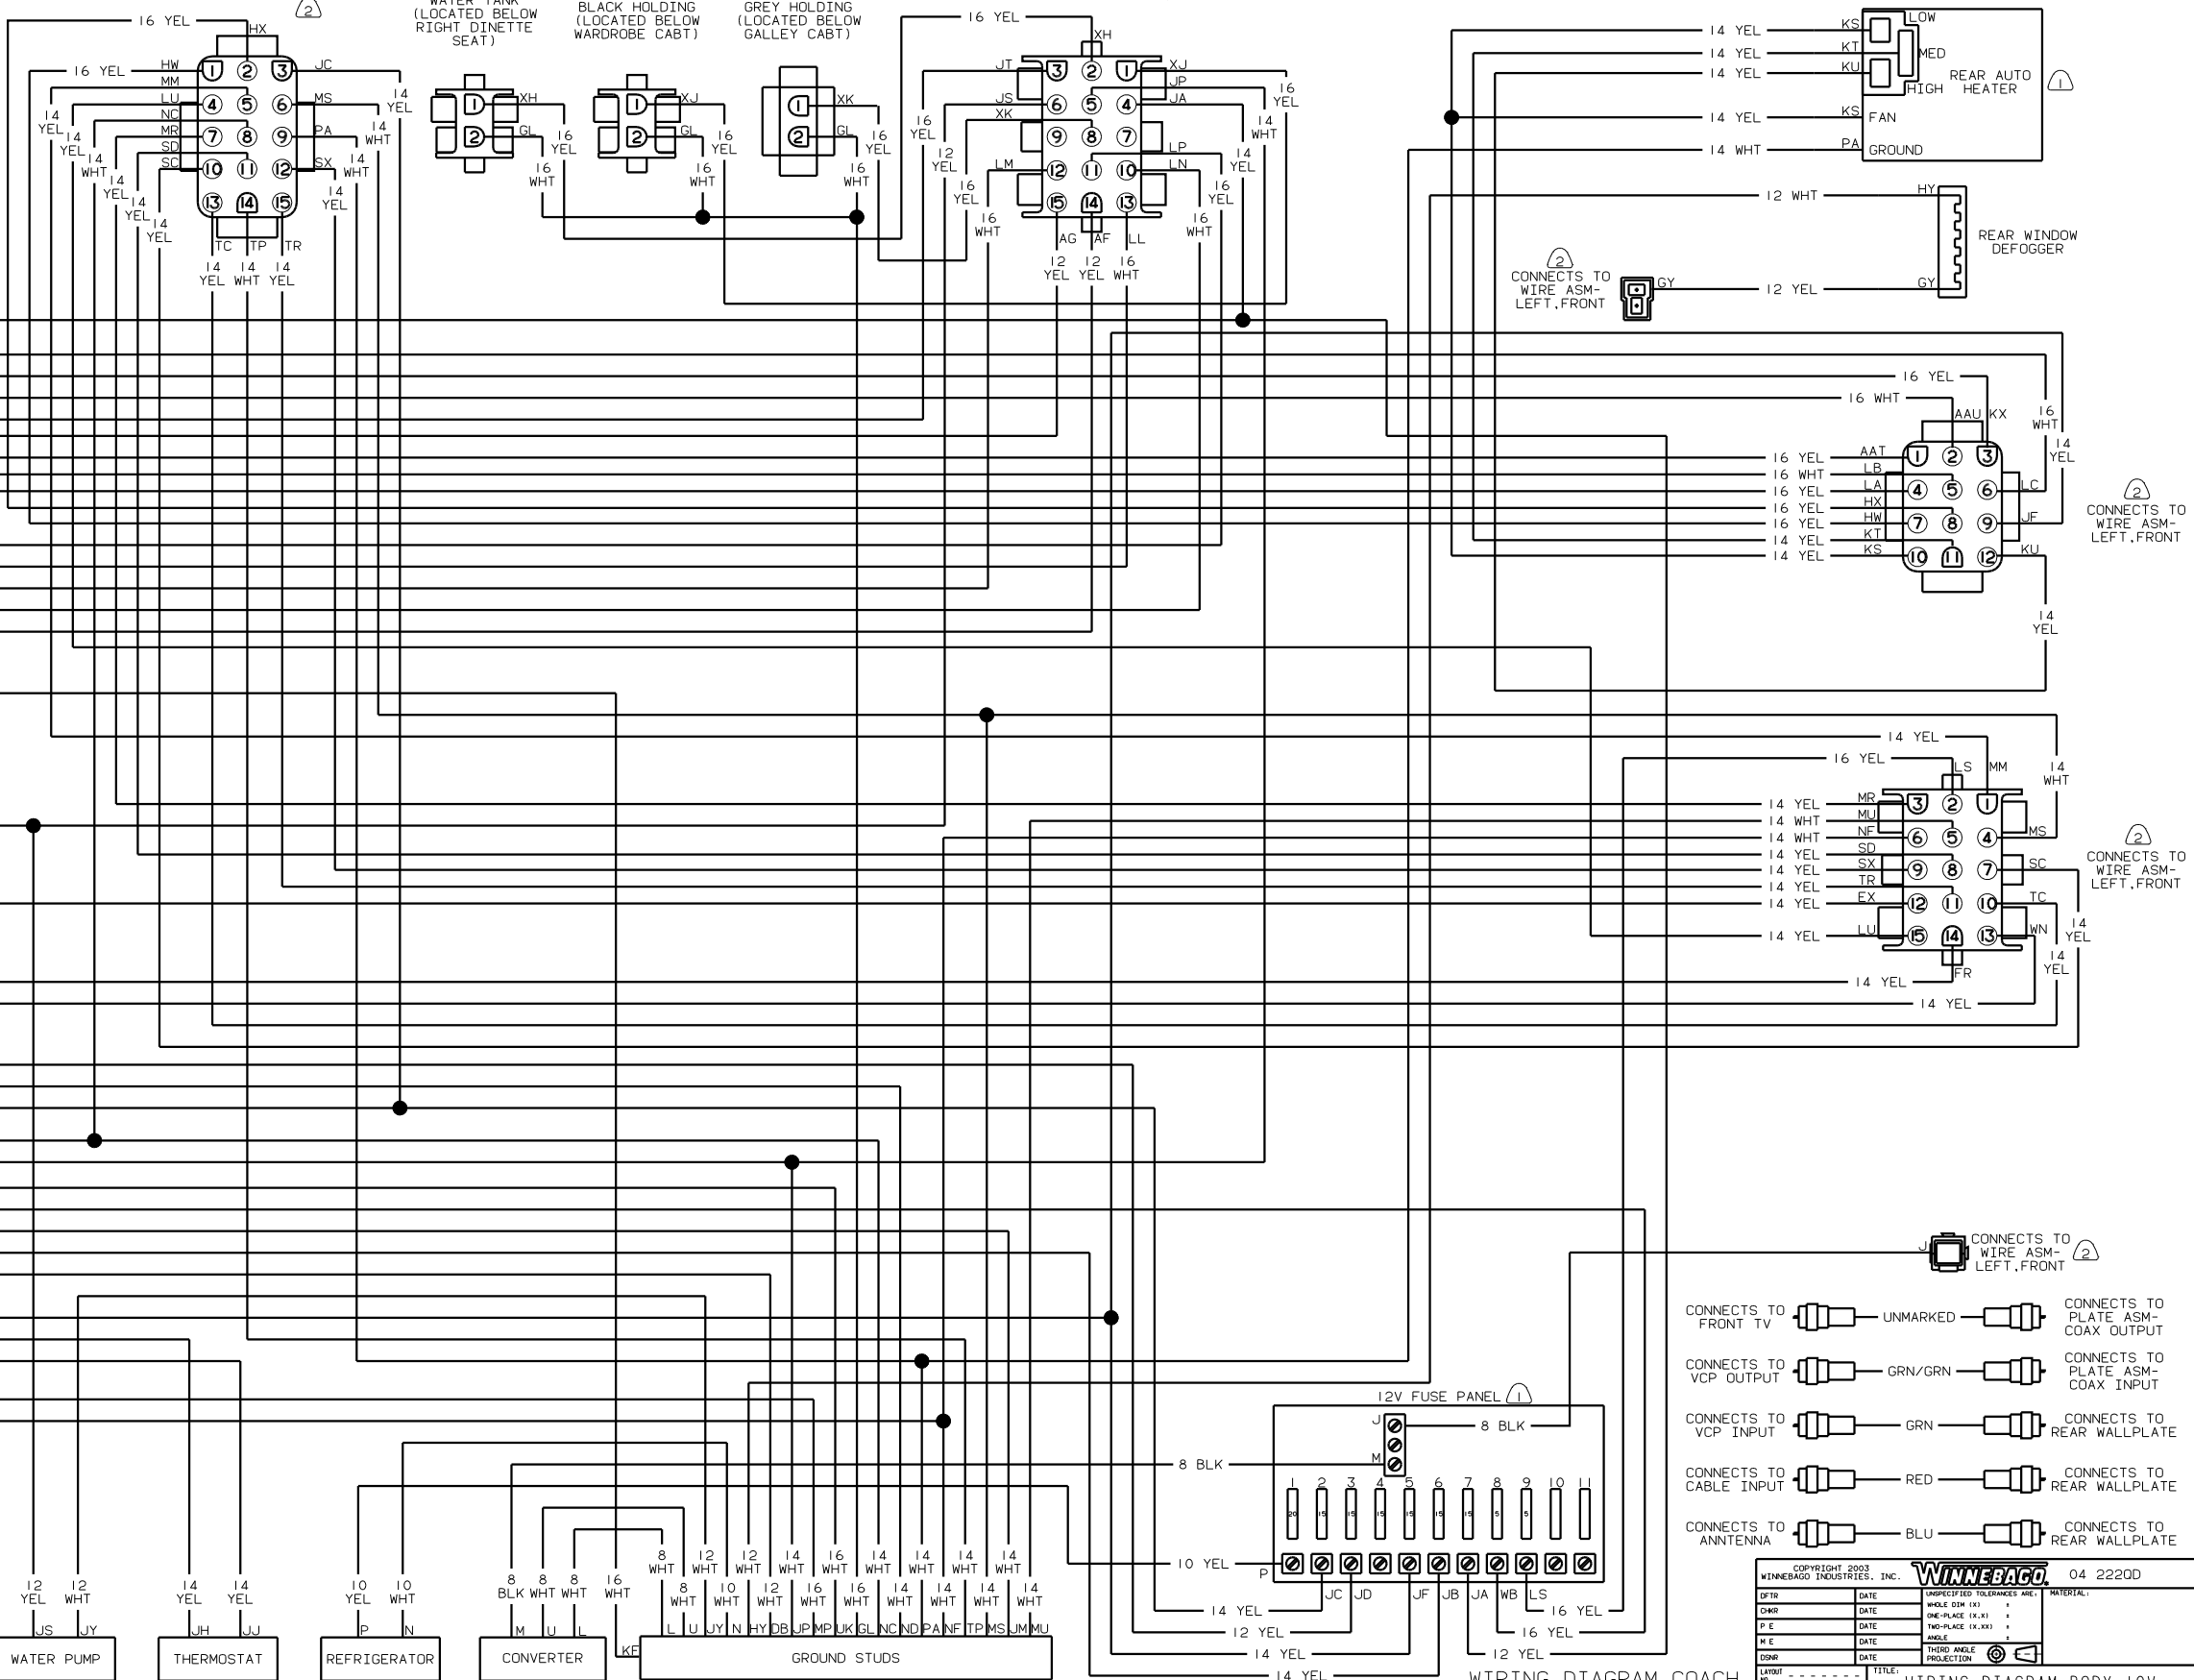
CONNECTS TO WIRE ASM-BACKWALL (LOCATED BEHIND CIRCUIT BREAKERS)

CONNECTS TO WIRE ASM-WATER TANK (LOCATED BELOW RIGHT DINETTE SEAT)

CONNECTS TO WIRE ASM-BLACK HOLDING (LOCATED BELOW WARDROBE CABT)

CONNECTS TO WIRE ASM- GREY HOLDING (LOCATED BELOW GALLEY CABT)

CONNECTS TO MONITOR PANEL (LOCATED IN LH TRANSITION PANEL)

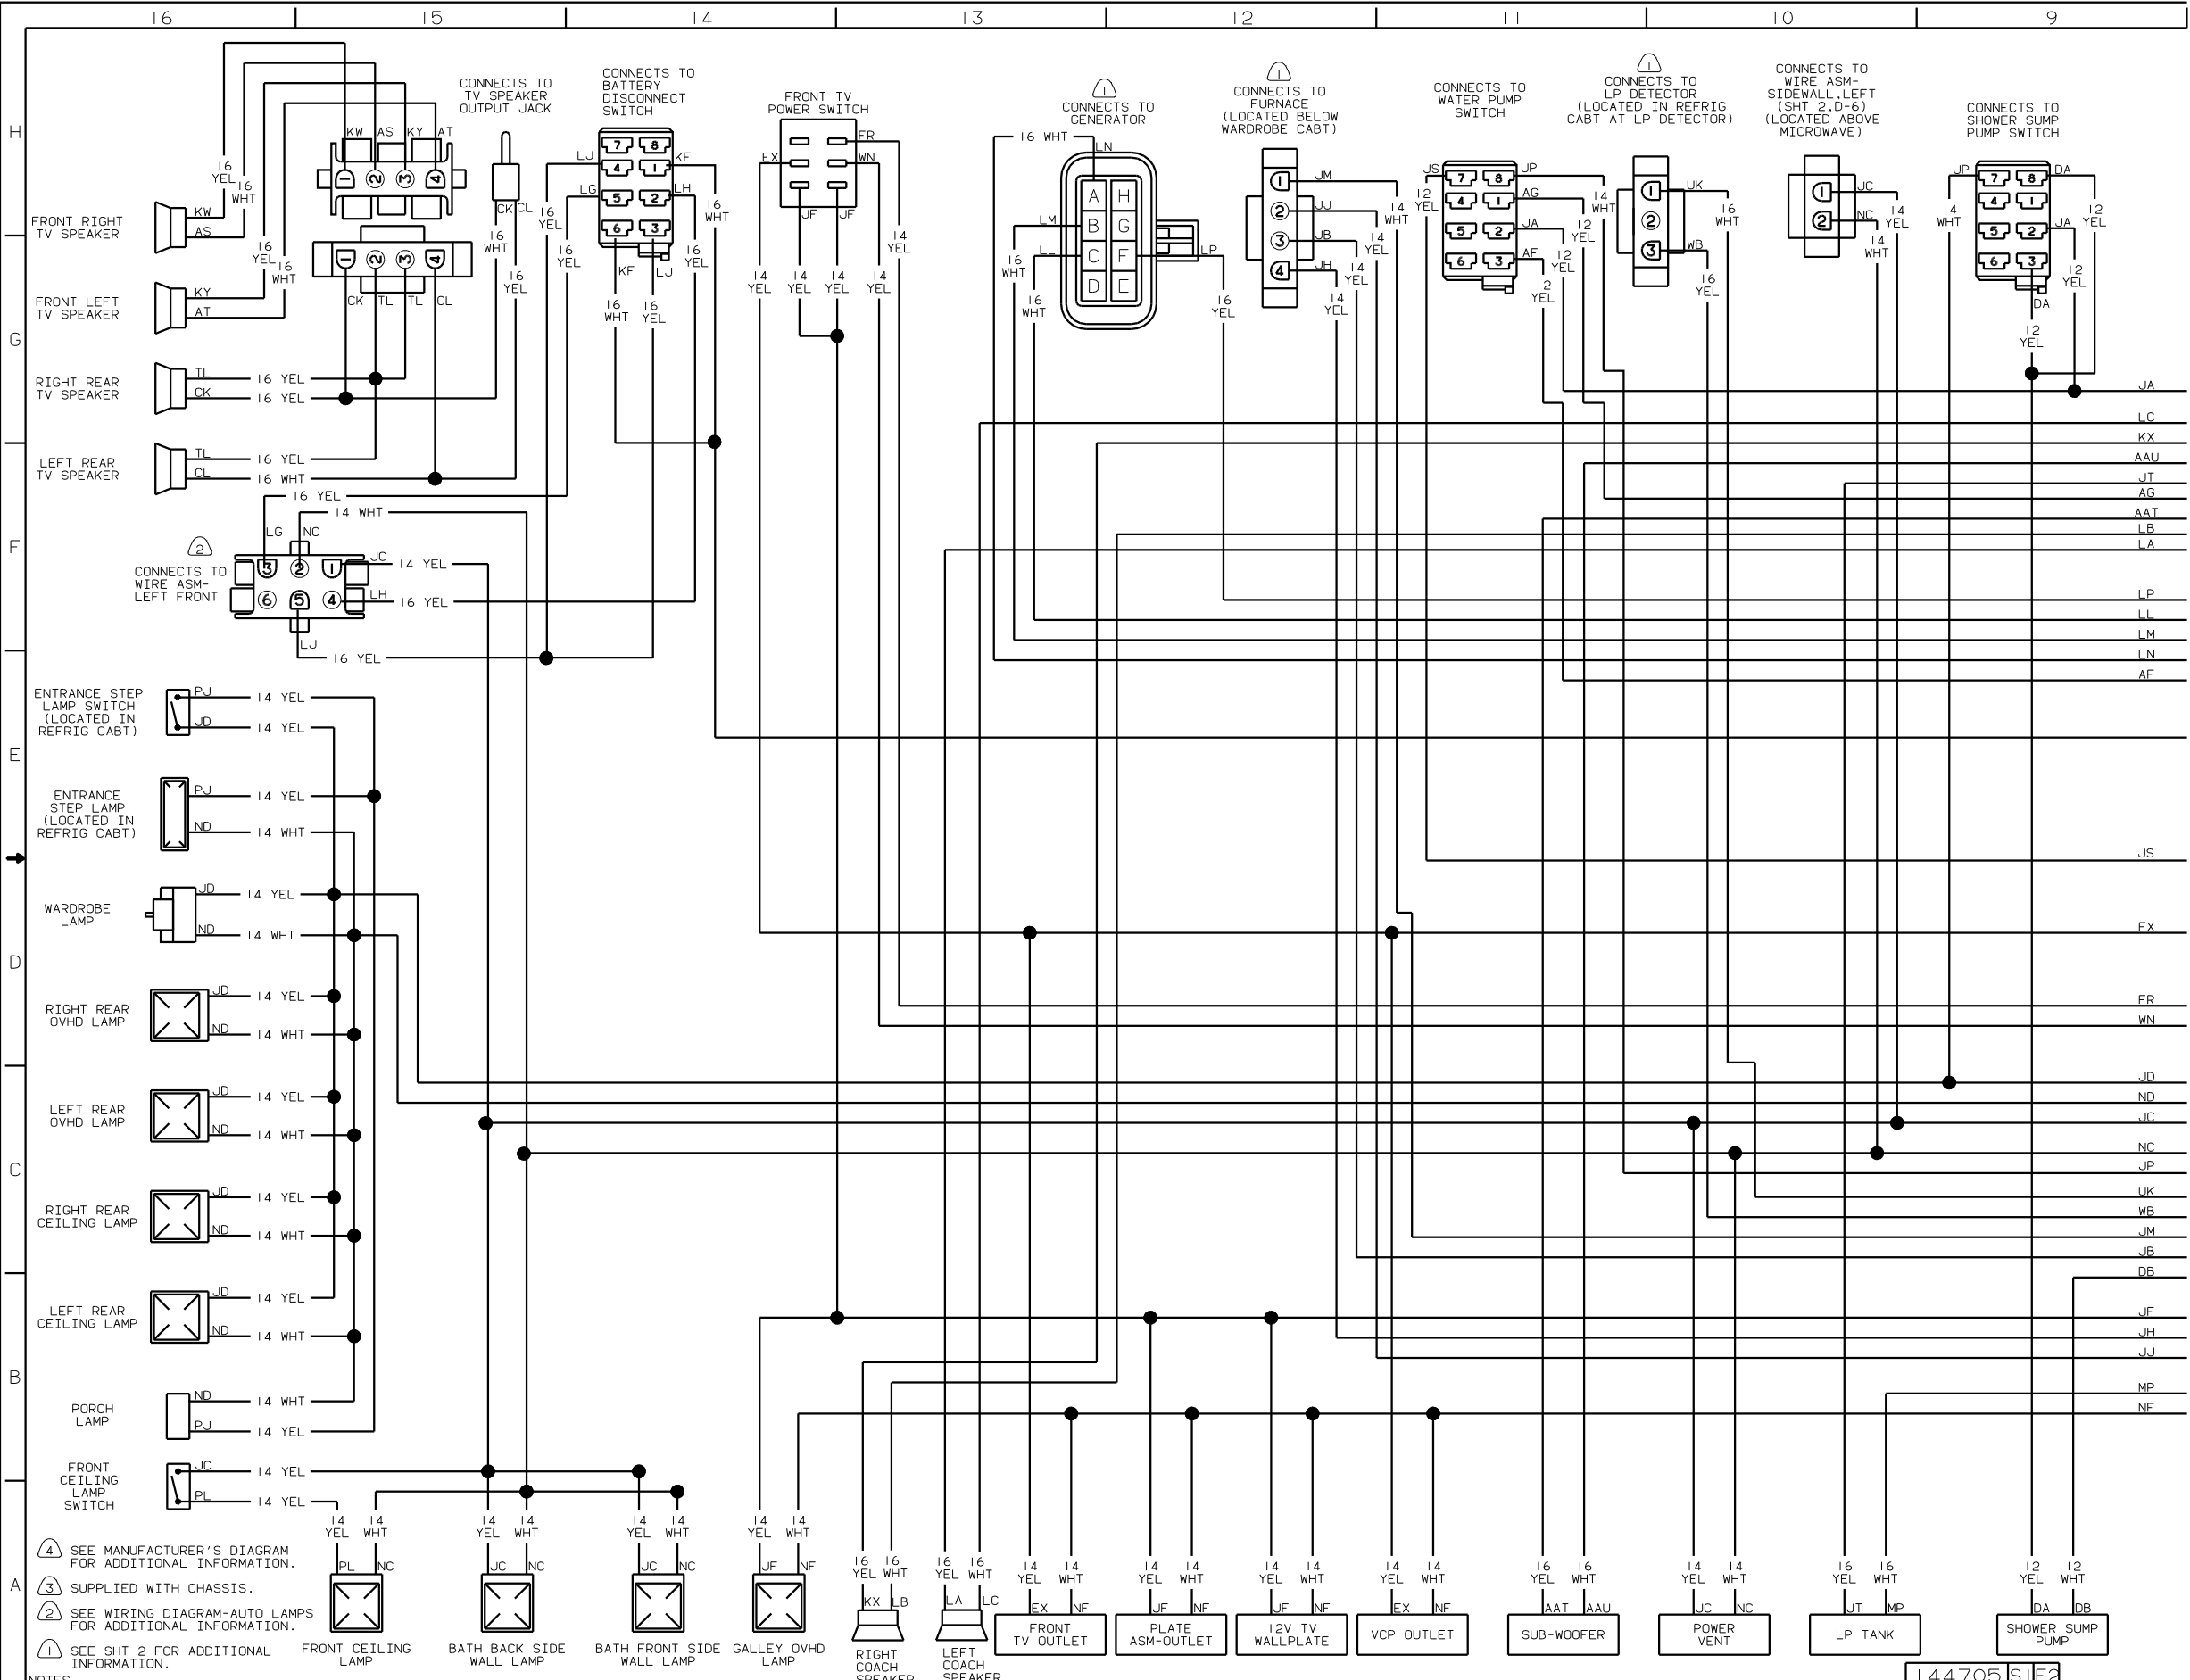
WIRING DIAGRAM-ROOF,FRONT
(WIRE ASM 119112)

CONNECTS TO
WIRE ASM-COACH
(SHT 1,H-10)
(LOCATED IN
MICROWAVE CABT)
