<b>WINNEBAGO</b>		COPYRIGHT 2004 WINNEBAGO INDUSTRIES, INC.	
DFT#	ORIG. DATE	ALL DIMENSIONS ARE IN MILLIMETERS	
CHK#		05 G33V	
P.E.			
M.E.	FIRST USED		
DSNR			
UNSPECIFIED TOLERANCES ARE:		MATERIAL:	
WHOLE DIM (X)	: 1		
ONE-PLACE (X.X)	: 1.5		
TWO-PLACE (X.XX)	: 0.50		
ANGLE	: 1°		
THIRD ANGLE PROJECTION			
<b>DO NOT SCALE DRAWING</b>			
TITLE: WIRING DIAGRAM-BODY, 110V			
SHEET 1 OF 2	PART NO	149166	
REF: 144940 1 5/12/2004

FIRST USED	05 G33V
TITLE	DO NOT SCALE DRAWING
WIRING DIAGRAM-BODY, 110V	
SHEET 2	PART NO 149166

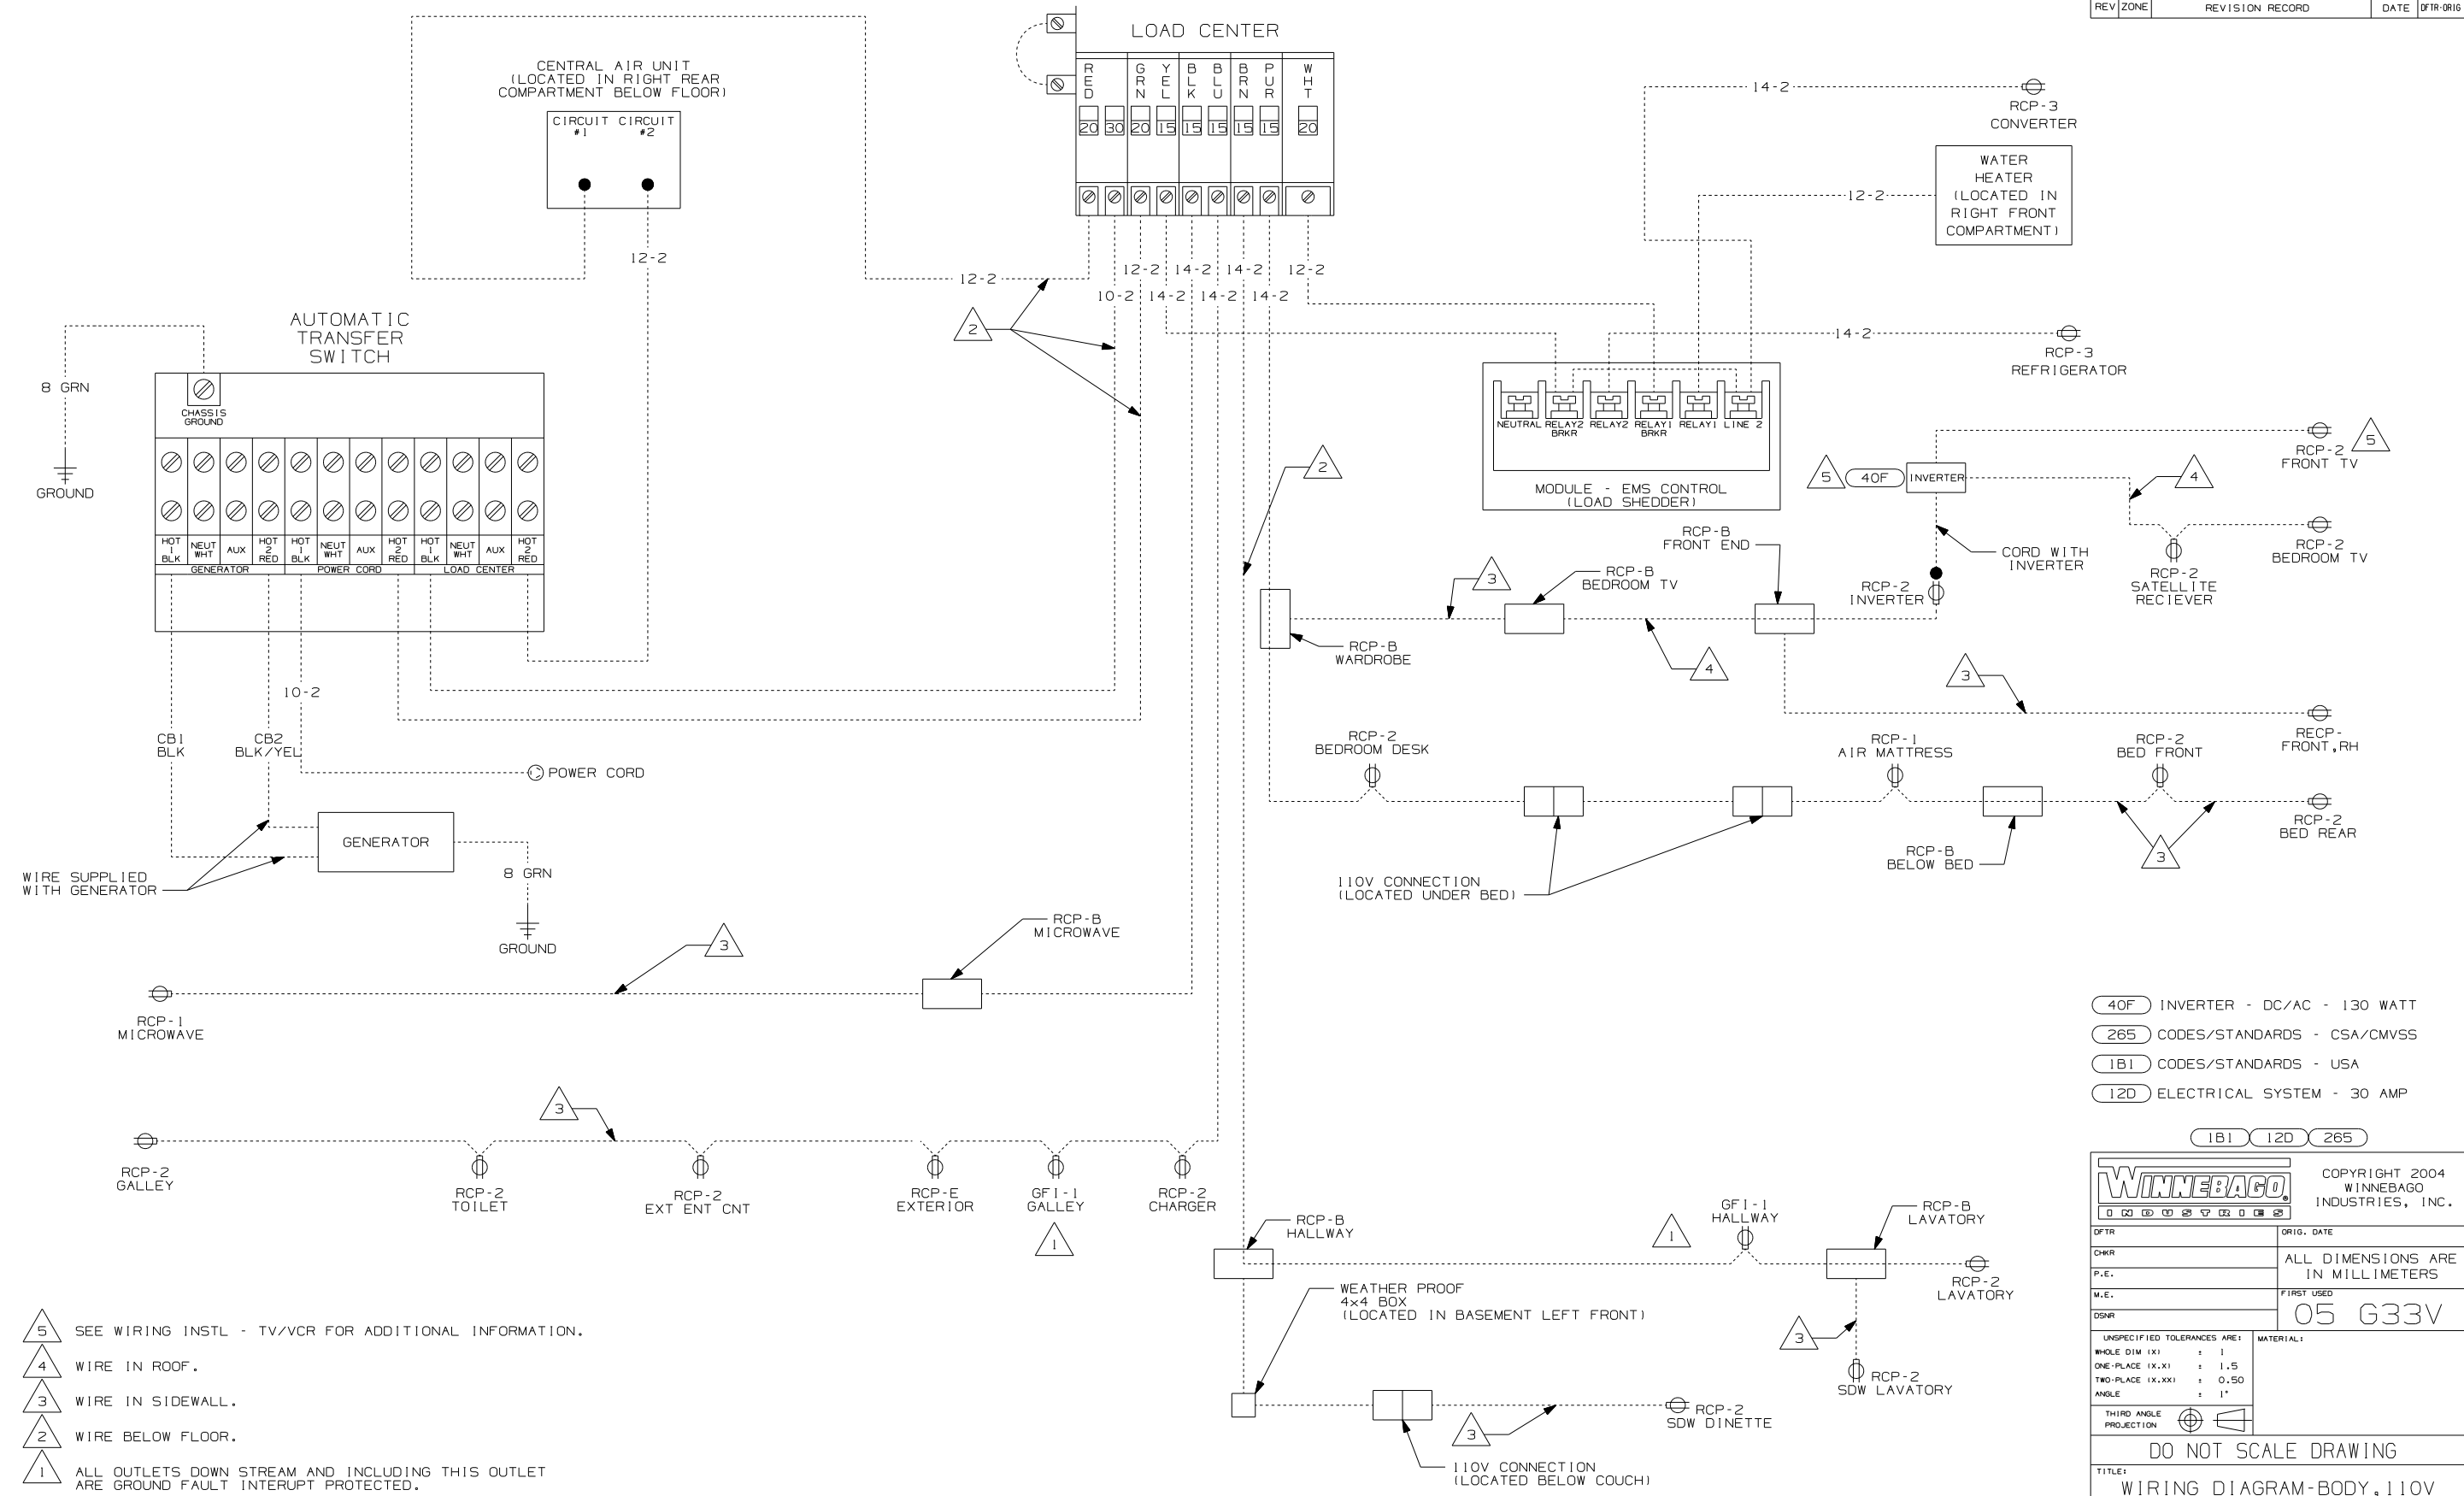
- 40F INVERTER - DC/AC - 130 WATT
- 265 CODES/STANDARDS - CSA/CMVSS
- 1B1 CODES/STANDARDS - USA
- 12D ELECTRICAL SYSTEM - 30 AMP

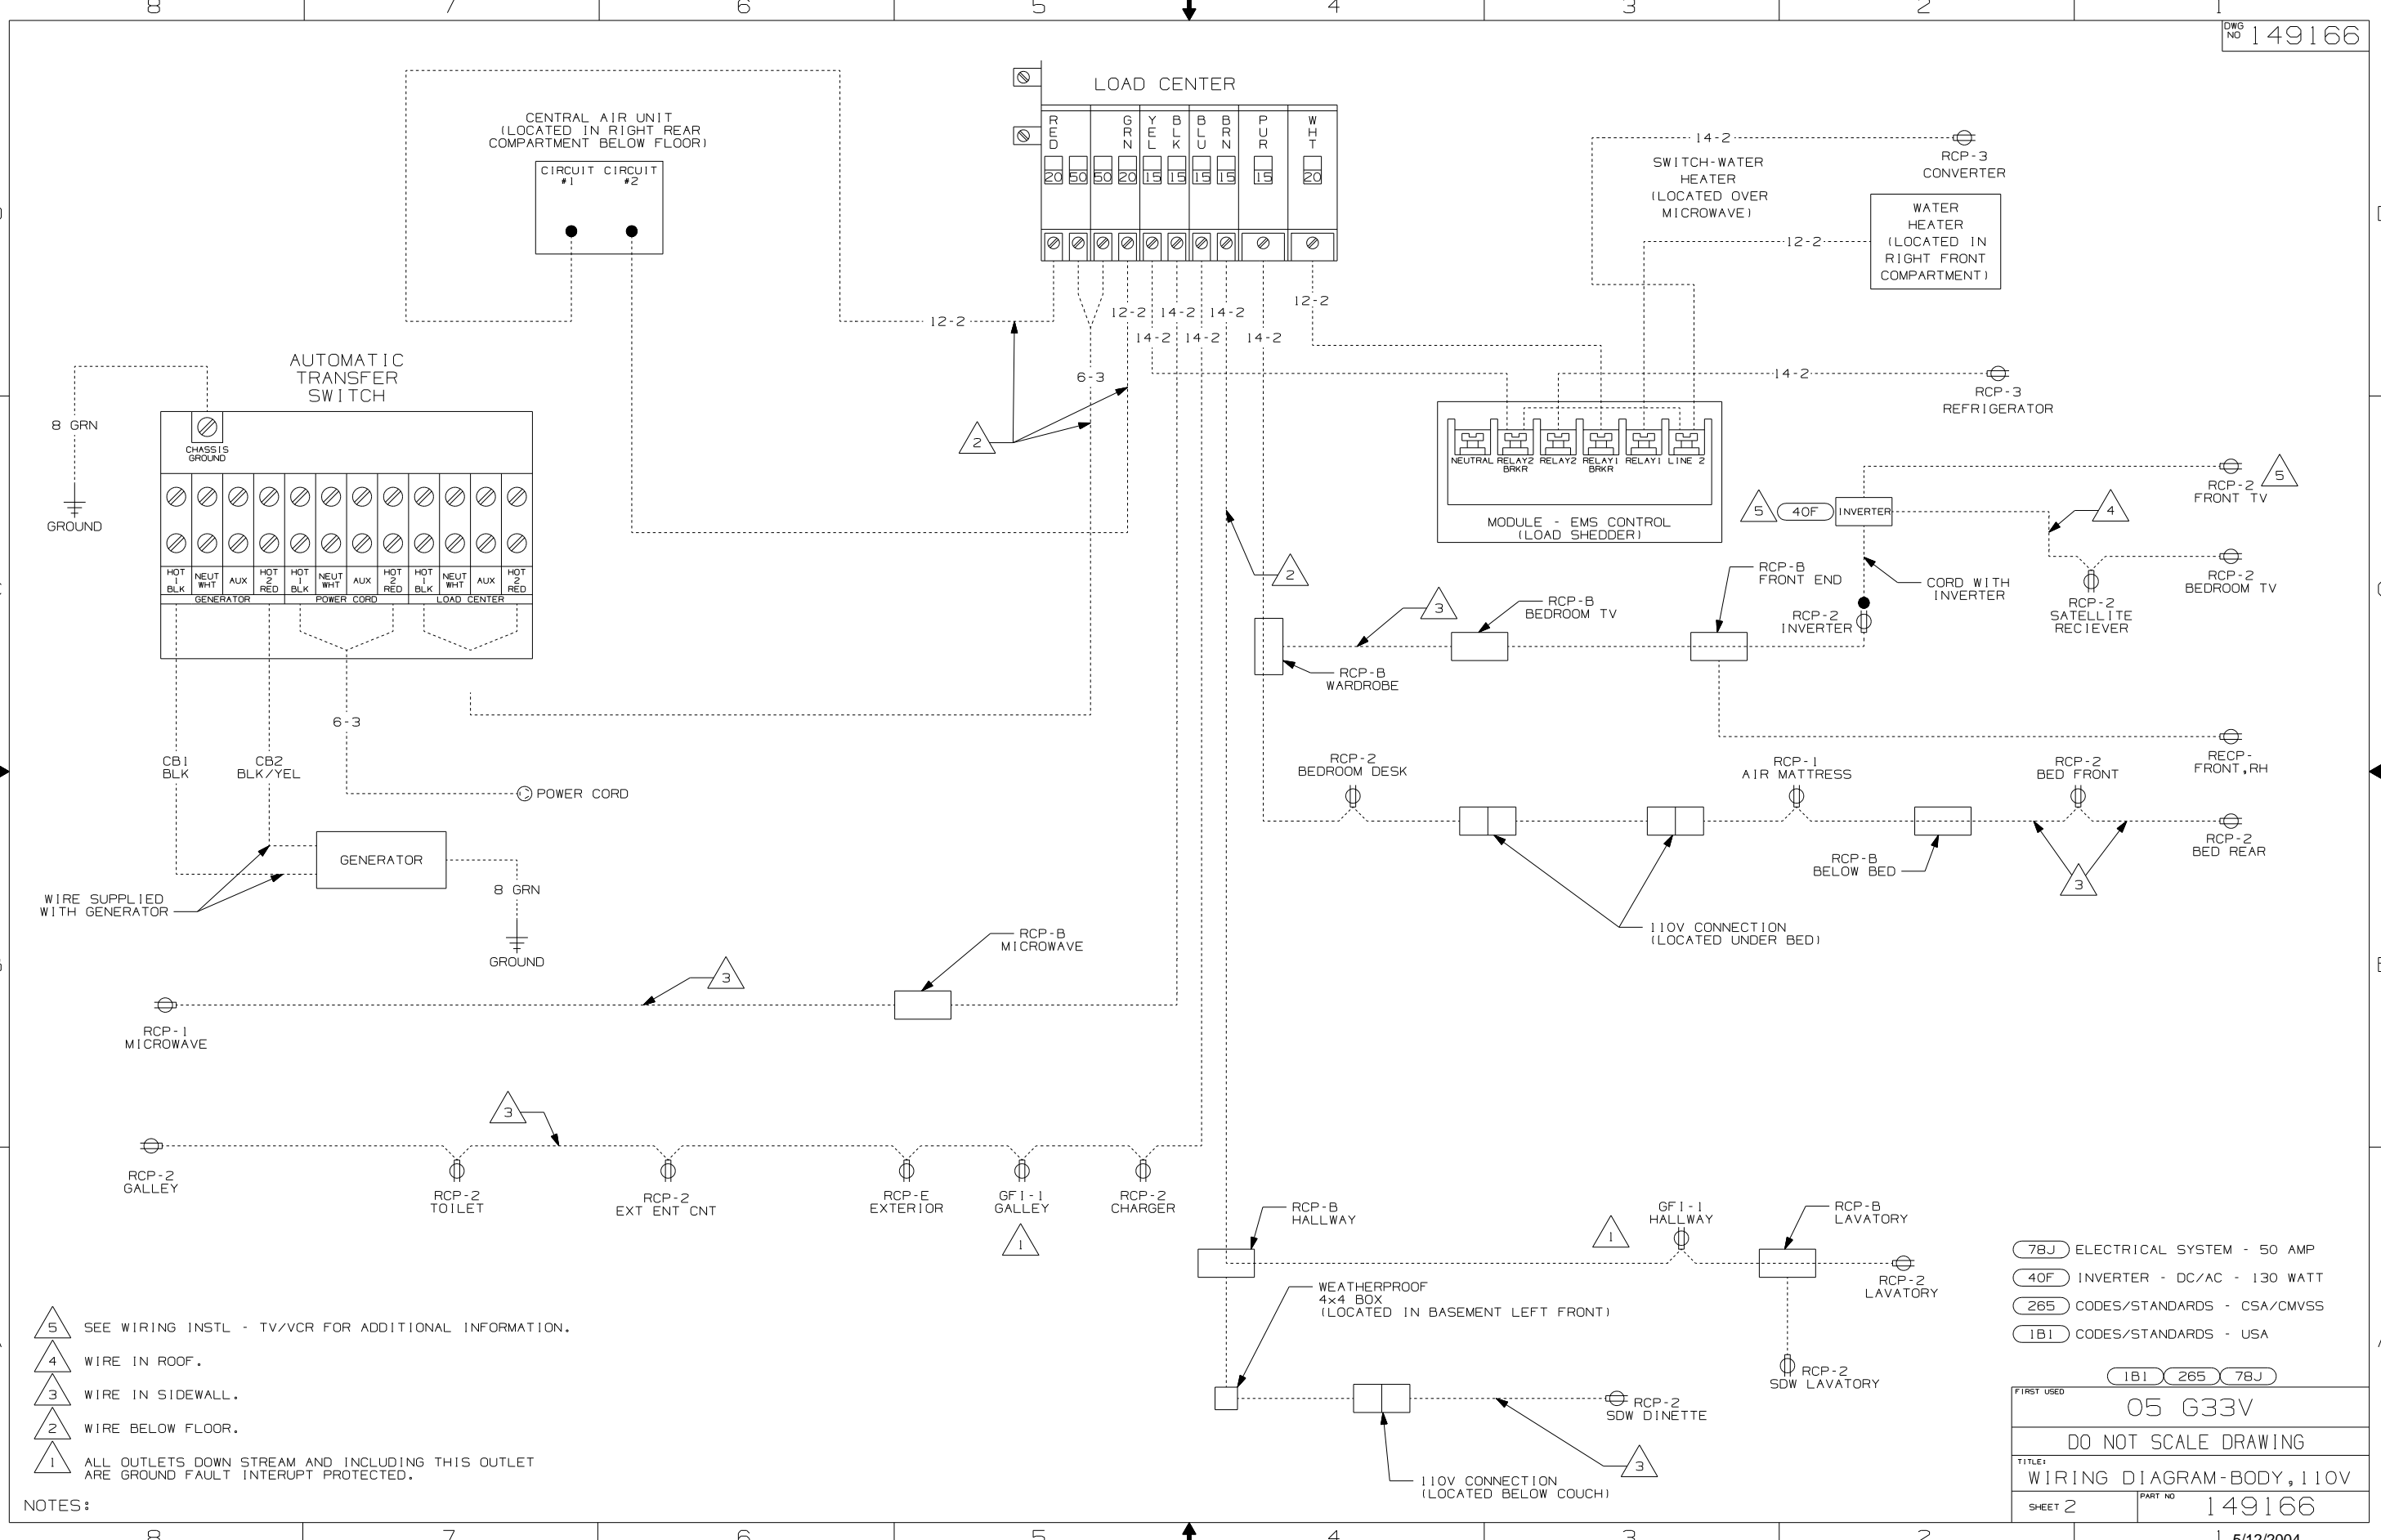
- 78J ELECTRICAL SYSTEM - 50 AMP
- 40F INVERTER - DC/AC - 130 WATT
- 265 CODES/STANDARDS - CSA/CMVSS
- 1B1 CODES/STANDARDS - USA
