WINNEBAGO		COPYRIGHT 2004 WINNEBAGO INDUSTRIES, INC.	
DFTR	ORIG. DATE		
CHKR	ALL DIMENSIONS ARE IN MILLIMETERS		
P.E.			
M.E.	FIRST USED		
DSNR	05 G35U		
UNSPECIFIED TOLERANCES ARE:		MATERIAL:	
WHOLE DIM (X)	:		*
ONE-PLACE (X.X)	:		*
TWO-PLACE (X.XX)	:		*
ANGLE	:		*
THIRD ANGLE PROJECTION			
DO NOT SCALE DRAWING			
TITLE: WIRING DIAGRAM-BODY, 110V			
SHEET 1 OF 2	PART NO	150455

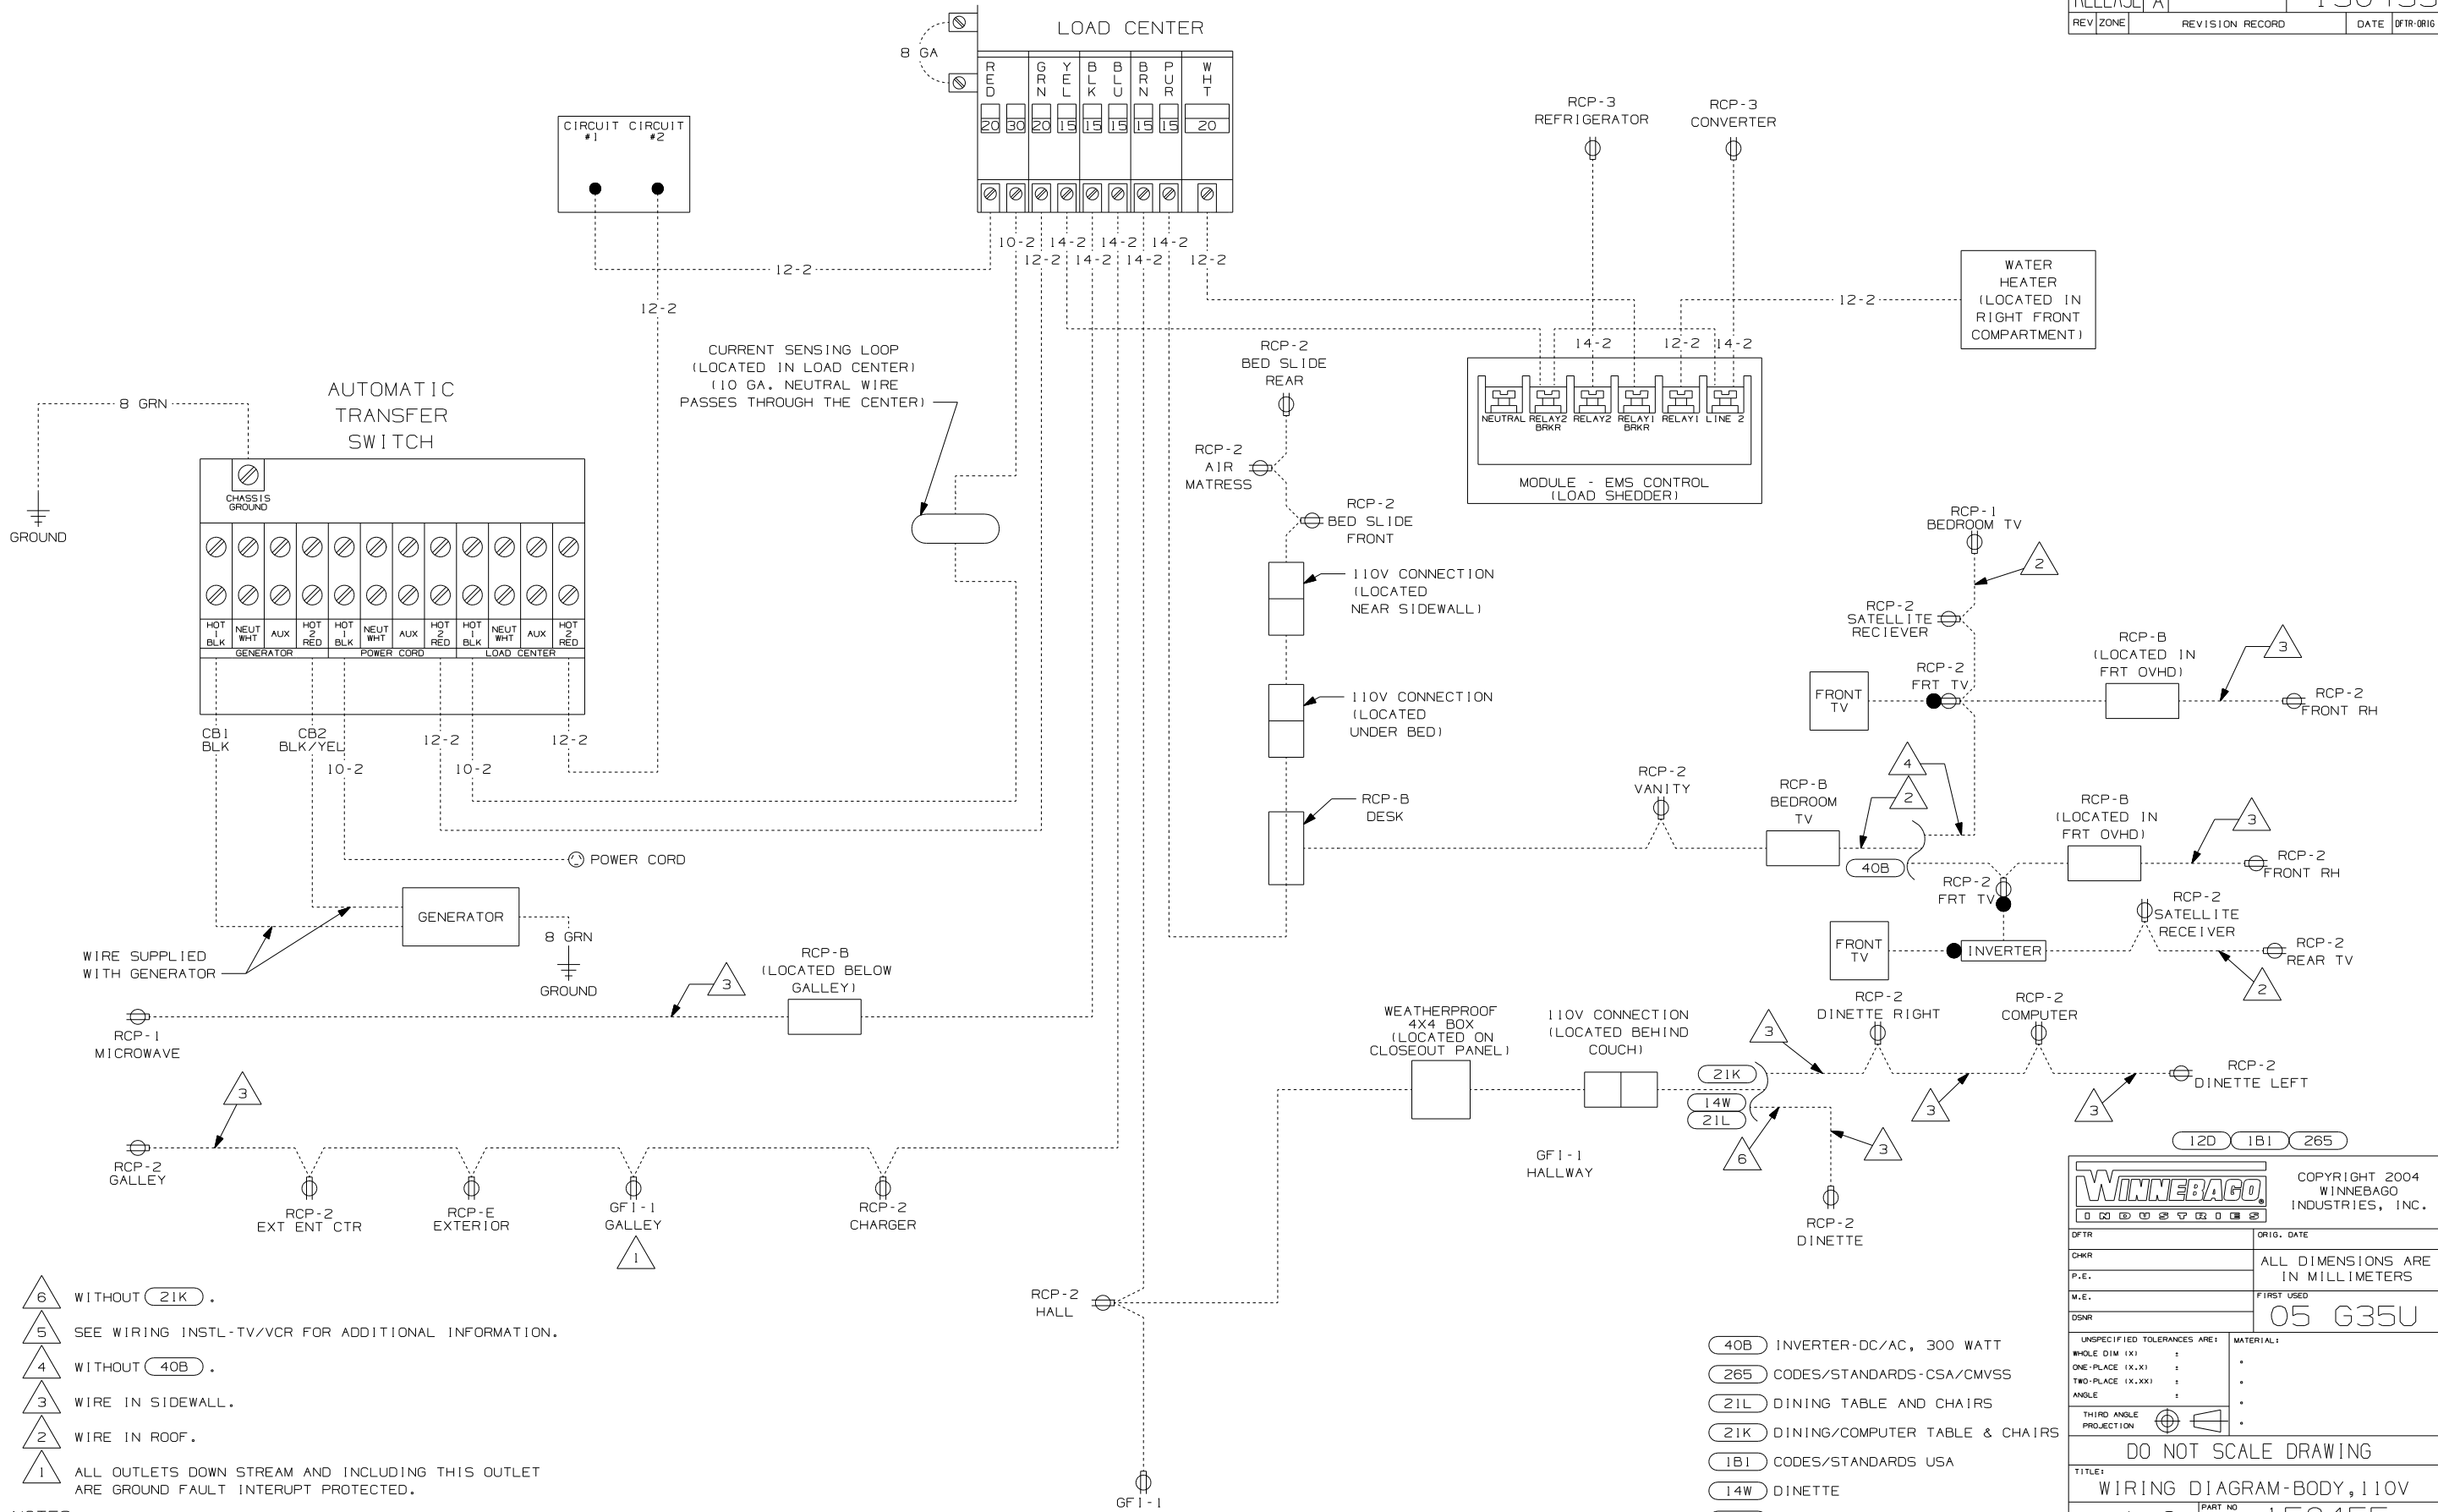
- NOTES:
- 6 WITHOUT (21K).
 - 5 SEE WIRING INSTL-TV/VCR FOR ADDITIONAL INFORMATION.
 - 4 WITHOUT (40B).
 - 3 WIRE IN SIDEWALL.
 - 2 WIRE IN ROOF.
 - 1 ALL OUTLETS DOWN STREAM AND INCLUDING THIS OUTLET ARE GROUND FAULT INTERRUPT PROTECTED.
