FIRST USED	05 G38G
DO NOT SCALE DRAWING	
TITLE:	WIRING DIAGRAM-BODY, 110V
SHEET 2	PART NO 151276

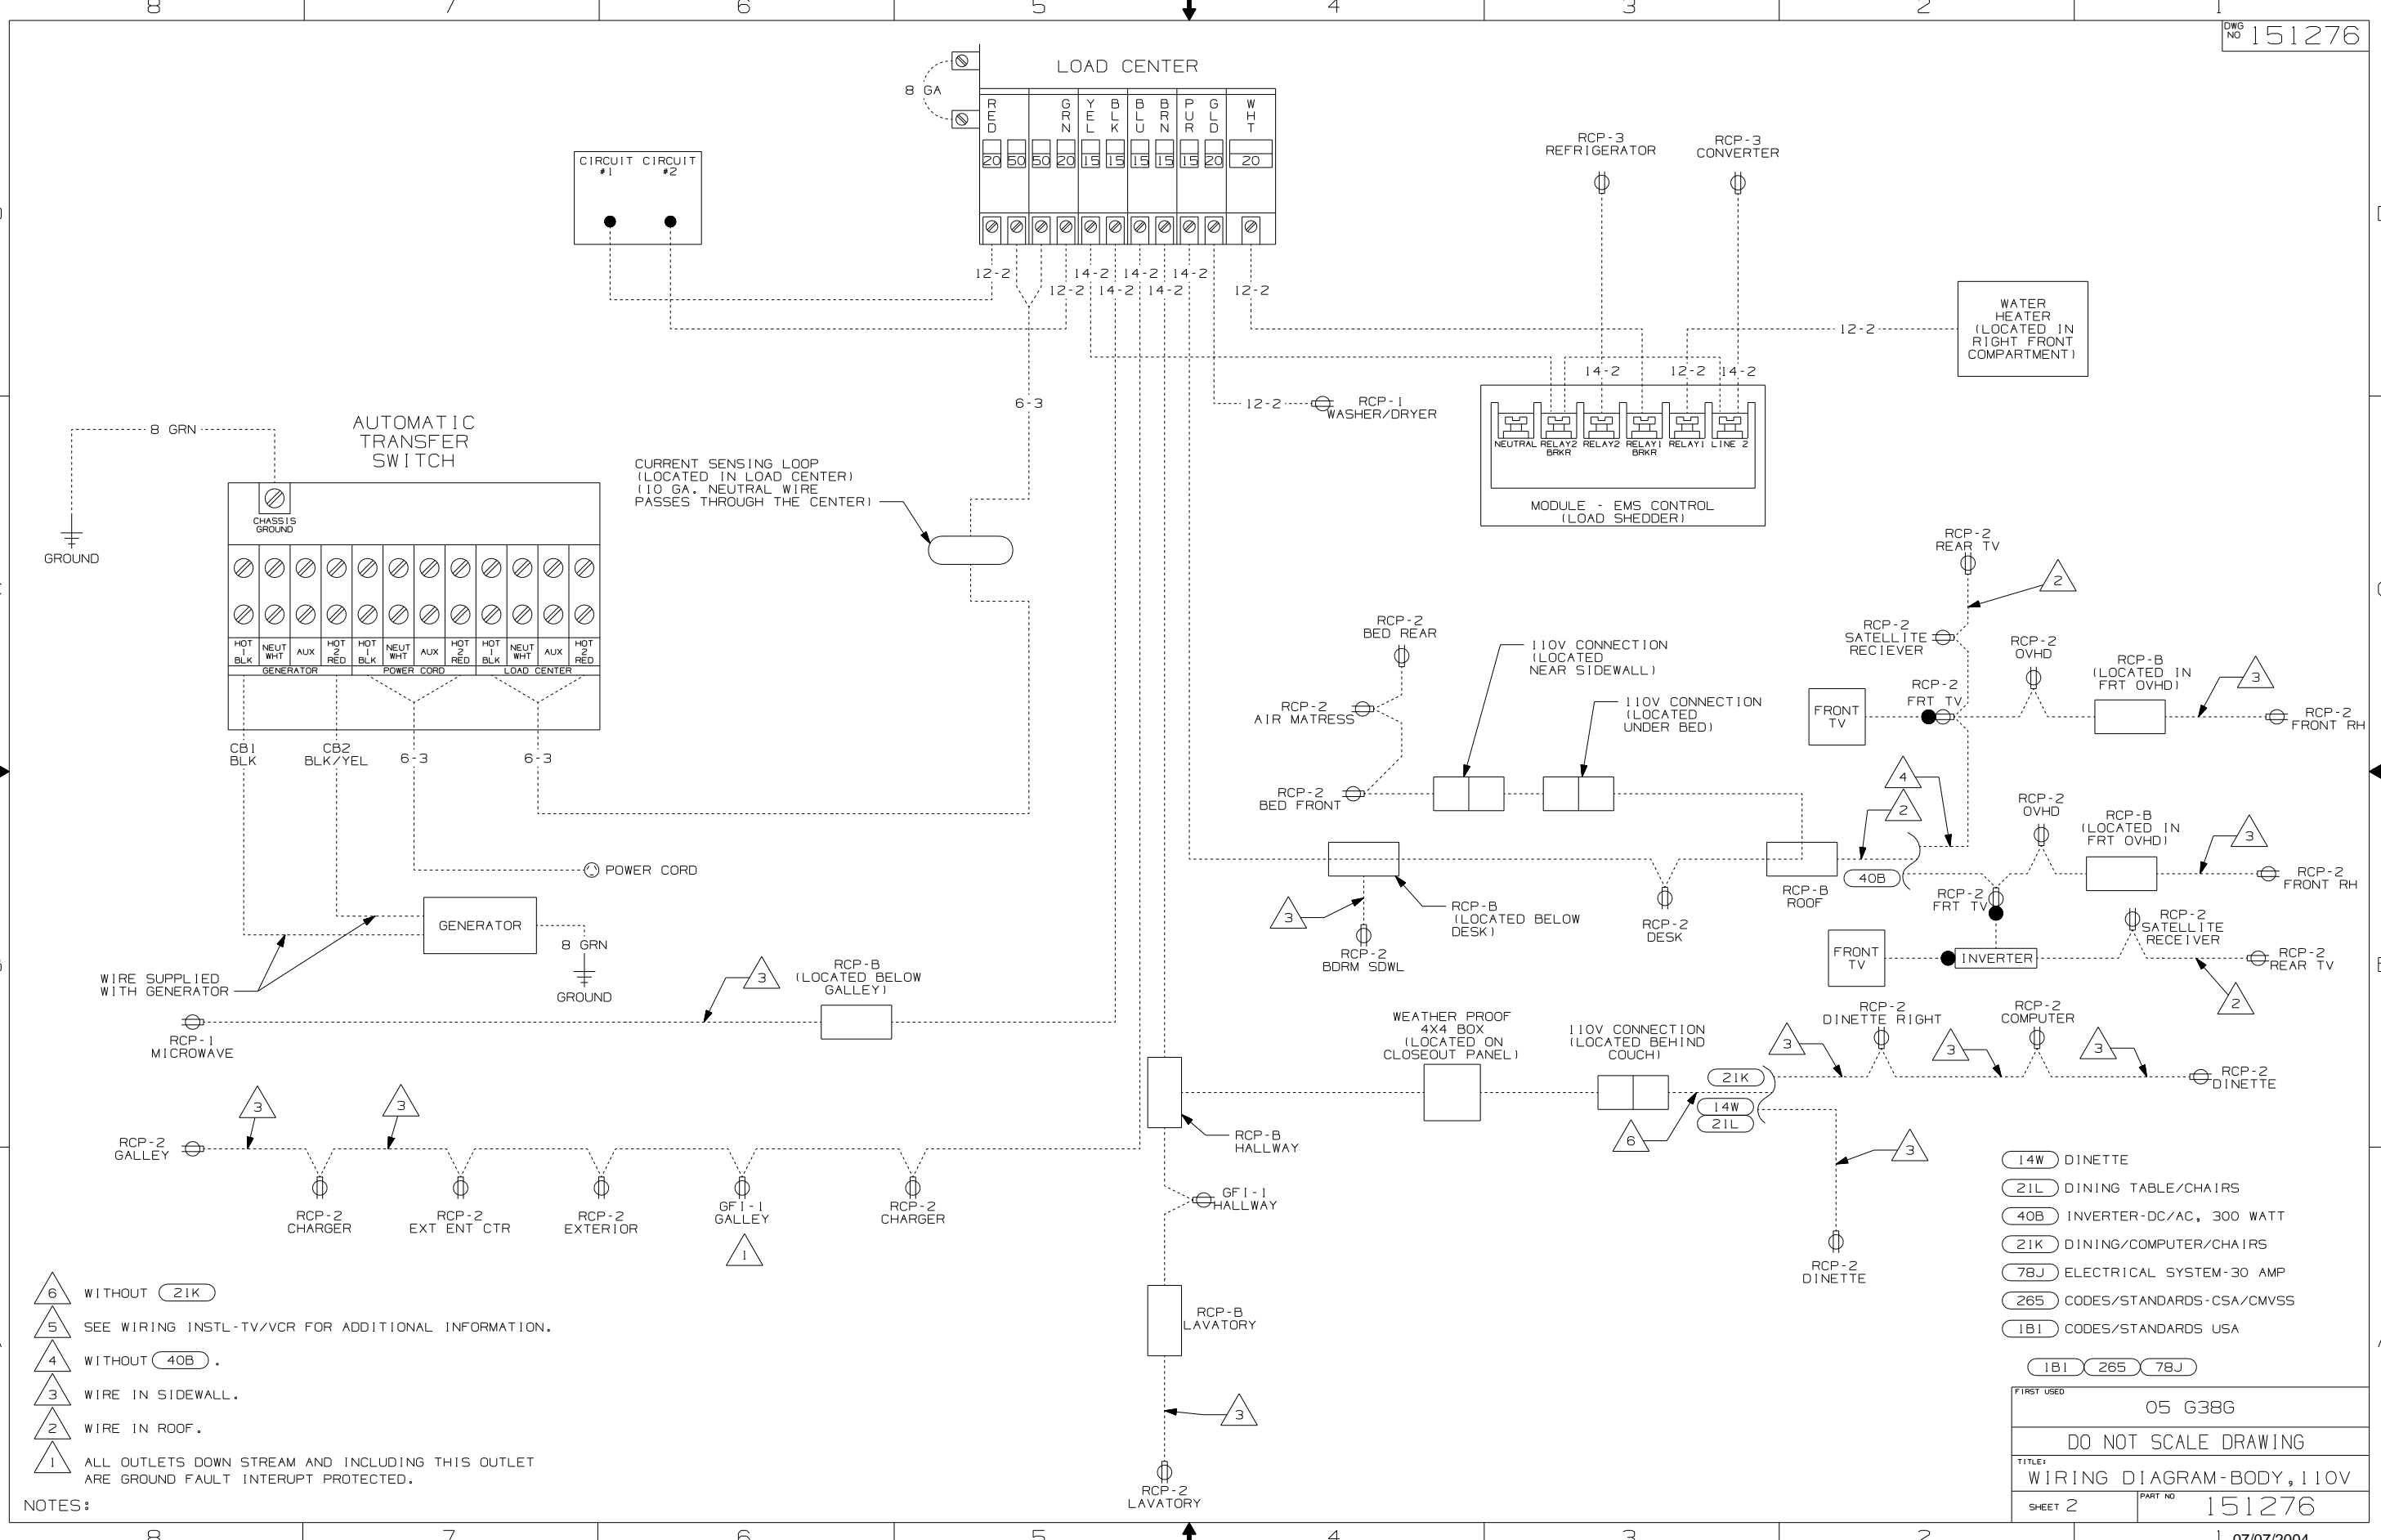
- 6 WITHOUT (21K)
- 5 SEE WIRING INSTL-TV/VCR FOR ADDITIONAL INFORMATION.
- 4 WITHOUT (40B)
- 3 WIRE IN SIDEWALL.
- 2 WIRE IN ROOF.
- 1 ALL OUTLETS DOWN STREAM AND INCLUDING THIS OUTLET ARE GROUND FAULT INTERRUPT PROTECTED.
