<b>WINNEBAGO</b>		COPYRIGHT 2004 WINNEBAGO INDUSTRIES, INC.	
DFTR	ORIG. DATE		
CHKR	ALL DIMENSIONS ARE IN MILLIMETERS		
P.E.	FIRST USED	05 G38R	
M.E.			
DSNR			
UNSPECIFIED TOLERANCES ARE:		MATERIAL:	
WHOLE DIM (X)	:		
ONE-PLACE (X.X)	:		
TWO-PLACE (X.XX)	:		
ANGLE	:		
THIRD ANGLE PROJECTION			
<b>DO NOT SCALE DRAWING</b>			
TITLE: WIRING DIAGRAM-BODY, 110V			
SHEET 1 OF 2	PART NO	150017	
REF:146267 1 5/12/2004

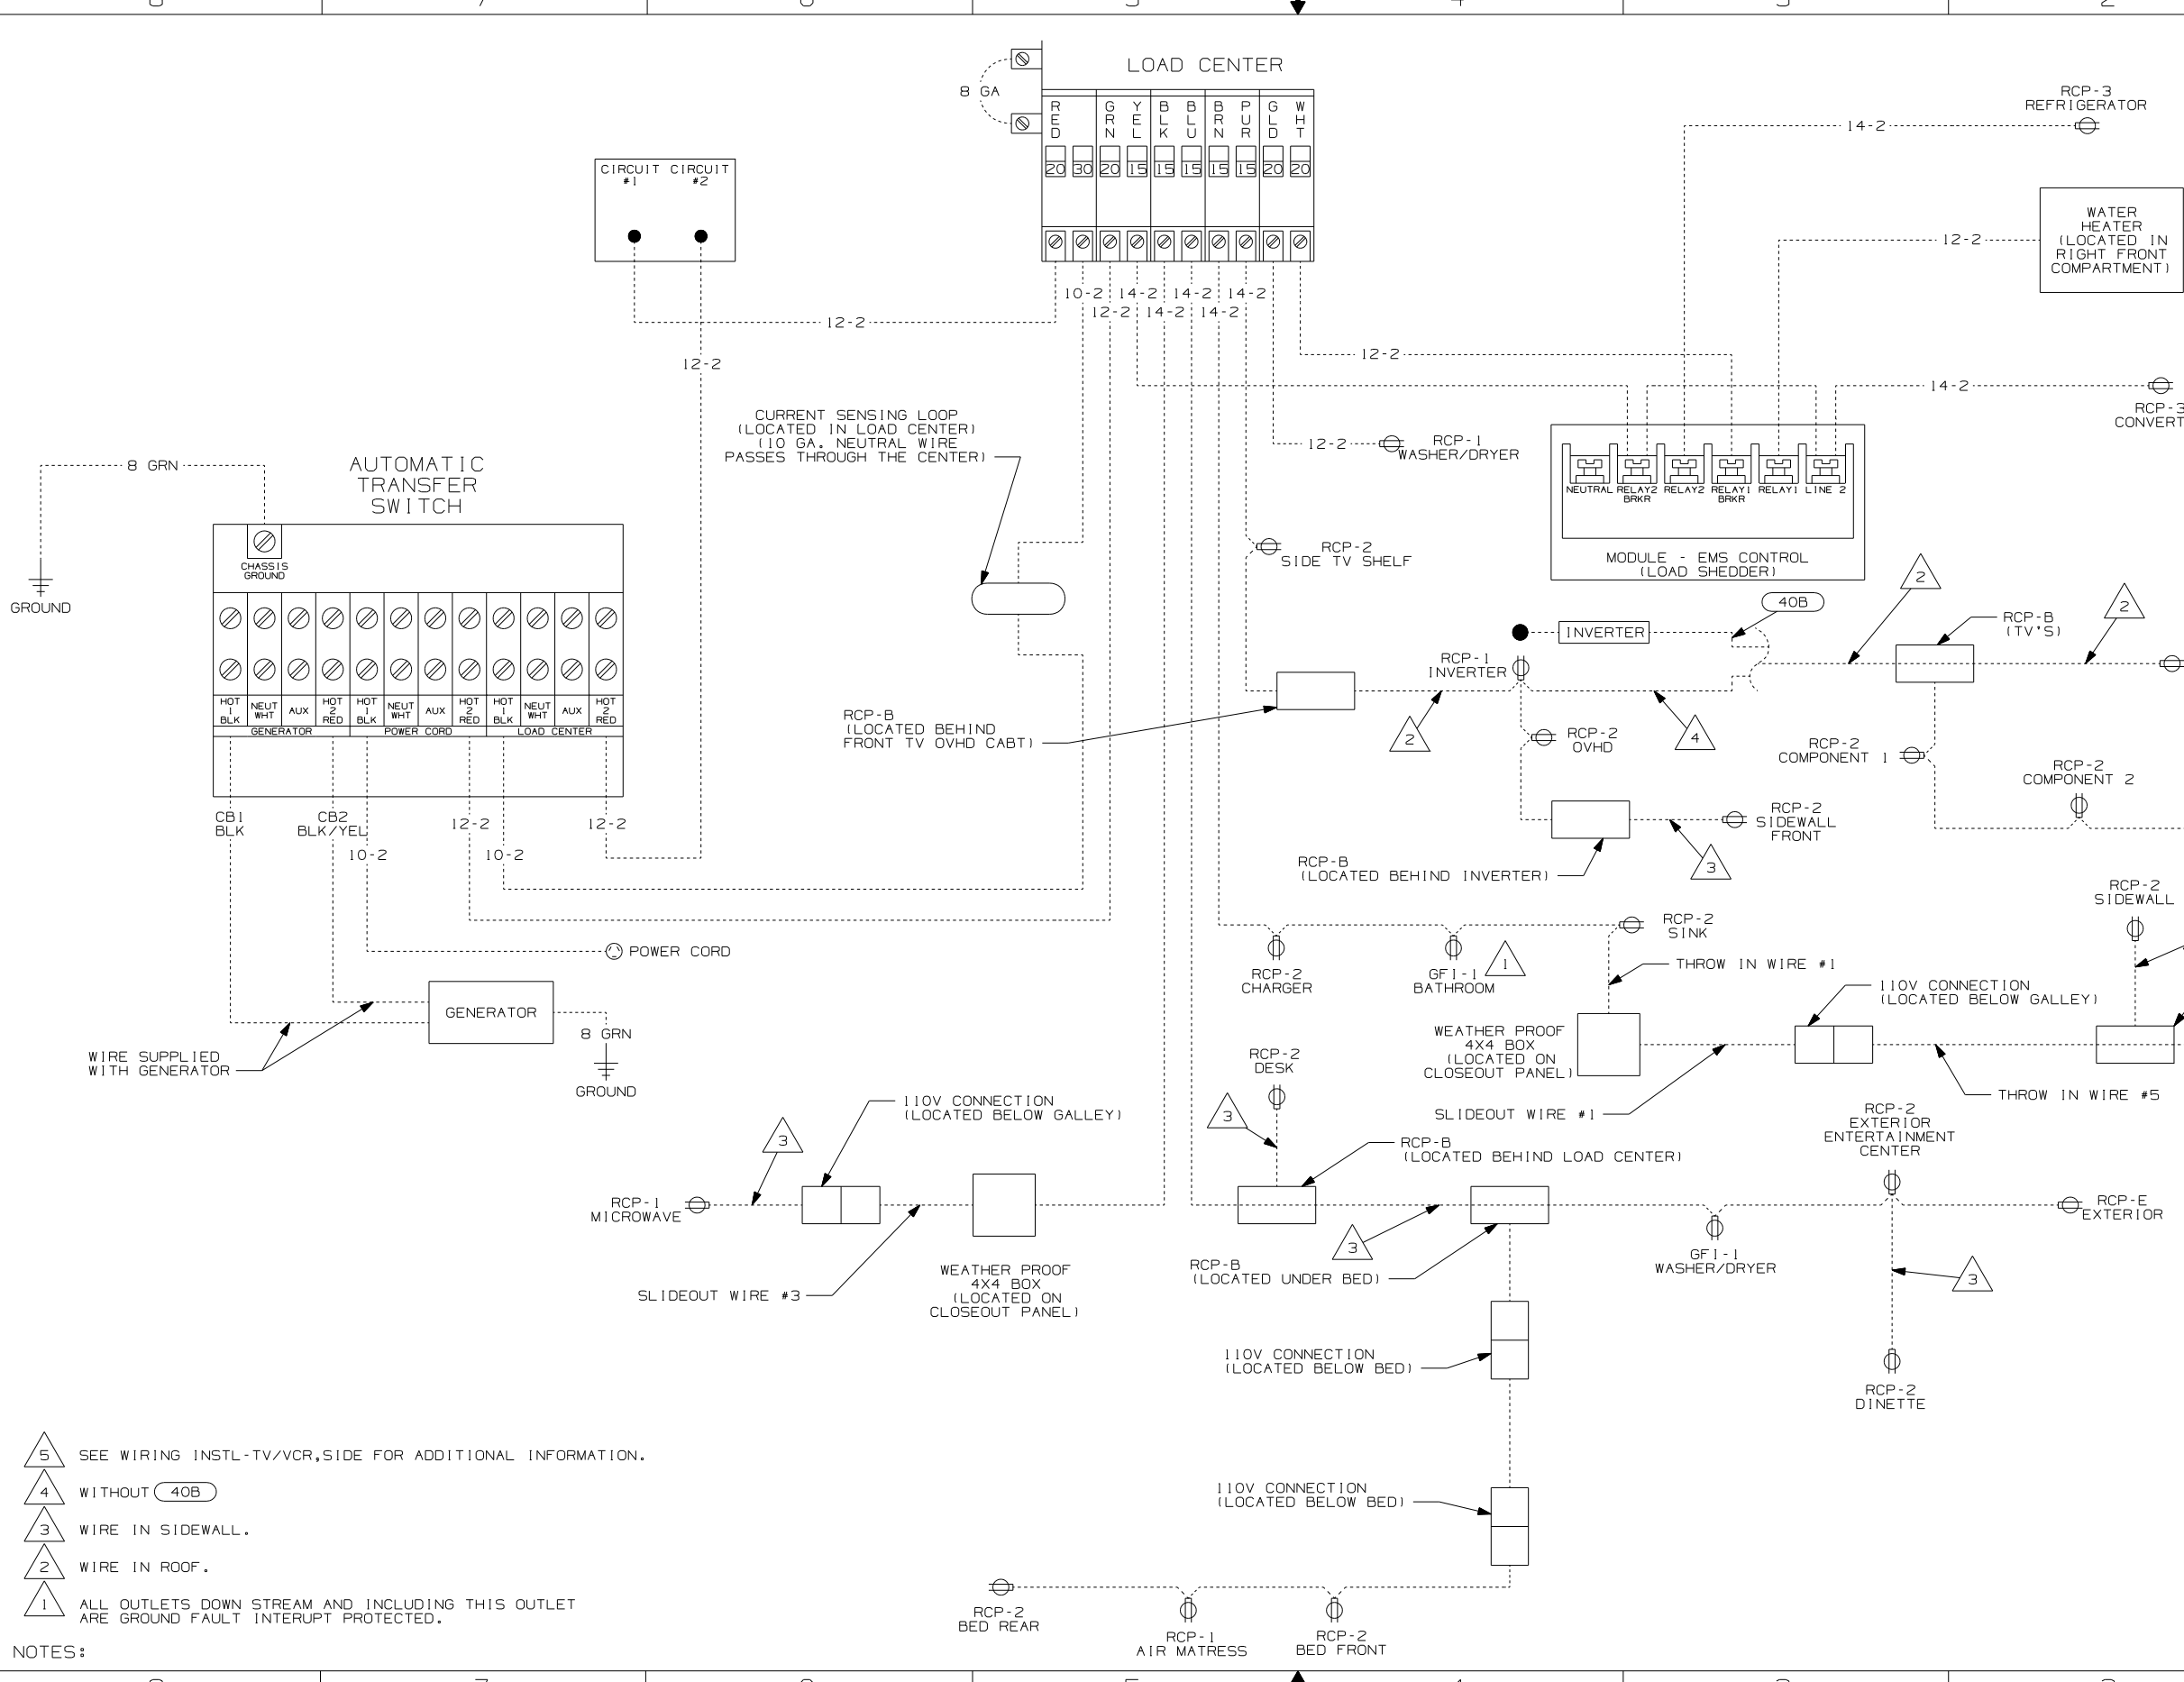
- NOTES:
- 5 SEE WIRING INSTL-TV/VCR,SIDE FOR ADDITIONAL INFORMATION.
  - 4 WITHOUT 40B
  - 3 WIRE IN SIDEWALL.
  - 2 WIRE IN ROOF.
  - 1 ALL OUTLETS DOWN STREAM AND INCLUDING THIS OUTLET ARE GROUND FAULT INTERRUPT PROTECTED.

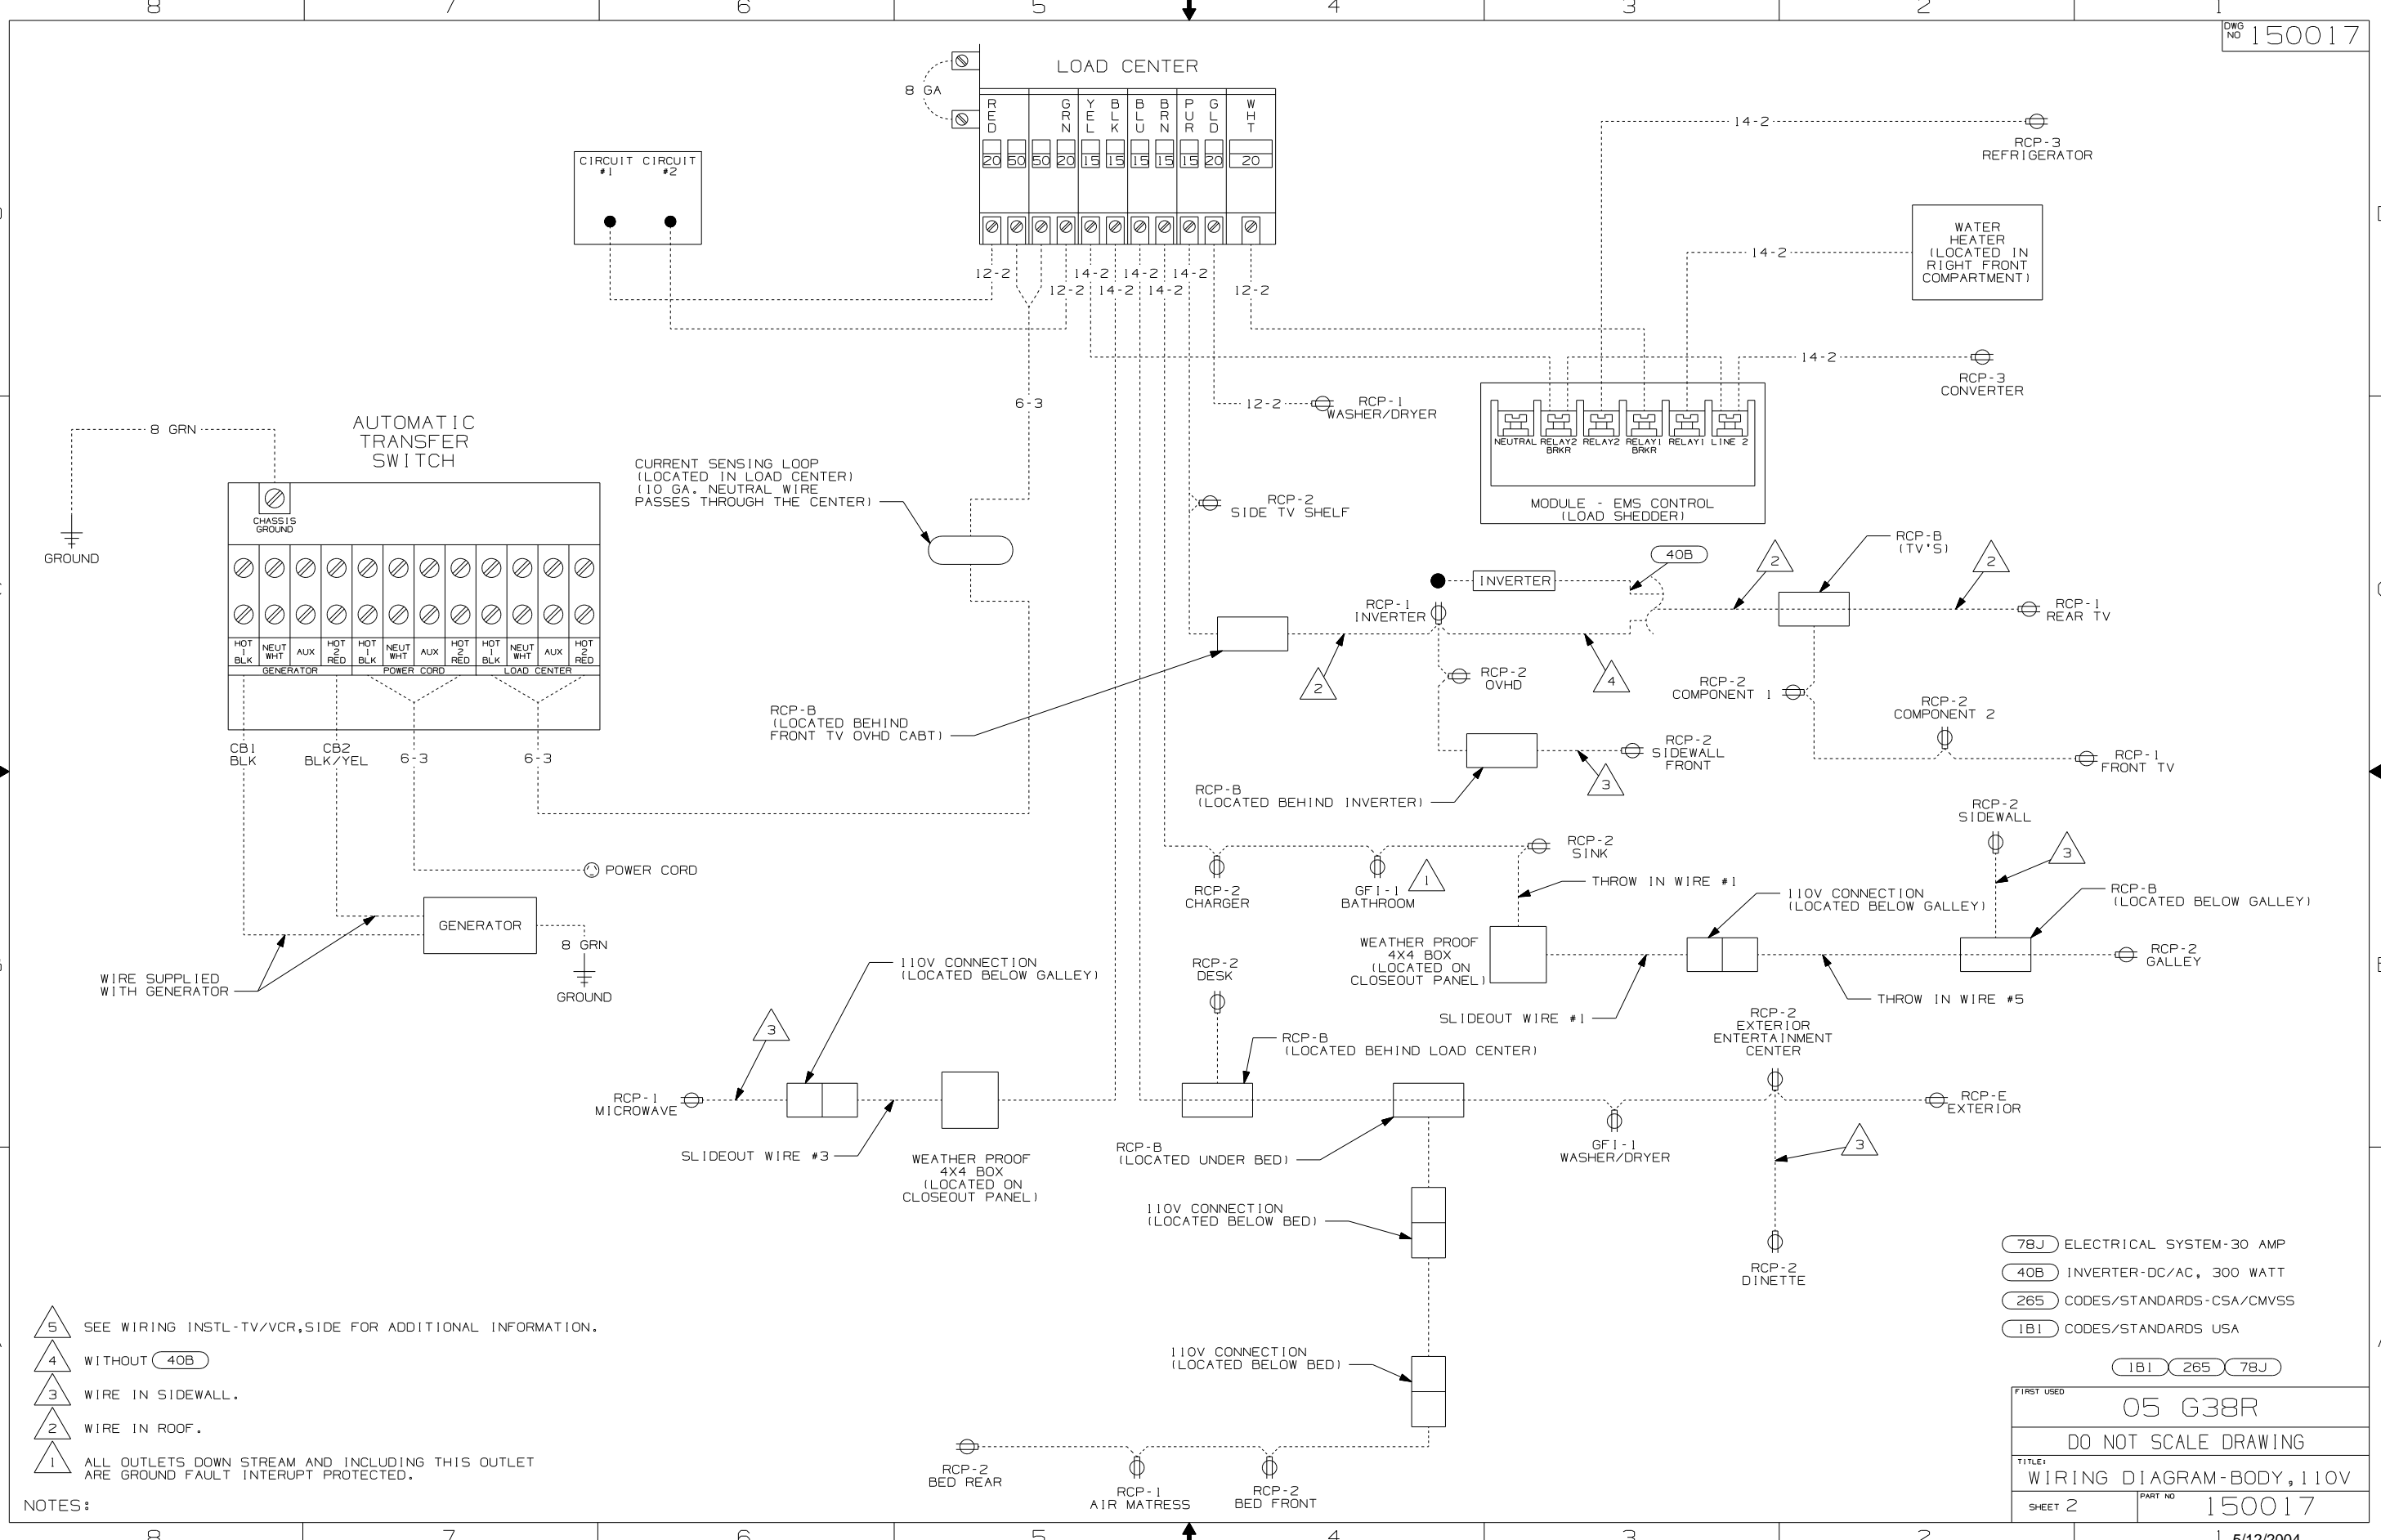
FIRST USED	05 G38R
TITLE	DO NOT SCALE DRAWING
TITLE	WIRING DIAGRAM-BODY, 110V
SHEET 2	PART NO 150017

- NOTES:
- 5 SEE WIRING INSTL-TV/VCR,SIDE FOR ADDITIONAL INFORMATION.
  - 4 WITHOUT 40B
  - 3 WIRE IN SIDEWALL.
  - 2 WIRE IN ROOF.
  - 1 ALL OUTLETS DOWN STREAM AND INCLUDING THIS OUTLET ARE GROUND FAULT INTERRUPT PROTECTED.
