| M.E. | FIRST USED | 05 S36RD | |
| TITLE: WIRING DIAGRAM-BODY, 110V | | | |
| SHEET 1 OF 1 | PART NO | 150029 | |

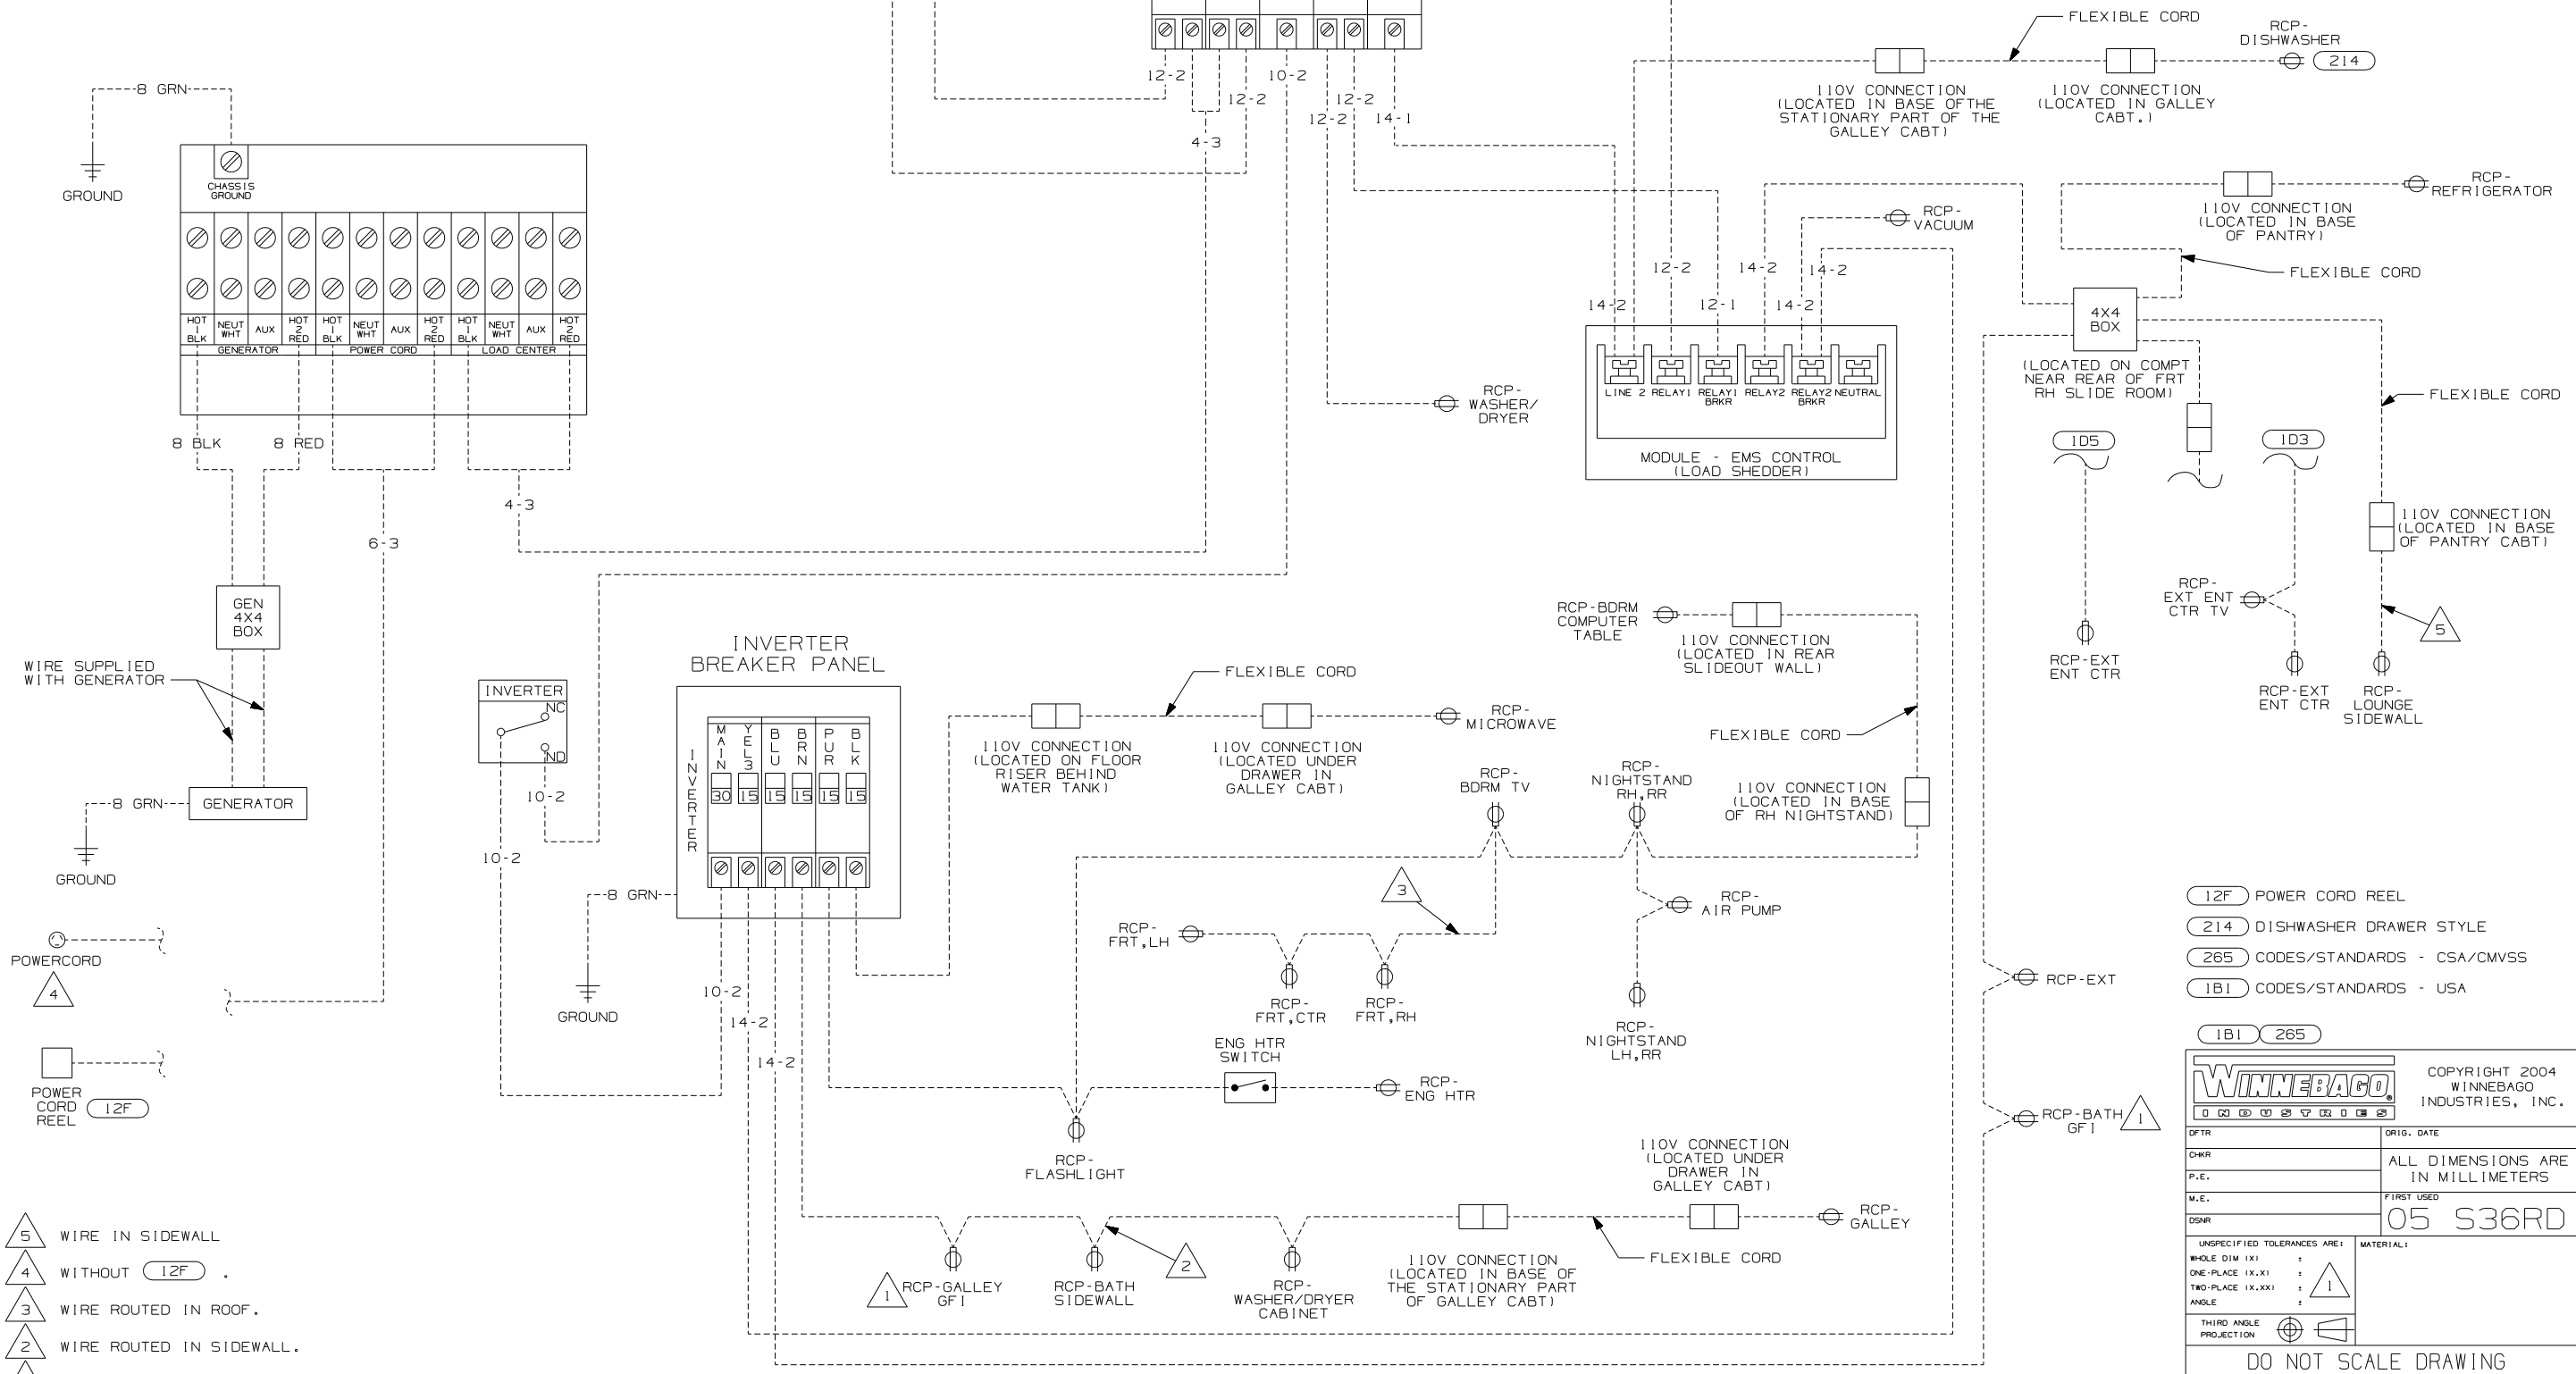
- NOTES:
- 5 WIRE IN SIDEWALL
 - 4 WITHOUT 12F
 - 3 WIRE ROUTED IN ROOF.
 - 2 WIRE ROUTED IN SIDEWALL.
 - 1 ALL OUTLETS DOWN STREAM AND INCLUDING THIS OUTLET ARE GROUND GAULT INTERRUPT PROTECTED.
