WINNEBAGO		COPYRIGHT 2004 WINNEBAGO INDUSTRIES, INC.	
DFT	ORIG. DATE		
CHKR	ALL DIMENSIONS ARE IN MILLIMETERS		
P.E.			
M.E.	FIRST USED		
DSNR	06 324V		
UNSPECIFIED TOLERANCES ARE:		MATERIAL:	
WHOLE DIM (X)	:		*
ONE-PLACE (X.X)	:		*
TWO-PLACE (X.XX)	:		*
ANGLE	:		*
THIRD ANGLE PROJECTION			
DO NOT SCALE DRAWING			
TITLE: WIRING DIAGRAM-BODY, 110V			
SHEET 1 OF 1	PART NO	155088	
REF:	1 8/8/2005

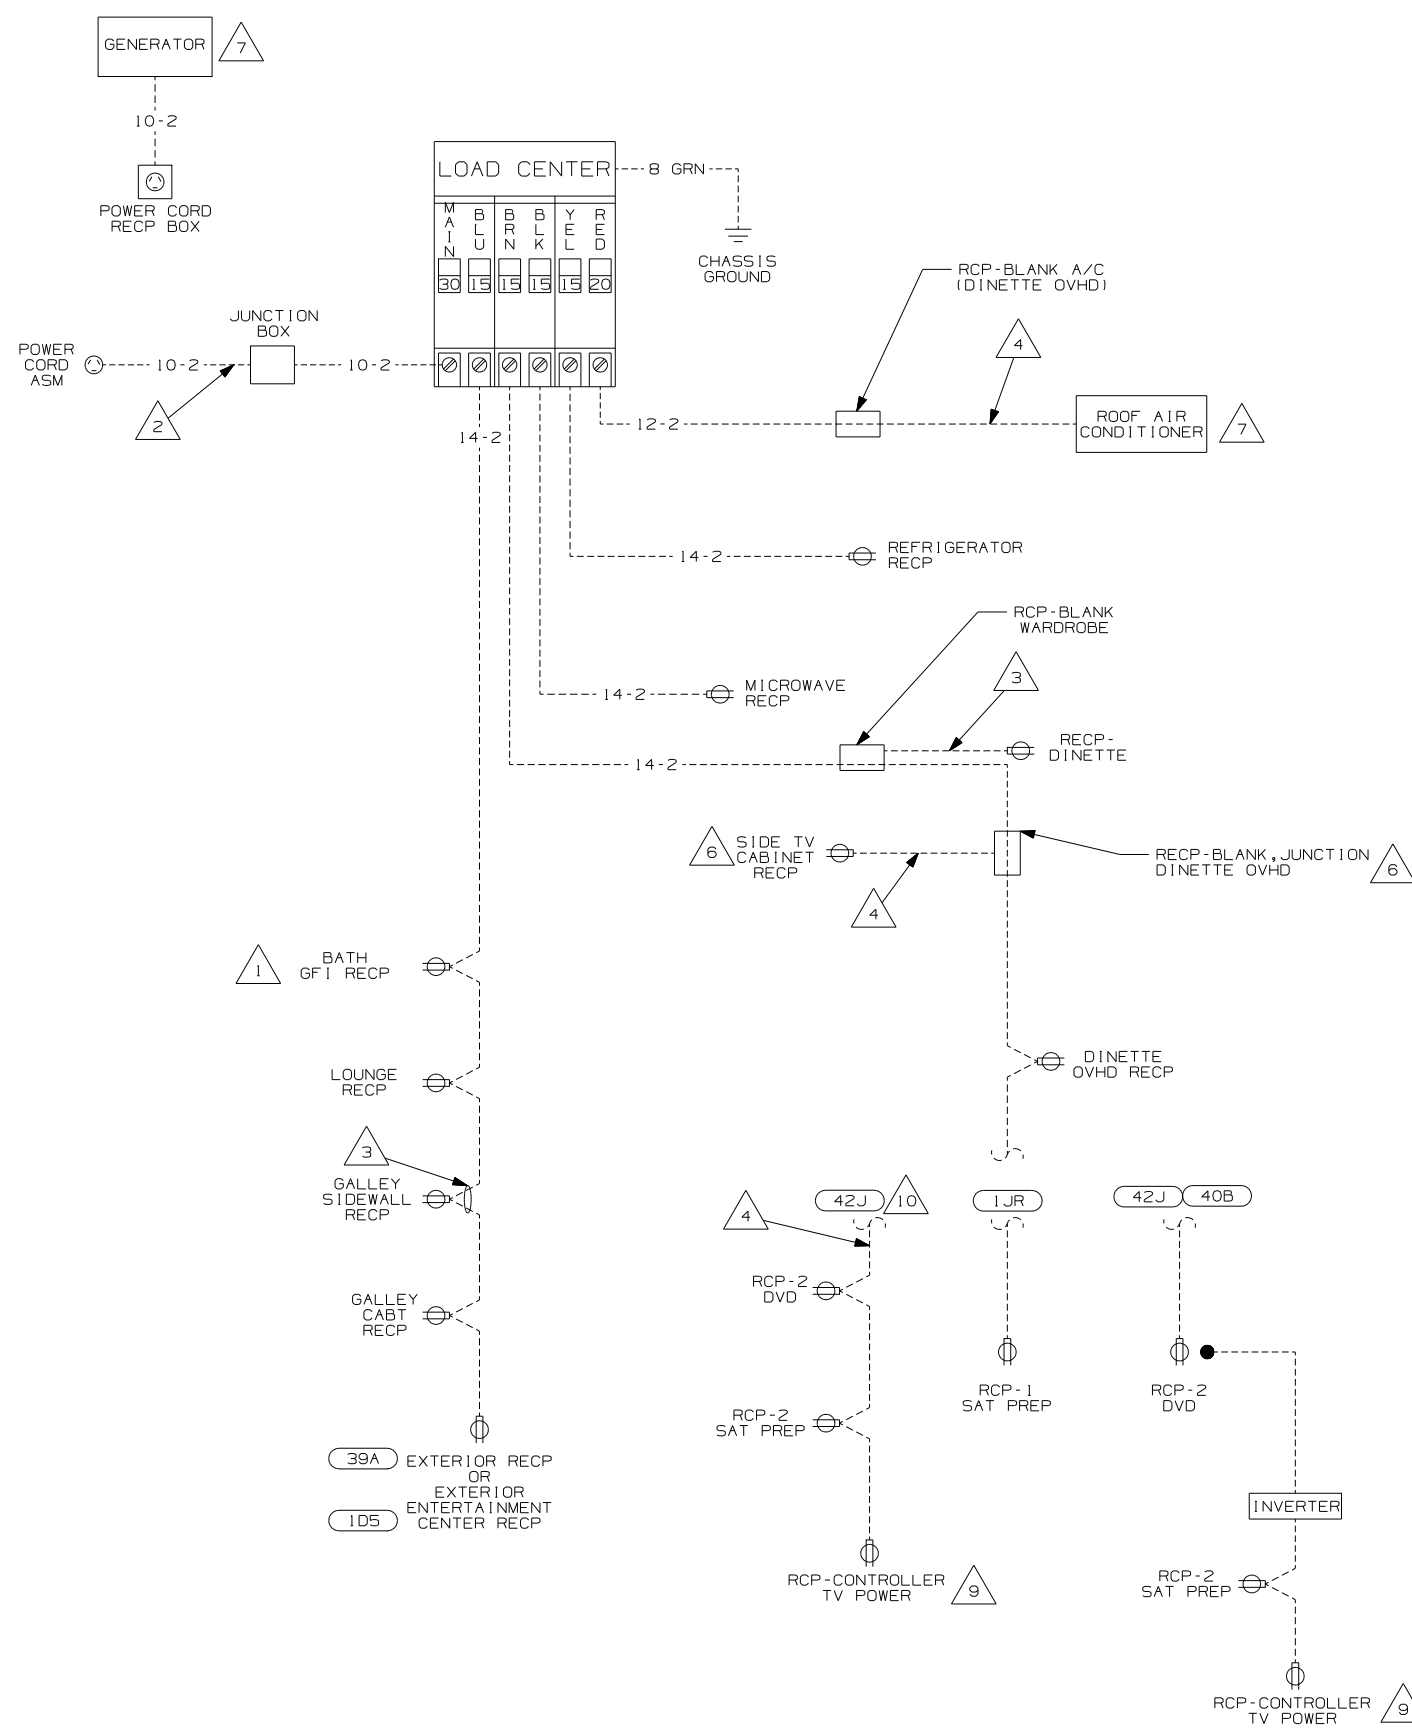
- 10 WITHOUT (40B).
- 9 SEE WIRING DIAGRAM-12V BODY FOR ADDITIONAL INFORMATION.
- 8 NOT USED WITH (42J).
- 7 SEE MANUFACTURERS DIAGRAM.
- 6 NOT USED WITH (42J) OR (1JR).
- 5 ONLY WITH (42J).
- 4 WIRE ROUTED THRU ROOF.
- 3 WIRE ROUTED THRU SIDEWALL.
- 2 WIRE ROUTED THRU FLOOR.
- 1 ALL OUTLETS DOWN STREAM AND INCLUDING THIS OUTLET ARE GROUND FAULT CIRCUIT INTERRUPT PROTECTED.
