WINNEBAGO		COPYRIGHT 2004 WINNEBAGO INDUSTRIES, INC.	
DFTR	ORIG. DATE		
CHKR	ALL DIMENSIONS ARE IN MILLIMETERS		
P.E.			
M.E.	FIRST USED	06 326A	
DSNR			
UNSPECIFIED TOLERANCES ARE:		MATERIAL:	
WHOLE DIM (X)	:		
ONE-PLACE (X.X)	:		
TWO-PLACE (X.XX)	:		
ANGLE	:		
THIRD ANGLE PROJECTION			
DO NOT SCALE DRAWING			
TITLE: WIRING DIAGRAM-BODY, 110V			
SHEET 1 of 1	PART NO	155290	
REF:		1 8/8/2005

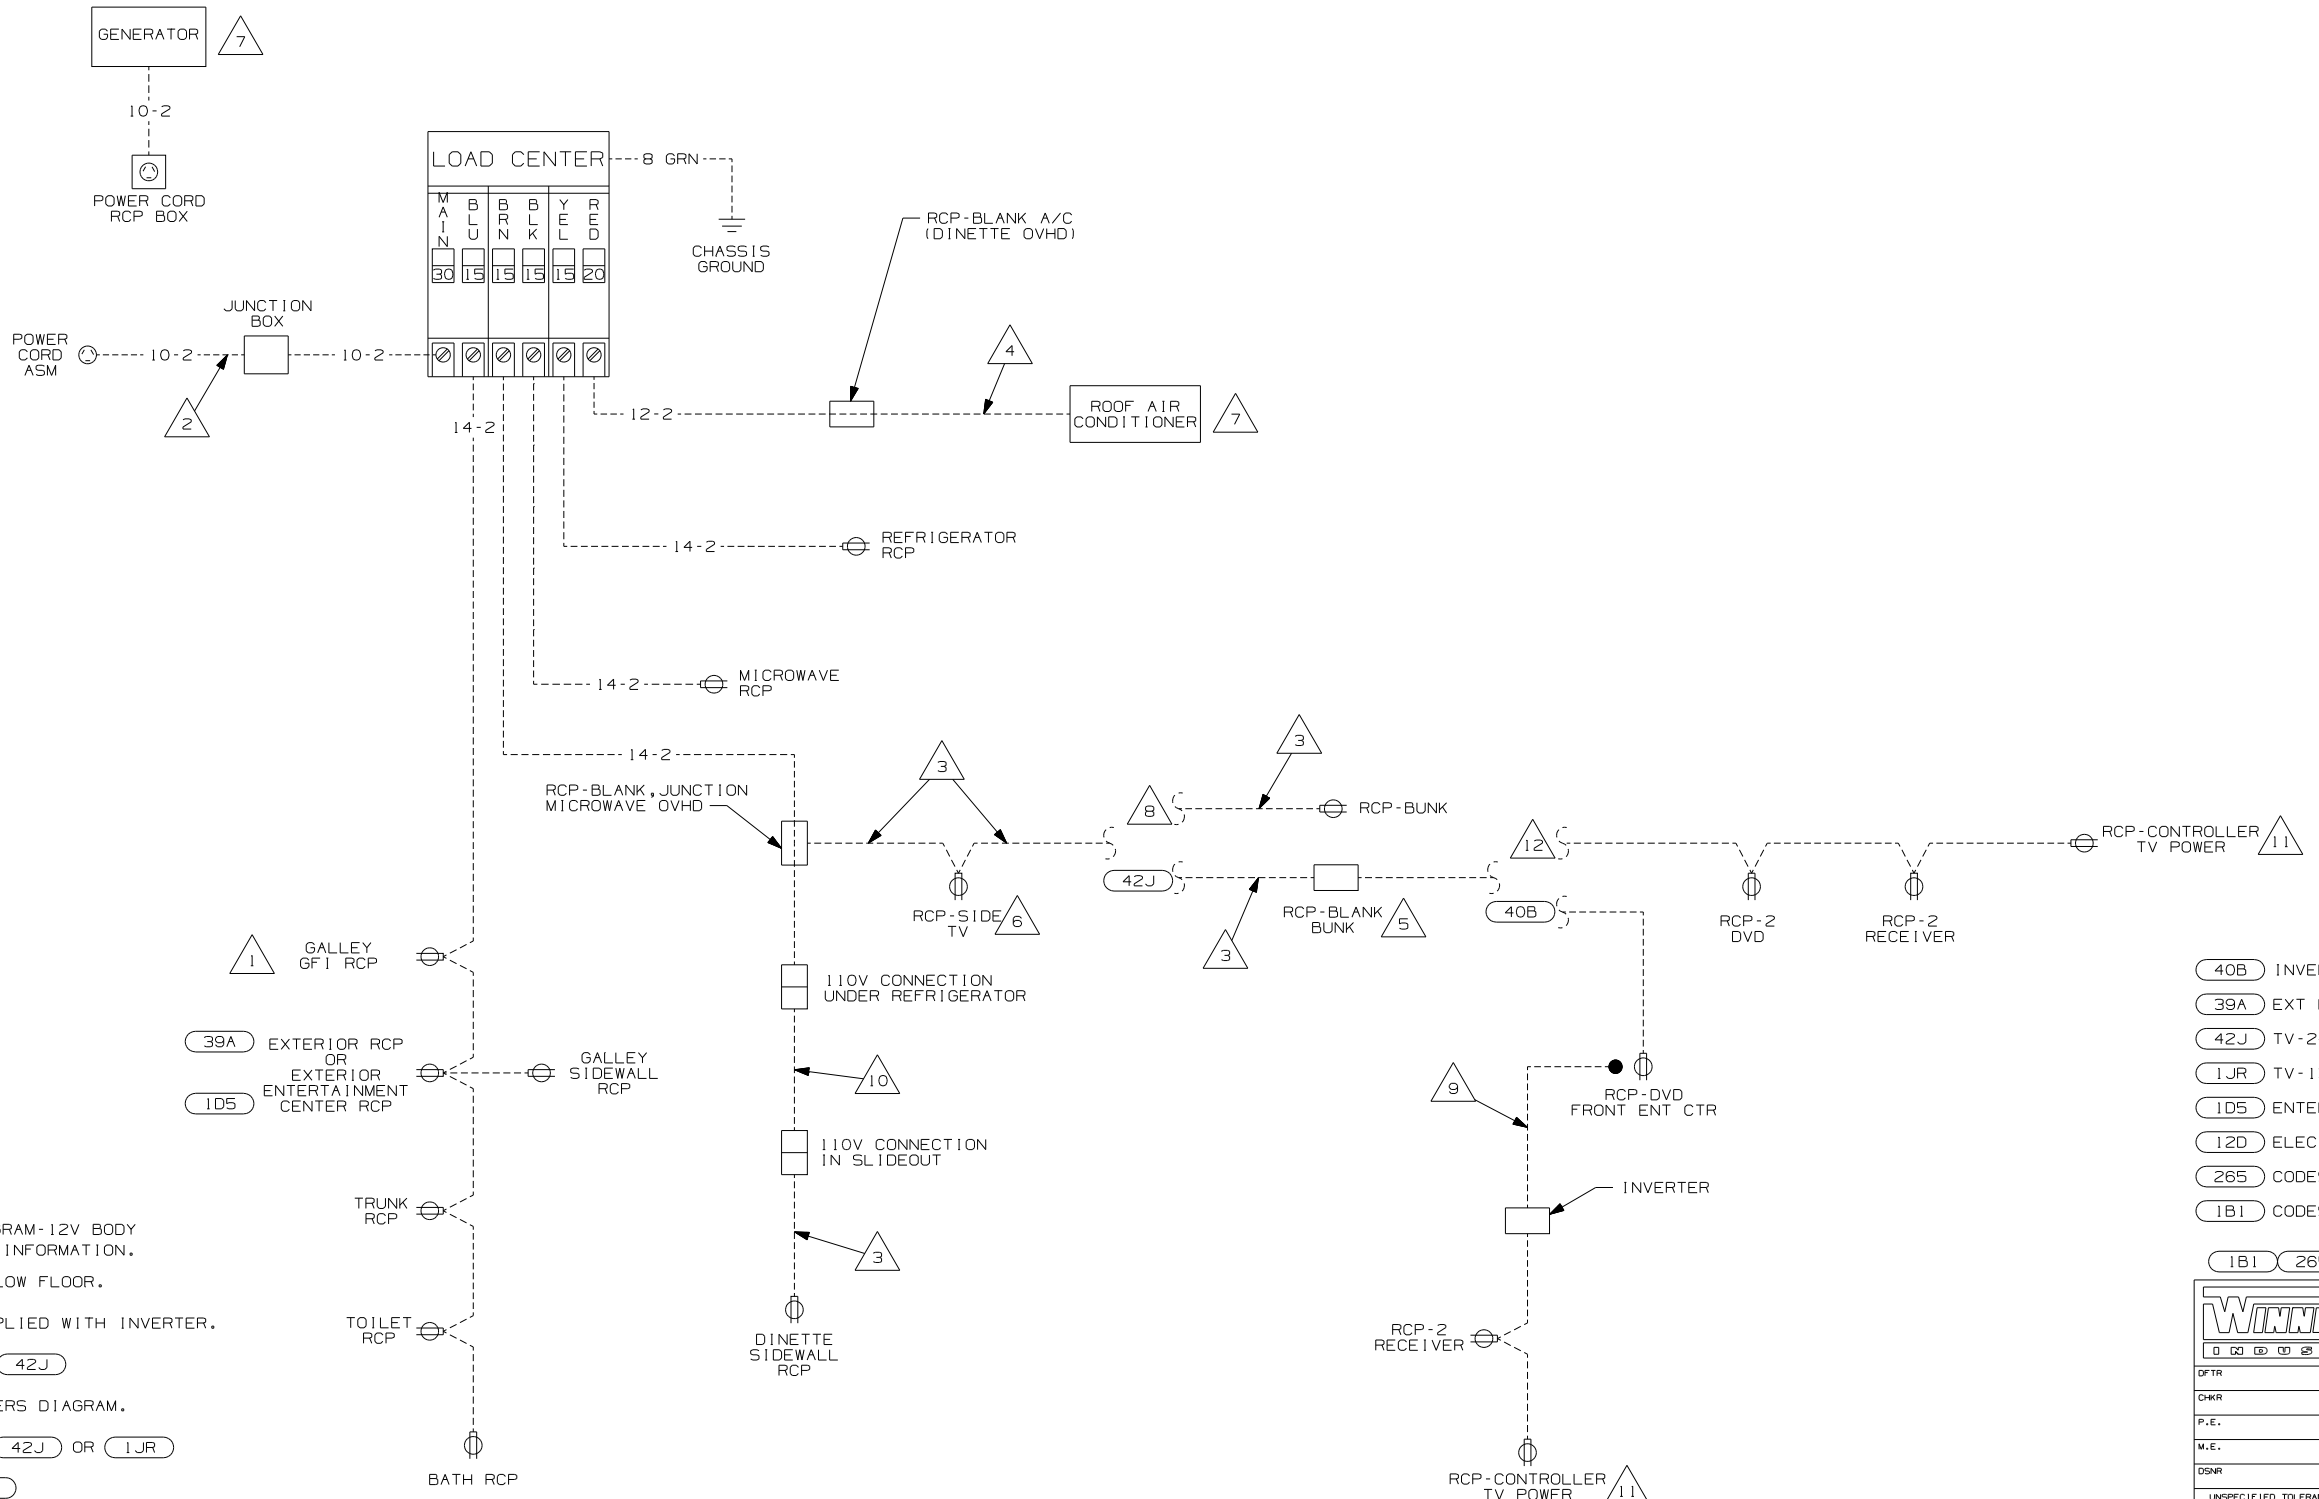
- 12 WITHOUT 40B
- 11 SEE WIRING DIAGRAM-12V BODY FOR ADDITIONAL INFORMATION.
- 10 WIRE ROUTED BELOW FLOOR.
- 9 POWER CORD SUPPLIED WITH INVERTER.
- 8 NOT USED WITH 42J
- 7 SEE MANUFACTURERS DIAGRAM.
- 6 NOT USED WITH 42J OR 1JR
- 5 ONLY WITH 42J
- 4 WIRE ROUTED THRU ROOF.
- 3 WIRE ROUTED THRU SIDEWALL.
- 2 WIRE ROUTED THRU FLOOR.
- 1 ALL OUTLETS DOWN STREAM AND INCLUDING THIS OUTLET ARE GROUND FAULT CIRCUIT INTERRUPT PROTECTED.

- 40B INVERTER-DC/AC, 300 WATT
- 39A EXT RECEPTACLE DPLX 120VAC
- 42J TV-24" COLOR, STEREO W/REMOTE
- 1JR TV-13" W/DVD-12V
- 1D5 ENTERTAINMENT CENTR/EXT W/CD
- 12D ELECTRICAL SYSTEM 30 AMP
- 265 CODES/STANDARDS-CSA/CMVSS
- 1B1 CODES/STANDARDS-USA
