<b>WINNEBAGO</b>		COPYRIGHT 2004 WINNEBAGO INDUSTRIES, INC.	
DFTR	ORIG. DATE	ALL DIMENSIONS ARE IN MILLIMETERS	
CHKR		FIRST USED <b>06 329K</b>	
P.E.			
M.E.		UNSPECIFIED TOLERANCES ARE: HOLE DIM (X) : ONE-PLACE (X.X) : TWO-PLACE (X.XX) : ANGLE : THIRD ANGLE PROJECTION	
DSNR			
<b>DO NOT SCALE DRAWING</b>			
TITLE: <b>WIRING DIAGRAM-BODY, 110V</b>			
SHEET 1 OF 1	PART NO	<b>155766</b>	
REF:		<b>1 8/8/2005</b>

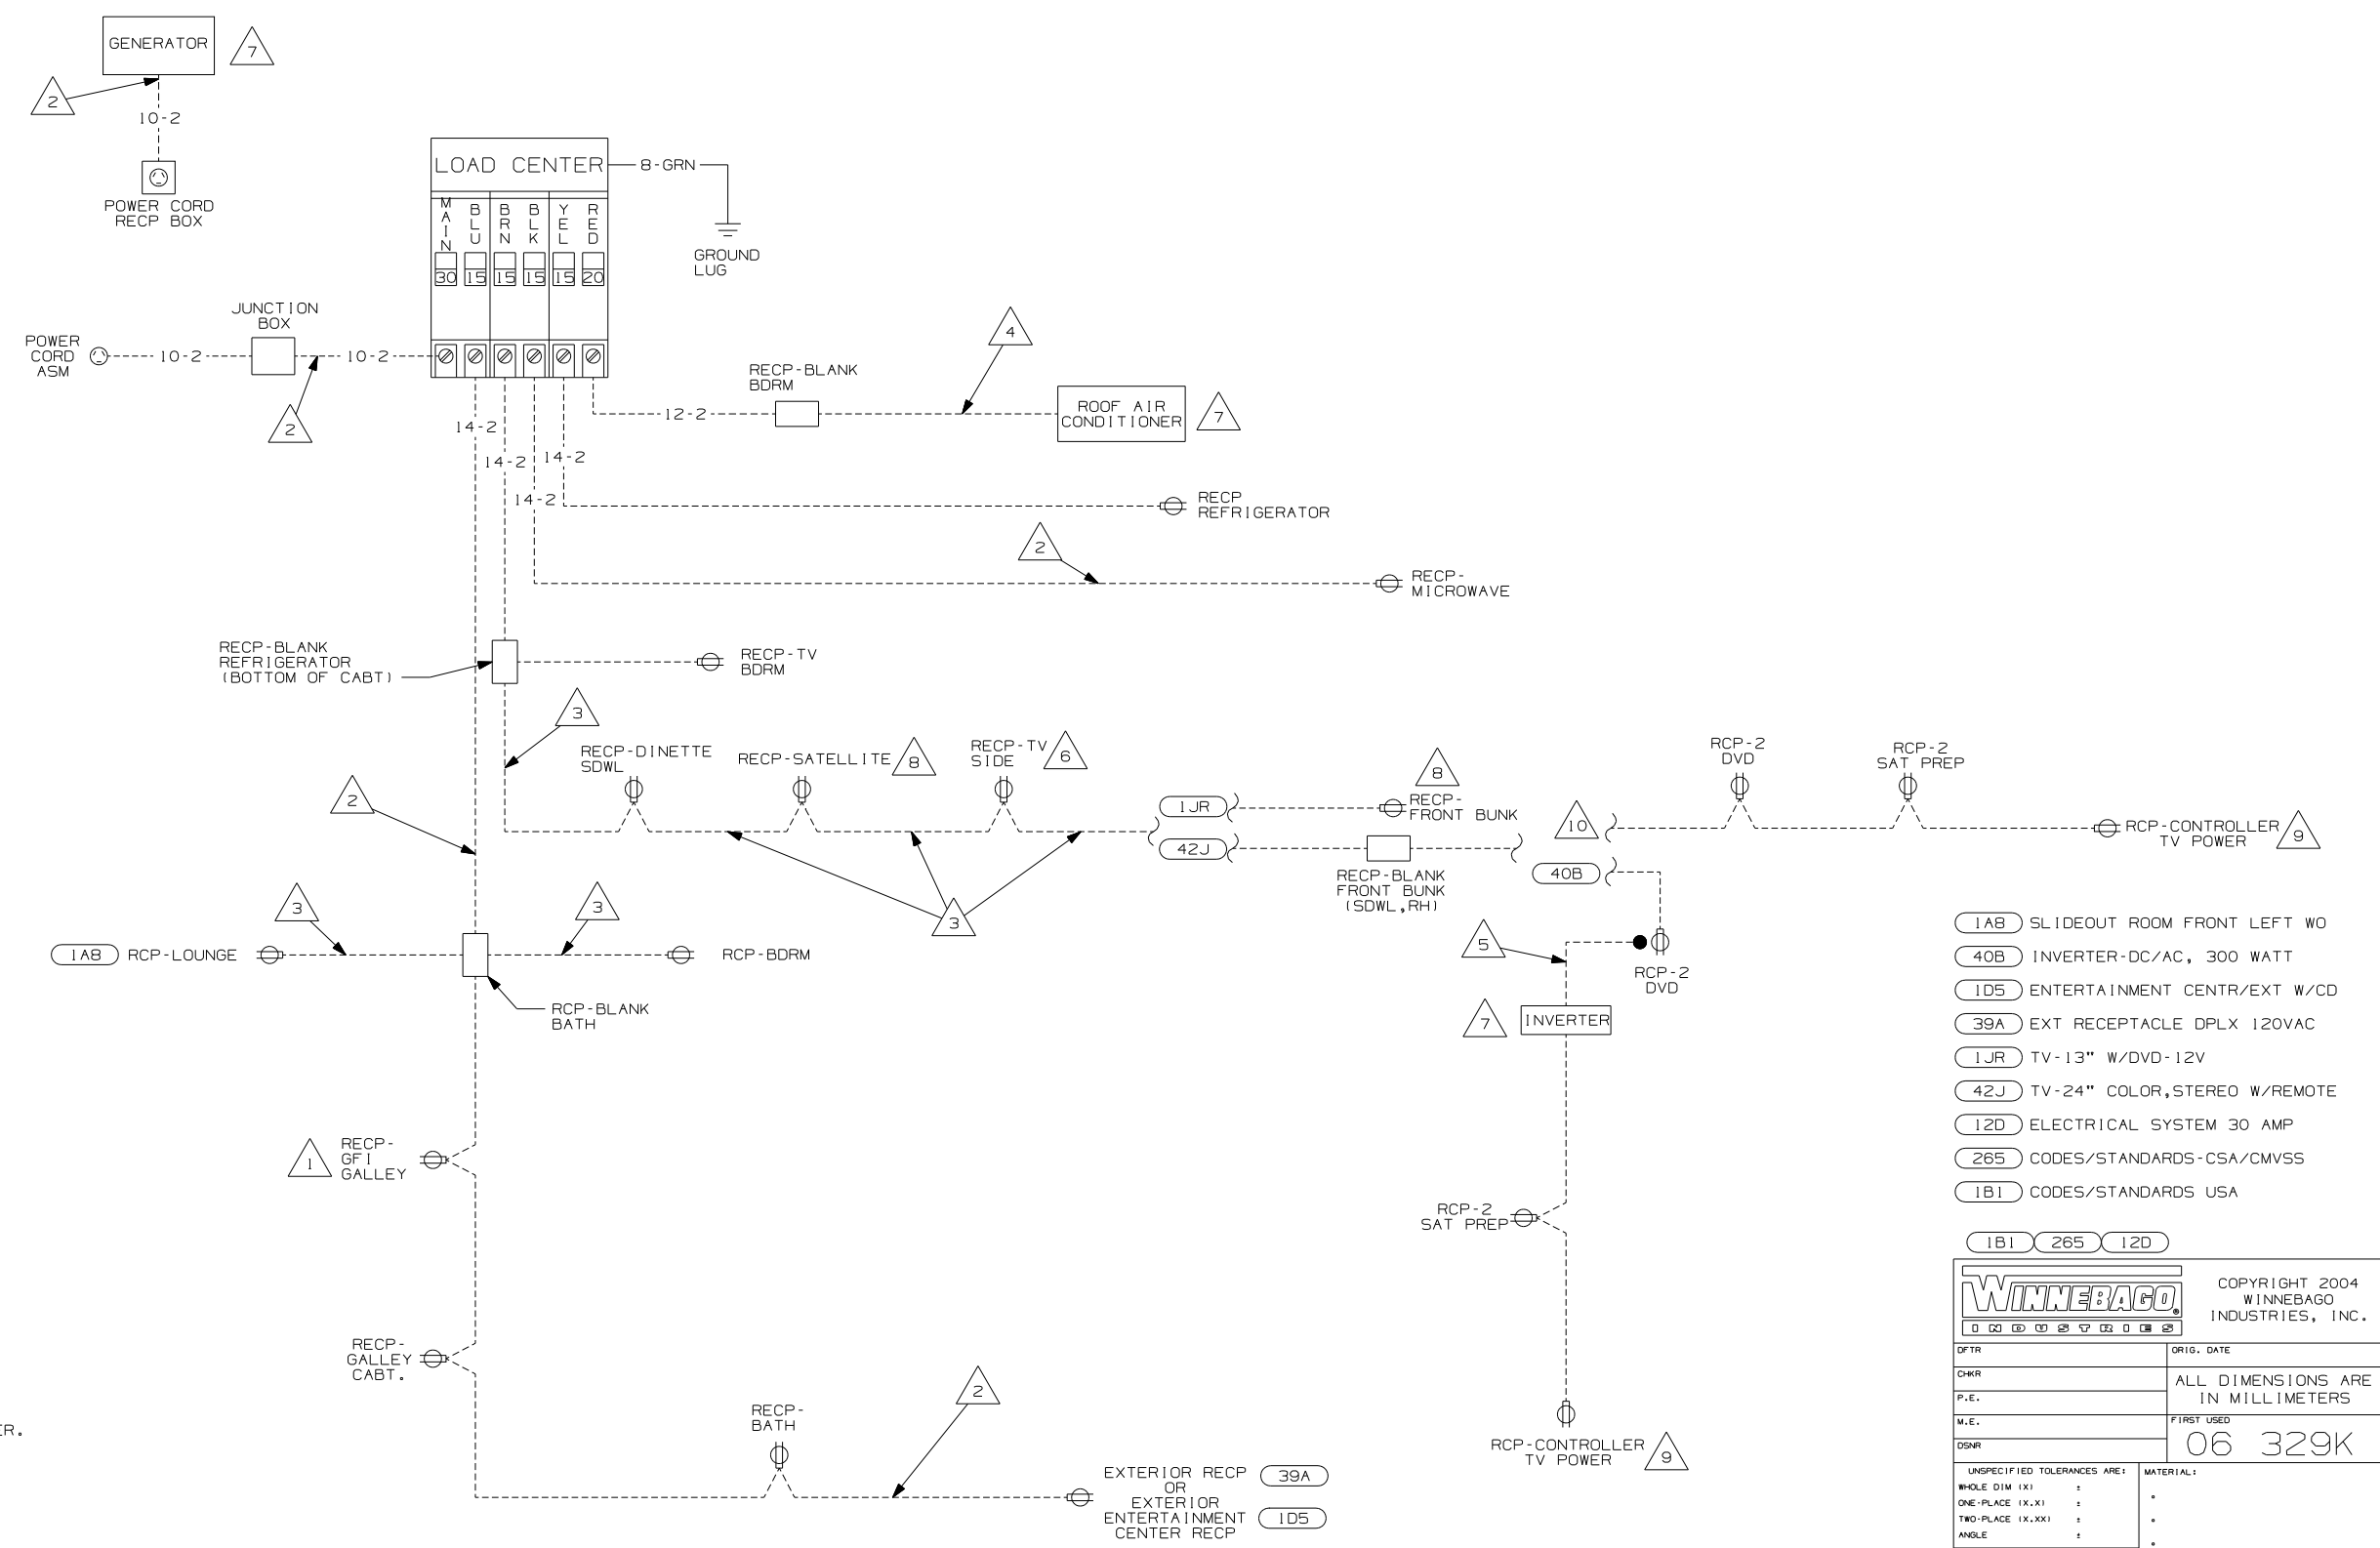
- 10 WITHOUT 40B
- 9 SEE WIRING DIAGRAM-12V BODY FOR ADDITIONAL INFORMATION.
- 8 NOT USED WITH 42J
- 7 SEE MANUFACTURERS DIAGRAM.
- 6 NOT USED WITH 42J OR 1JR .
- 5 POWER CORD SUPPLIED WITH INVERTER.
- 4 WIRE ROUTED IN ROOF.
- 3 WIRE ROUTED IN SIDEWALL.
- 2 WIRE ROUTED THRU FLOOR.
- 1 ALL WIRES DOWN STREAM AND INCLUDING THIS OUTLET ARE GROUND FAULT CIRCUIT INTERRUPT PROTECTED.

- 1AB SLIDEOUT ROOM FRONT LEFT WO
- 40B INVERTER-DC/AC, 300 WATT
- 1D5 ENTERTAINMENT CENTR/EXT W/CD
- 39A EXT RECEPTACLE DPLX 120VAC
- 1JR TV-13" W/DVD-12V
- 42J TV-24" COLOR, STEREO W/REMOTE
- 12D ELECTRICAL SYSTEM 30 AMP
- 265 CODES/STANDARDS-CSA/CMVSS
- 1B1 CODES/STANDARDS USA
