FIRST USED	
06 G38T	
DO NOT SCALE DRAWING	
TITLE: WIRING INSTL-CHASSIS	
SHEET 2	PART NO 154446

FIRST USED	06 G38T
DO NOT SCALE DRAWING	
TITLE:	WIRING INSTL-CHASSIS
SHEET 3	PART NO 154446

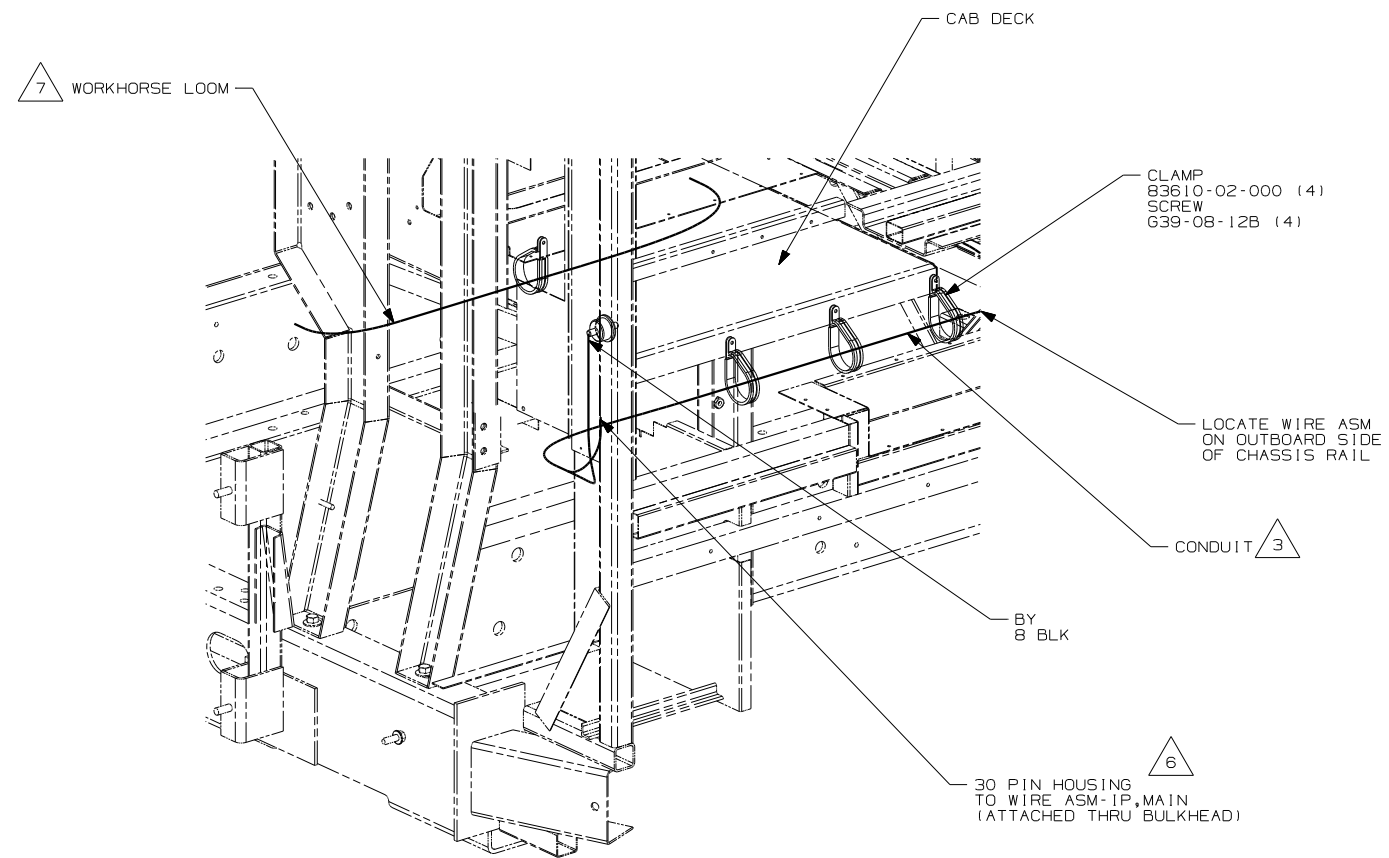
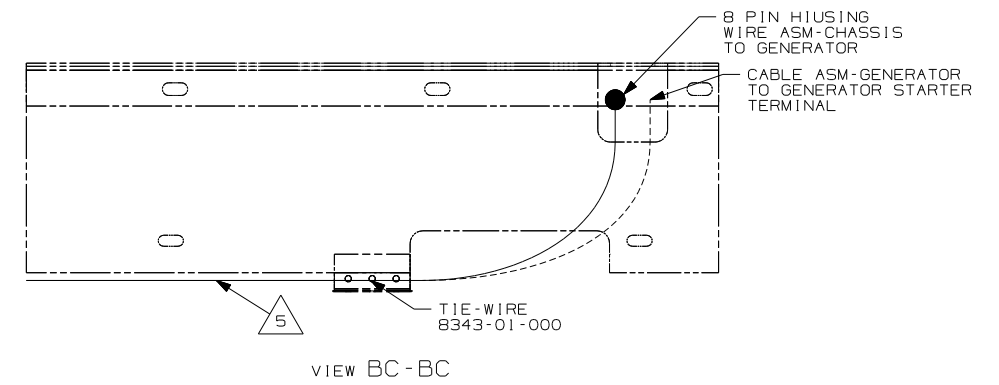
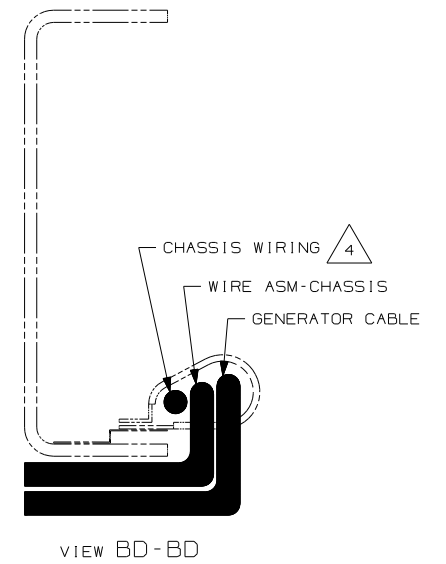
VIEW BA-BA

- 7 CLAMP WORKHORSE ENGINE HARNESS TO CAB DECK TO PROTECT HARNESS FROM DAMAGE.
- 6 SEE WIRING INSTL-FRONT END FOR ADDITIONAL INFORMATION.
- 5 SECURE SO WIRES DO NOT CONTACT EXHAUST.
- 4 SUPPLIED WITH CHASSIS.
- 3 COVER WITH CONDUIT 41953-10-000 AND 41953-11-000 AS REQUIRED.

- (IPV) WORKHORSE 24,000#-22.5 TIRE
- (265) CODES/STANDARDS-CSA/CMVSS
- (1B1) CODES/STANDARDS USA

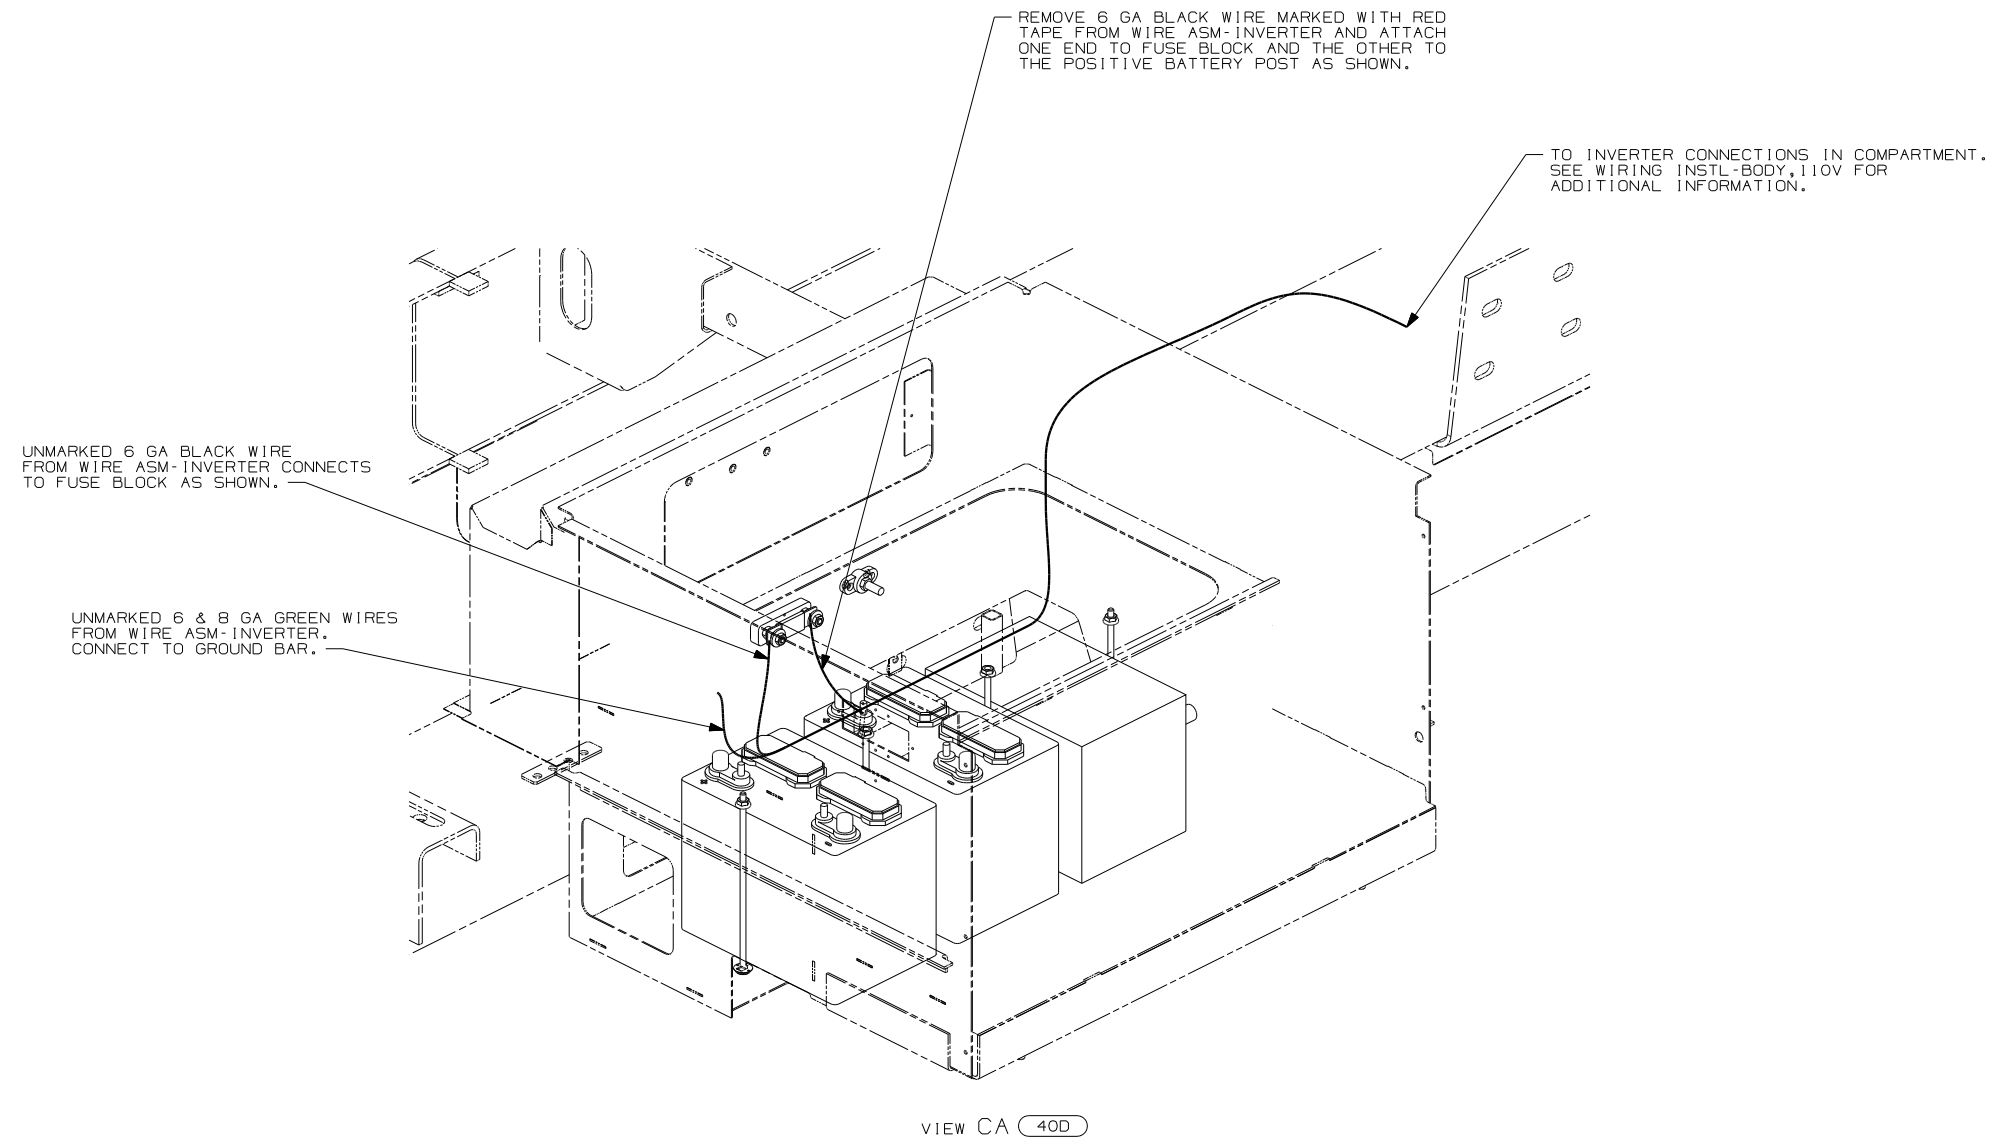
VIEW CA 40D

- 40D INVERTER-DC/AC, 600 WATT
- 265 CODES/STANDARDS - CSA/CMVSS
- 1B1 CODES/STANDARDS - USA
