**WINNEBAGO**

DFTR	ORIG. DATE
CHKR	ALL DIMENSIONS ARE IN MILLIMETERS
P.E.	FIRST USED
M.E.	06 P36G
DSNR	
UNSPECIFIED TOLERANCES ARE:	MATERIAL:
WHOLE DIM (X) :	
ONE-PLACE (X.X) :	
TWO-PLACE (X.XX) :	
ANGLE :	
THIRD ANGLE PROJECTION	
DO NOT SCALE DRAWING	
TITLE: WIRING DIAGRAM-BODY, 110V	
SHEET 1 OF 2	PART NO 153555
REF:	1 10/7/2005

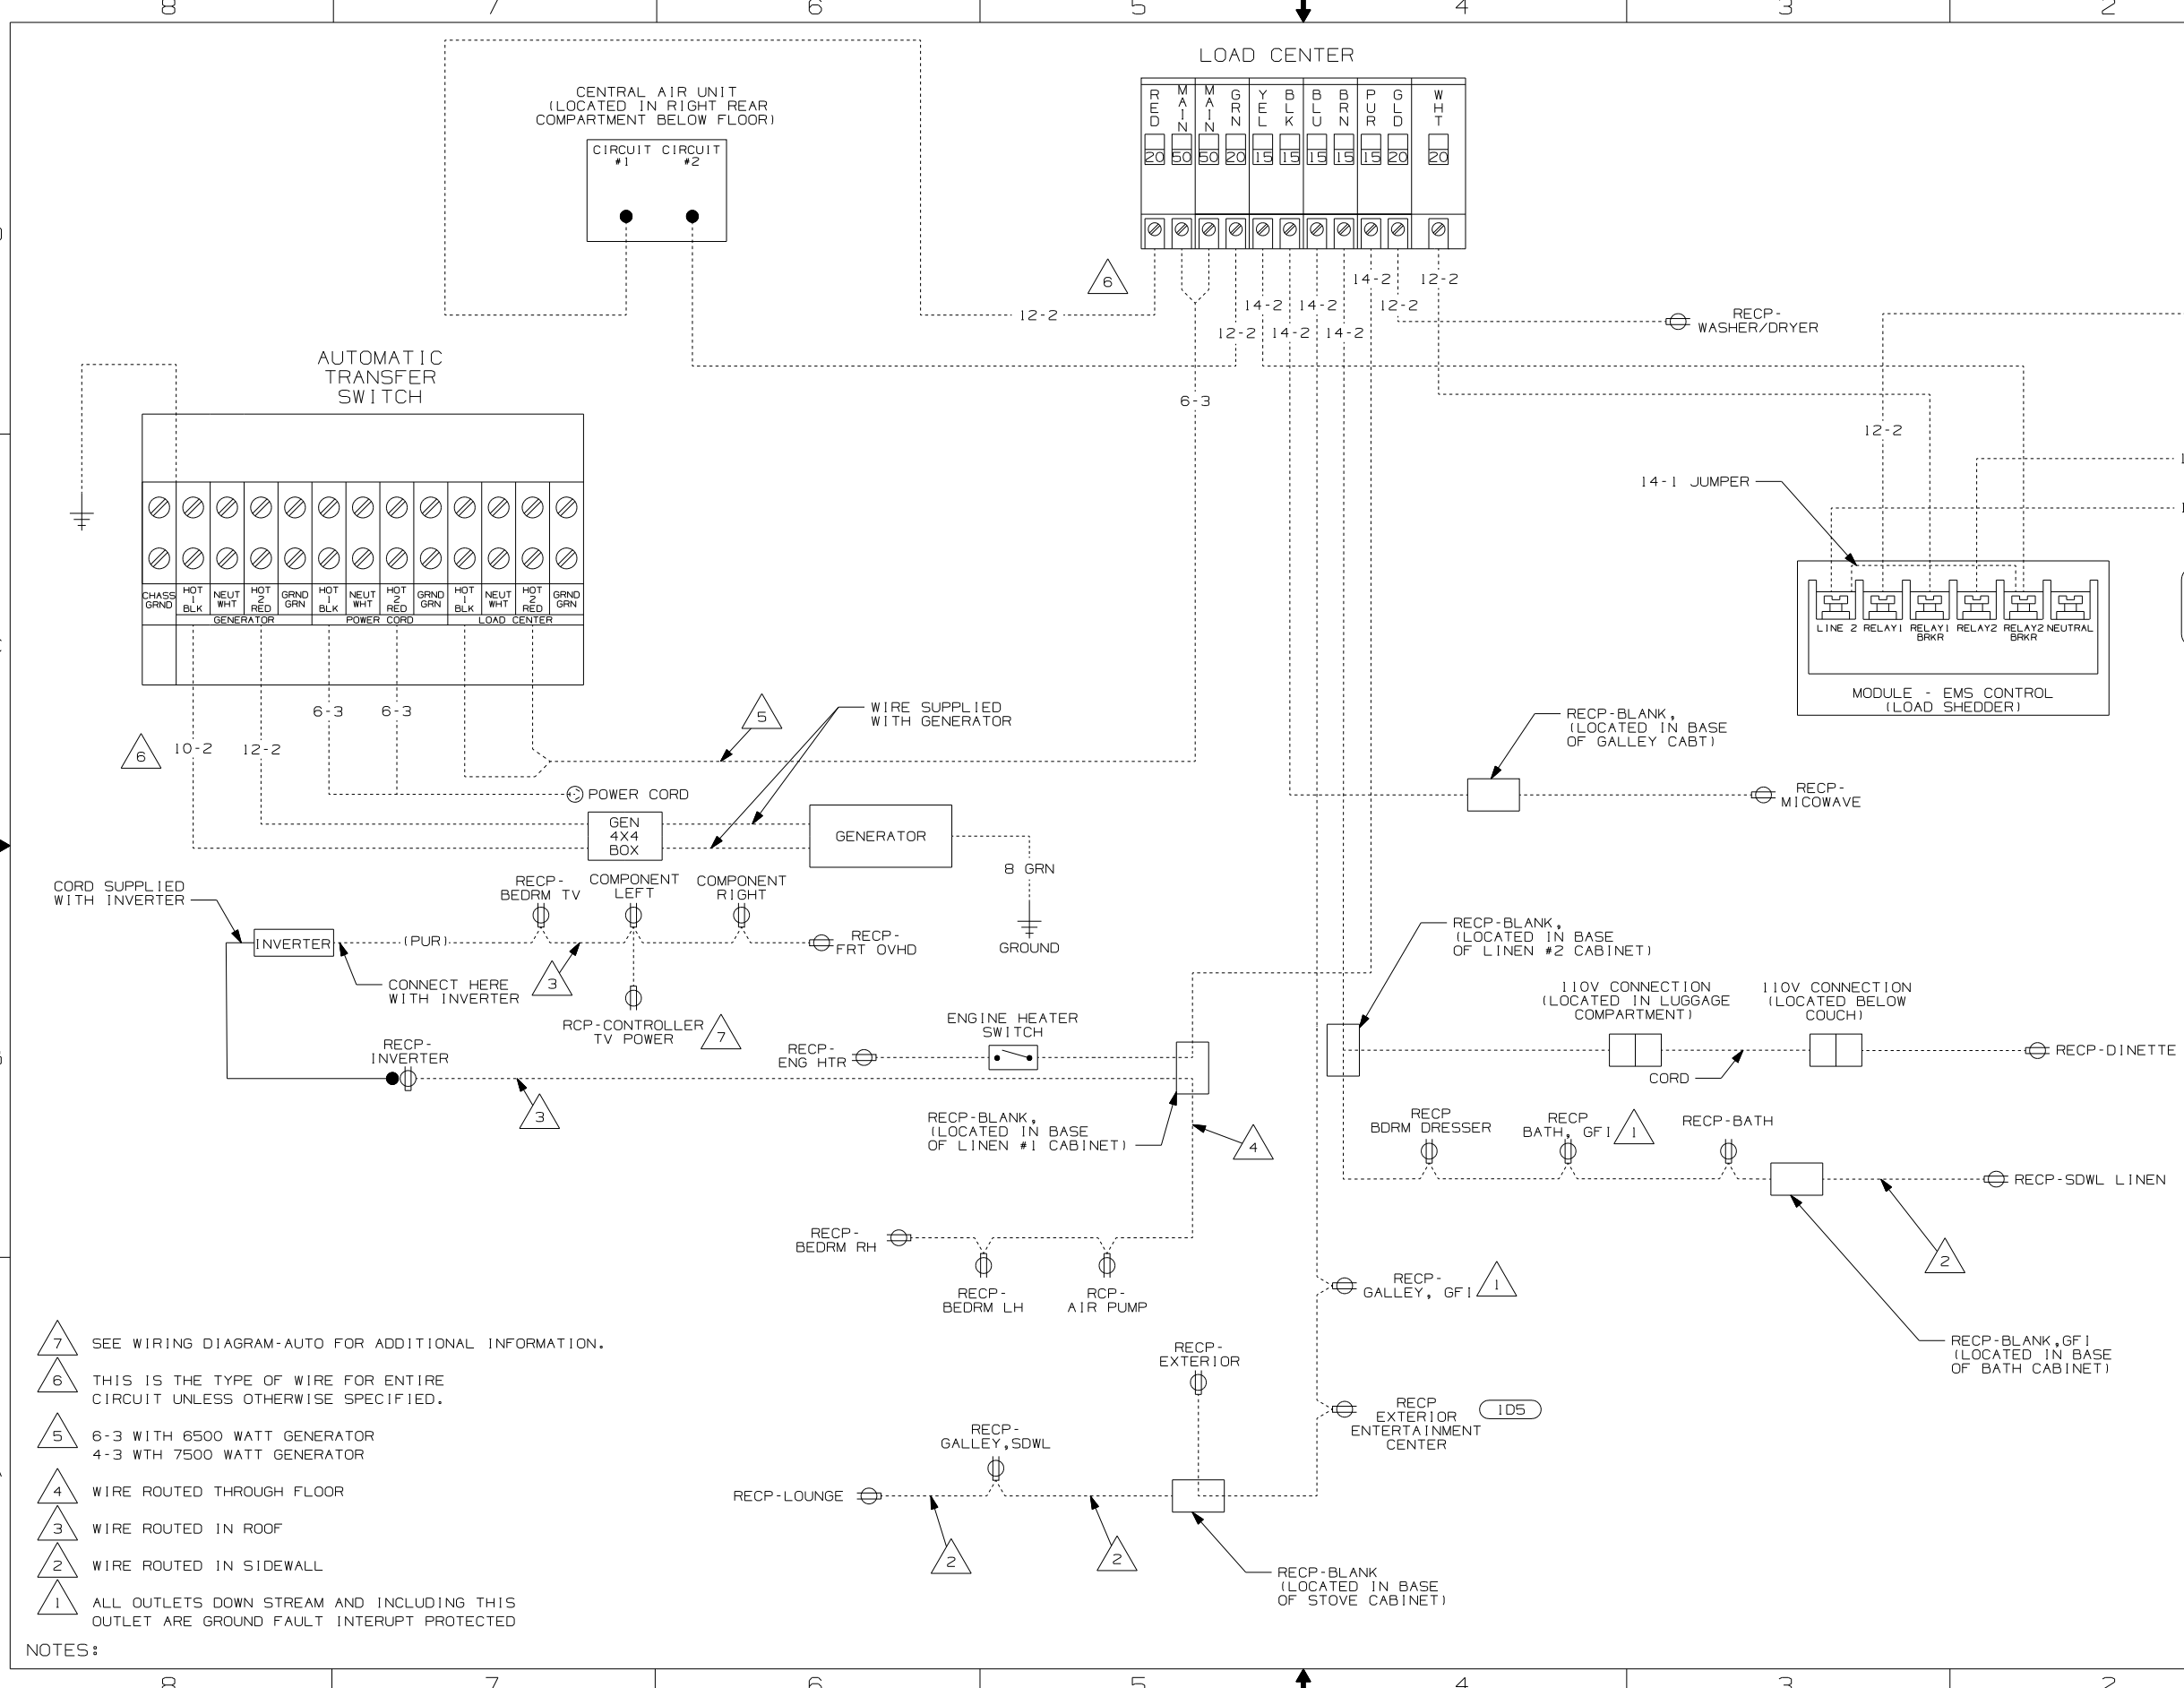
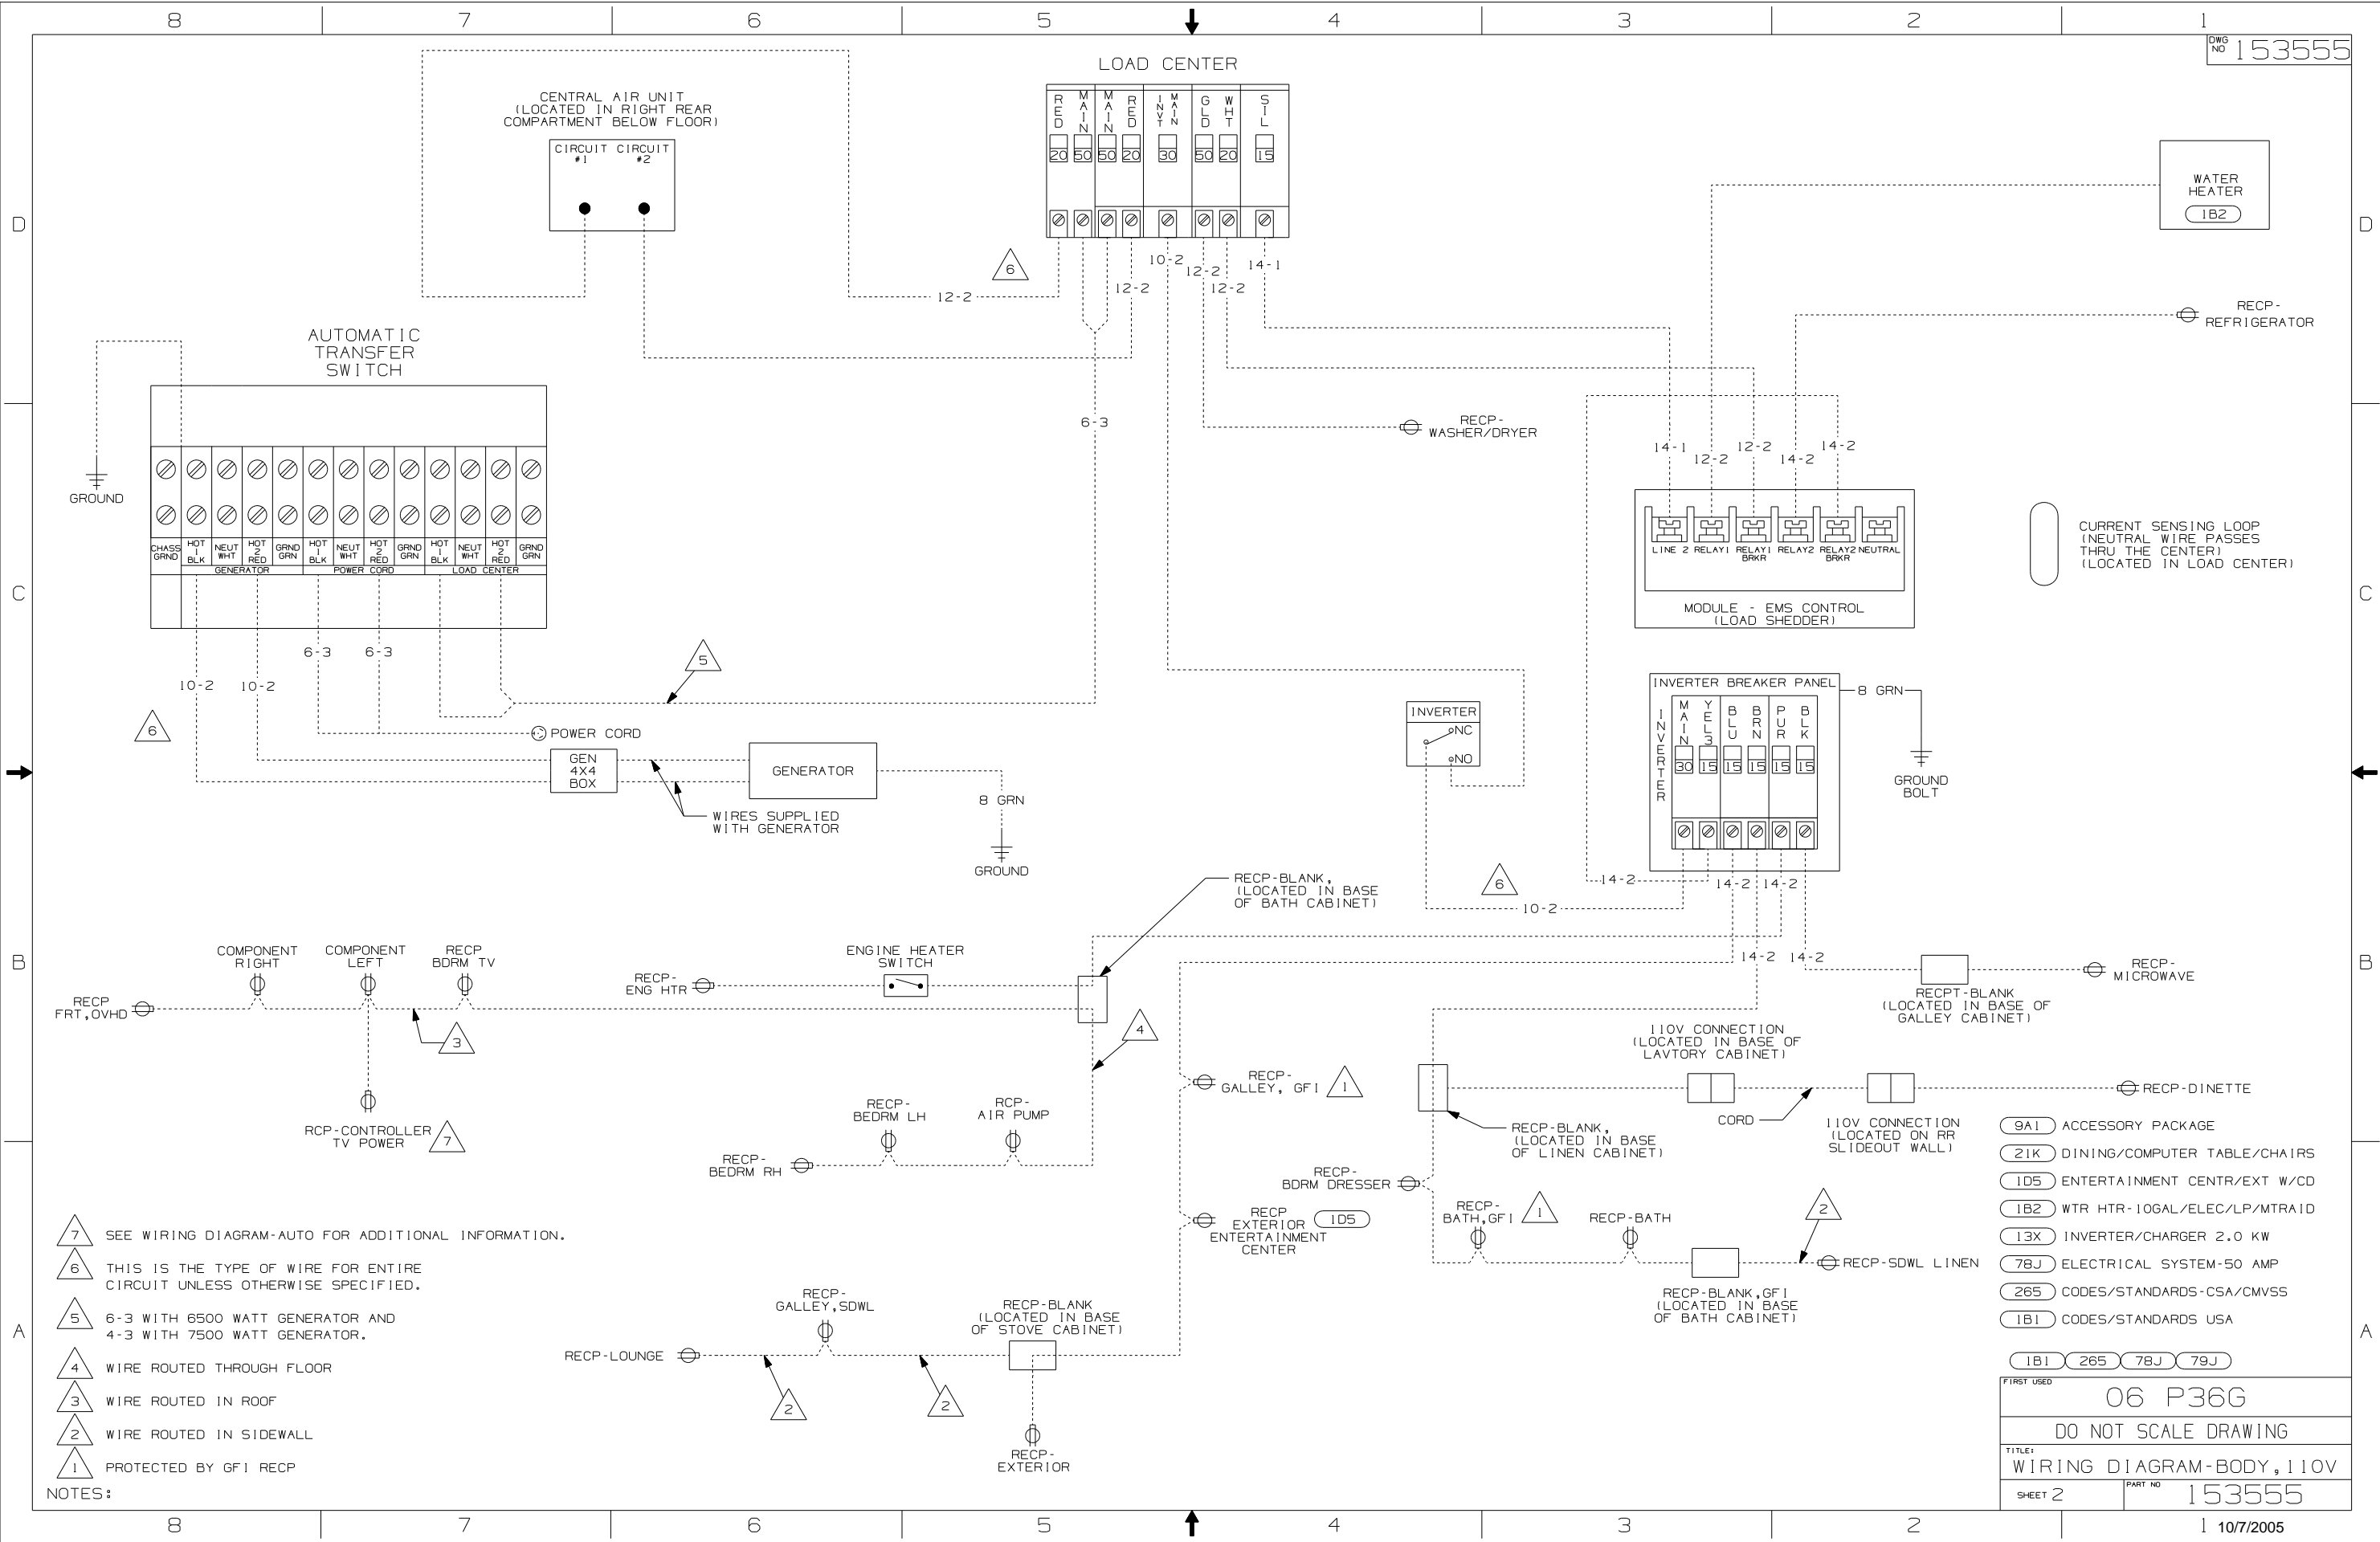
- 7 SEE WIRING DIAGRAM-AUTO FOR ADDITIONAL INFORMATION.
- 6 THIS IS THE TYPE OF WIRE FOR ENTIRE CIRCUIT UNLESS OTHERWISE SPECIFIED.
- 5 6-3 WITH 6500 WATT GENERATOR  
4-3 WITH 7500 WATT GENERATOR
- 4 WIRE ROUTED THROUGH FLOOR
- 3 WIRE ROUTED IN ROOF
- 2 WIRE ROUTED IN SIDEWALL
- 1 ALL OUTLETS DOWN STREAM AND INCLUDING THIS OUTLET ARE GROUND FAULT INTERRUPT PROTECTED
