WINNEBAGO		COPYRIGHT 2004 WINNEBAGO INDUSTRIES, INC.	
DFT	ORIG. DATE		
CHKR	ALL DIMENSIONS ARE IN MILLIMETERS		
P.E.			
M.E.	FIRST USED		
DSNR	06 R40FD		
UNSPECIFIED TOLERANCES ARE:		MATERIAL:	
WHOLE DIM (X)	:		
ONE-PLACE (X,X)	:		
TWO-PLACE (X,XX)	:		
ANGLE	:		
THIRD ANGLE PROJECTION	:		
DO NOT SCALE DRAWING			
TITLE: WIRING DIAGRAM-BODY, 110V			
SHEET 1 OF 1	PART NO.	154562

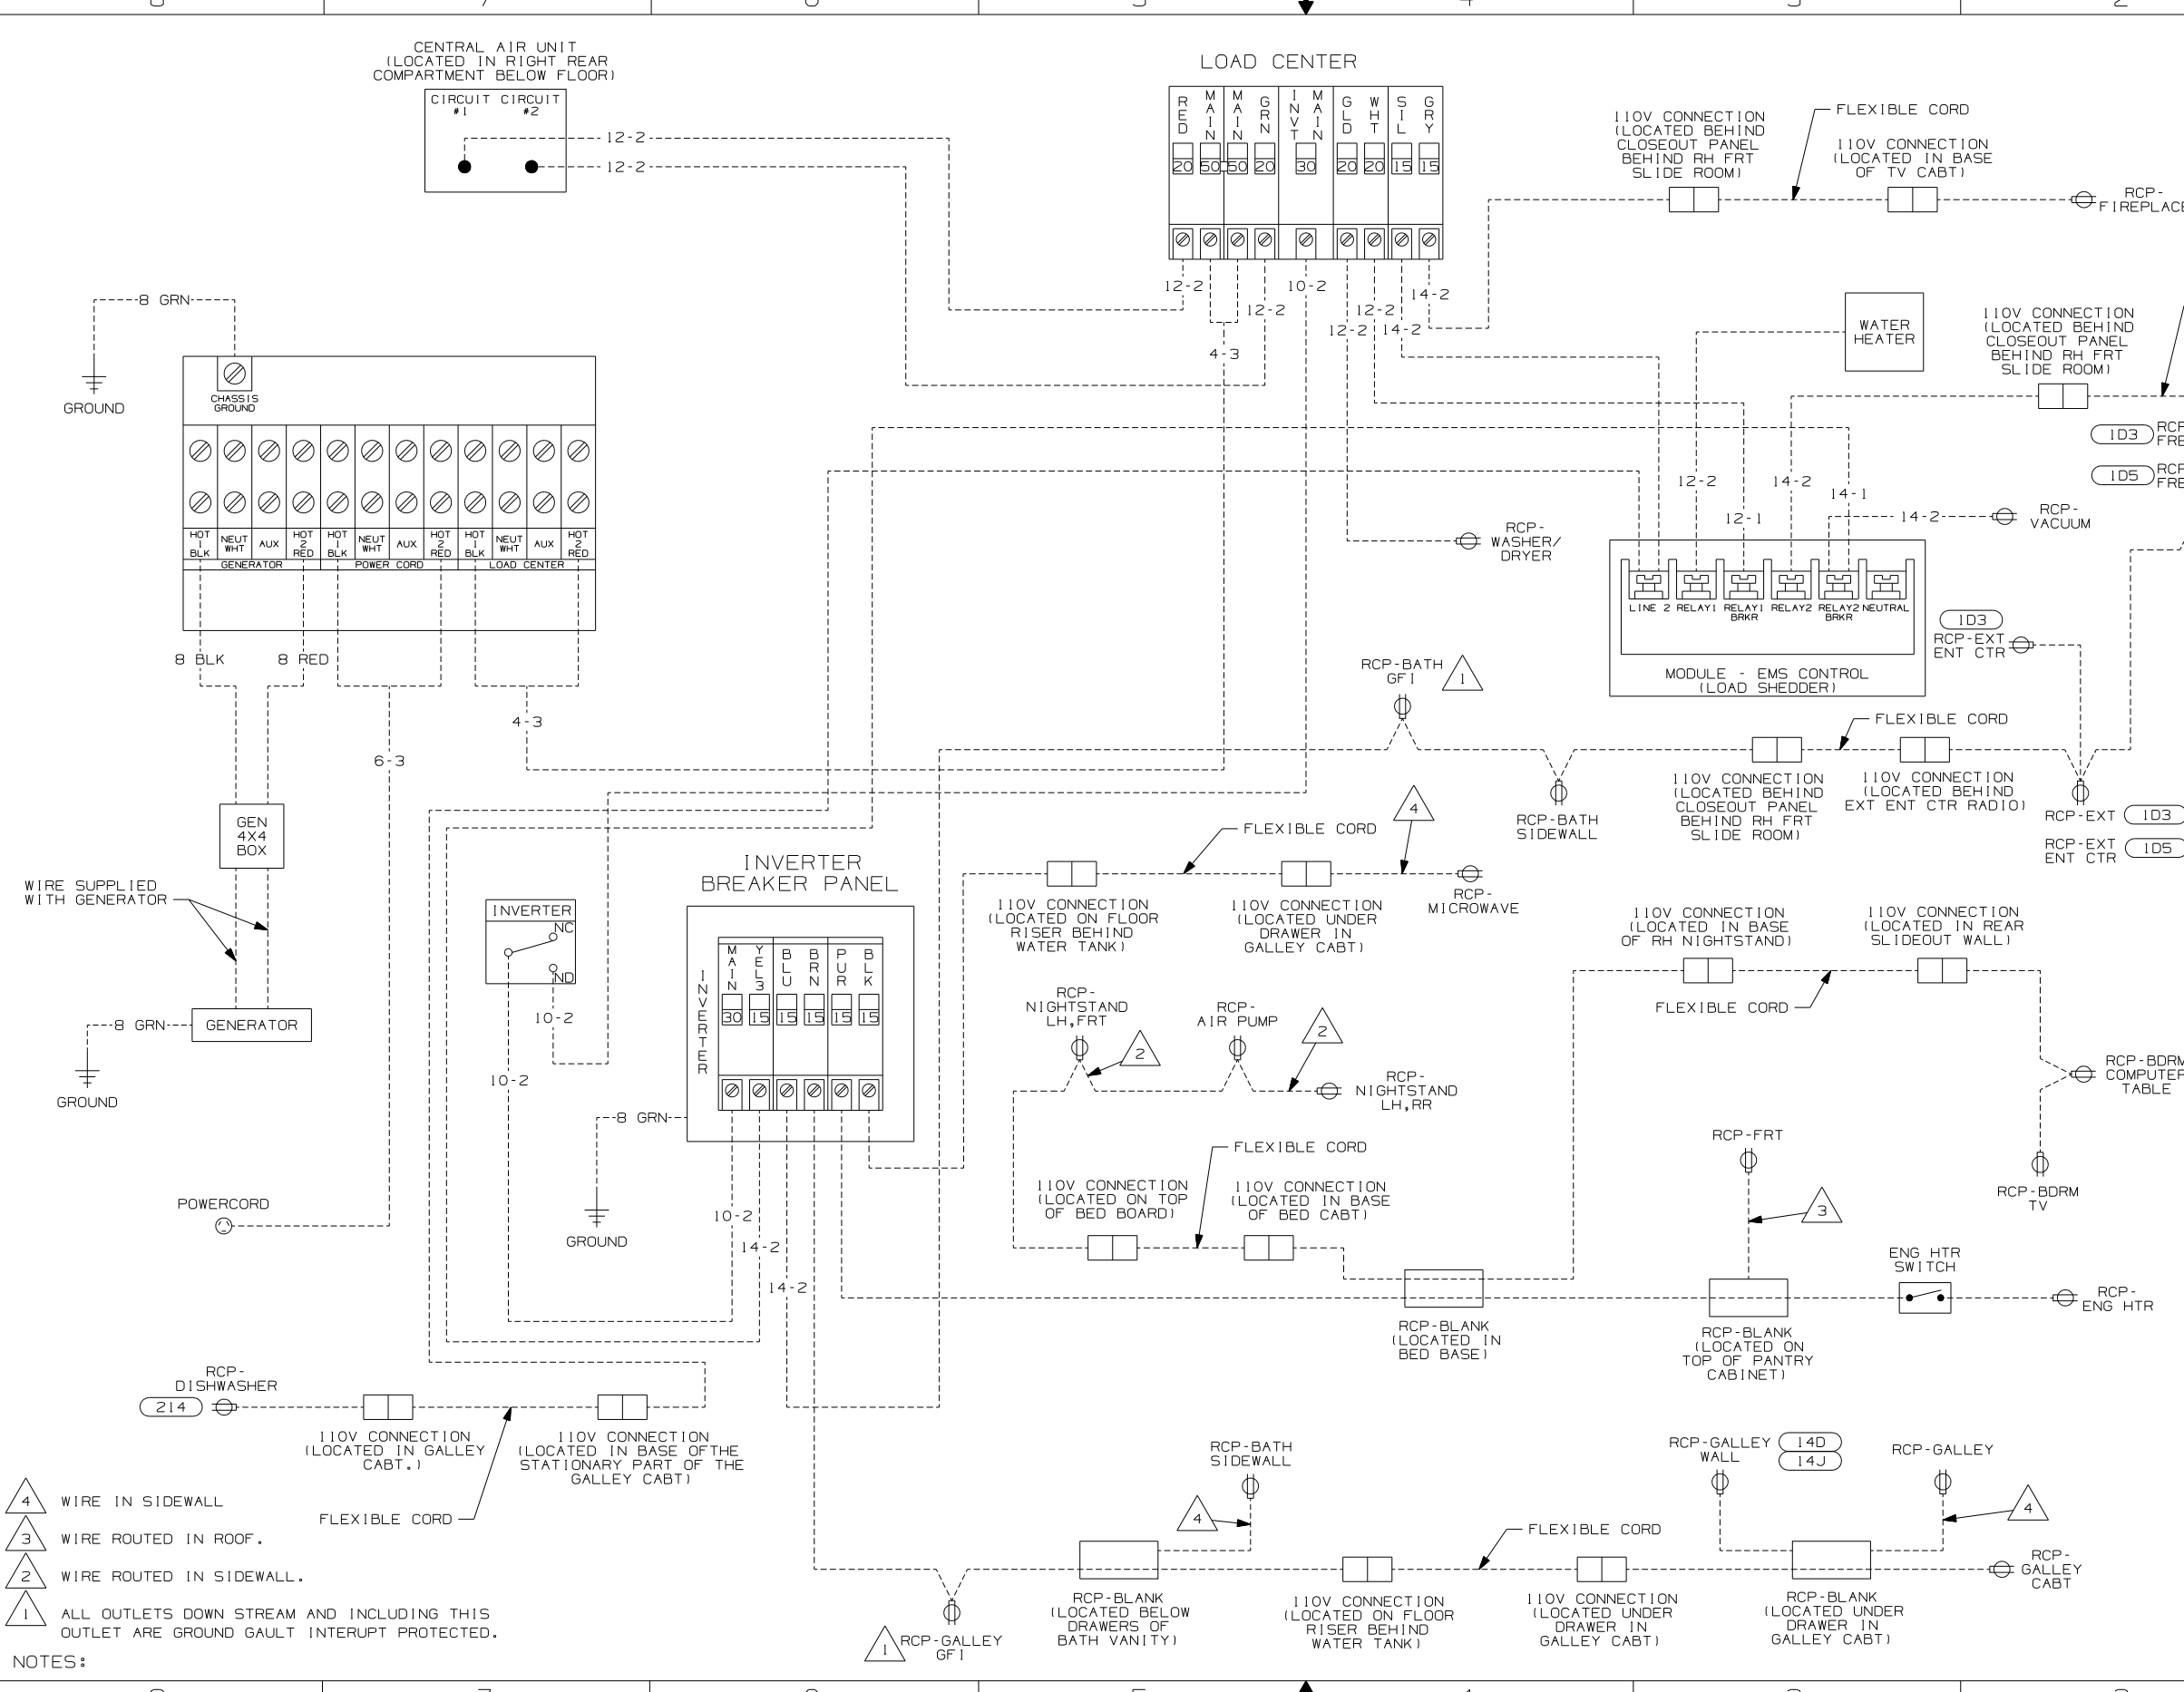
- NOTES:
- 4 WIRE IN SIDEWALL
 - 3 WIRE ROUTED IN ROOF.
 - 2 WIRE ROUTED IN SIDEWALL.
 - 1 ALL OUTLETS DOWN STREAM AND INCLUDING THIS OUTLET ARE GROUND GAULT INTERRUPT PROTECTED.

- 14C FIREPLACE-ELECTRIC
- 14J LOUNGE CHAIR-EURO ULTRALTHR
- 14D LOUNGE CHAIR-EURO LEATHER
- 1D5 ENTERTAINMENT CTR/EXT W/CD
- 1D3 ENTERTAIN CTR/EXT TV-DVD
- 12F POWER CORD REEL
- 214 DISHWASHER DRAWER STYLE
- 265 CODES/STANDARDS - CSA/CMVSS
- 1B1 CODES/STANDARDS - USA
