FIRST USED	07 G38T
DO NOT SCALE DRAWING	
TITLE: WIRING DIAGRAM-BODY, 110V	
SHEET 2	PART NO 158759

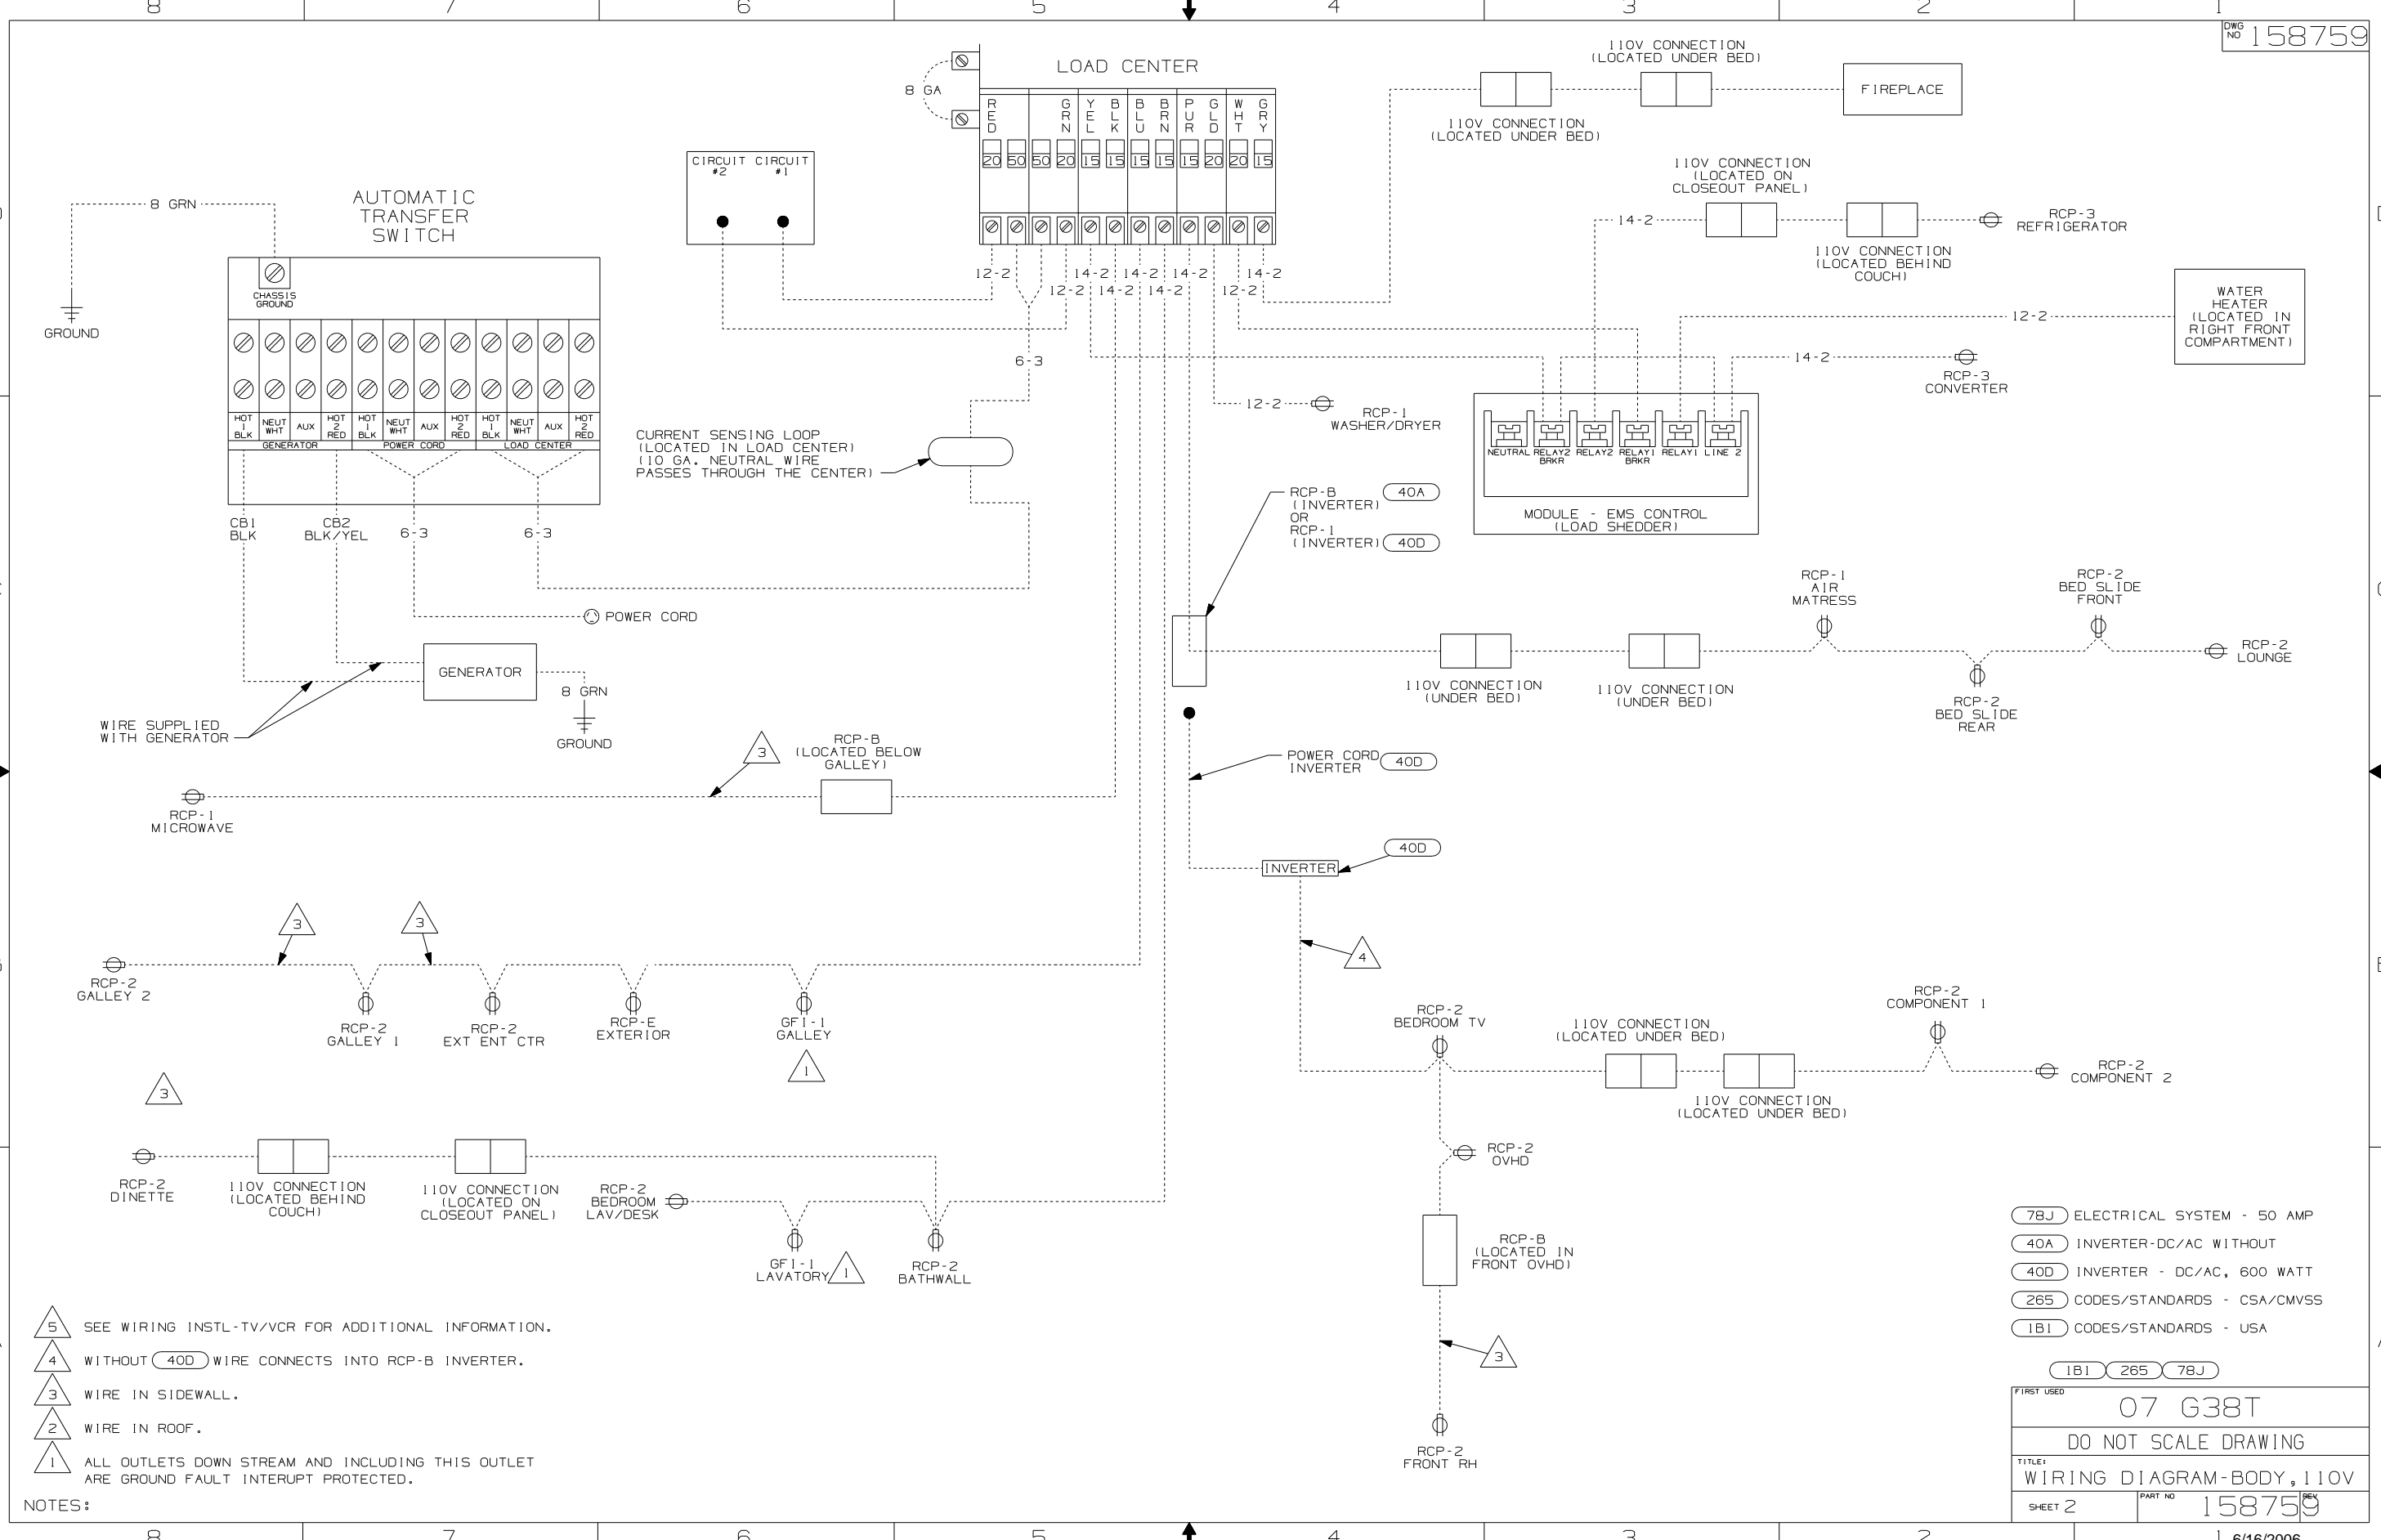
- 5 SEE WIRING INSTL-TV/VCR FOR ADDITIONAL INFORMATION.
- 4 WITHOUT 40D WIRE CONNECTS INTO RCP-B INVERTER.
- 3 WIRE IN SIDEWALL.
- 2 WIRE IN ROOF.
- 1 ALL OUTLETS DOWN STREAM AND INCLUDING THIS OUTLET ARE GROUND FAULT INTERRUPT PROTECTED.
