FIRST USED	08 G35L		
	DO NOT SCALE DRAWING		
TITLE#	WIRING DIAGRAM BODY, 12V		
F1	SHEET 2	PART NO	163178 REV

FIRST USED	08 G35L
TITLE	DO NOT SCALE DRAWING
WIRING DIAGRAM, BODY 12V	
SHEET 3	PART NO 163178

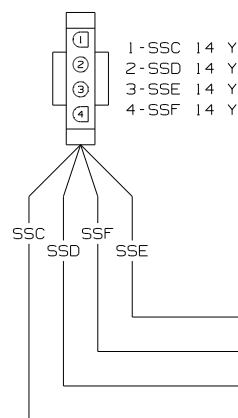
AUTO
LEVEL
SWITCH

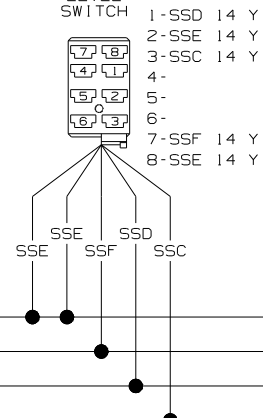
AUTO
LEVEL
SWITCH
