| DSNR | | 11 J-SERIES | |
| TITLE: MONITOR INSTL | | | |
| SHEET 1 of 2 | | PART NO 174638 | |

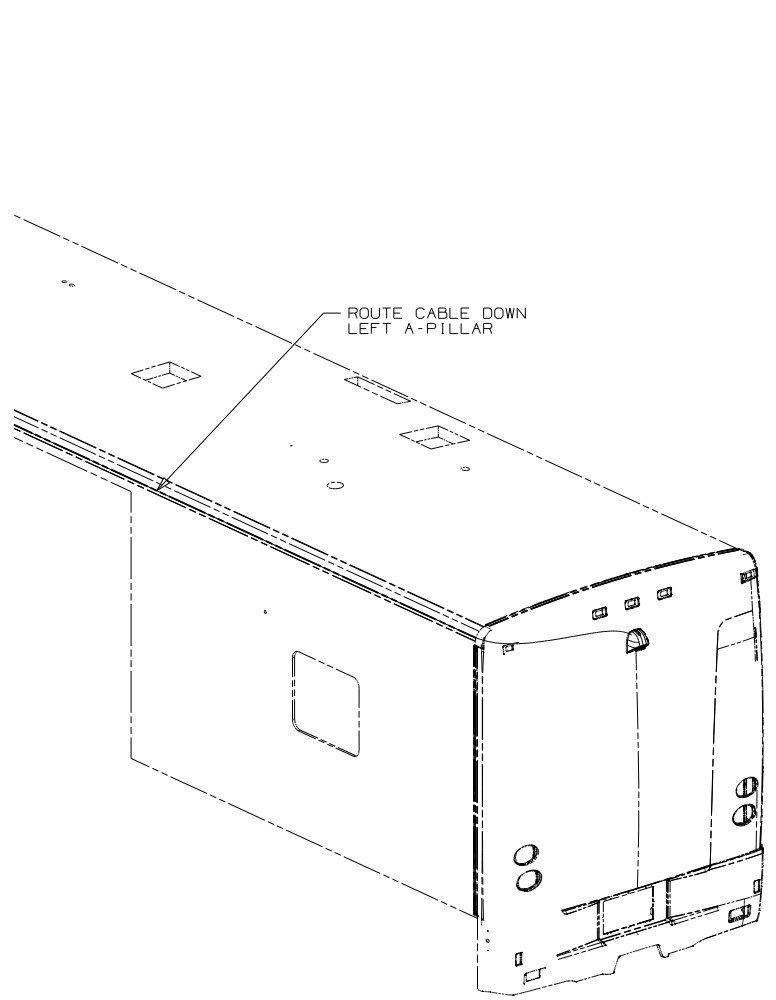
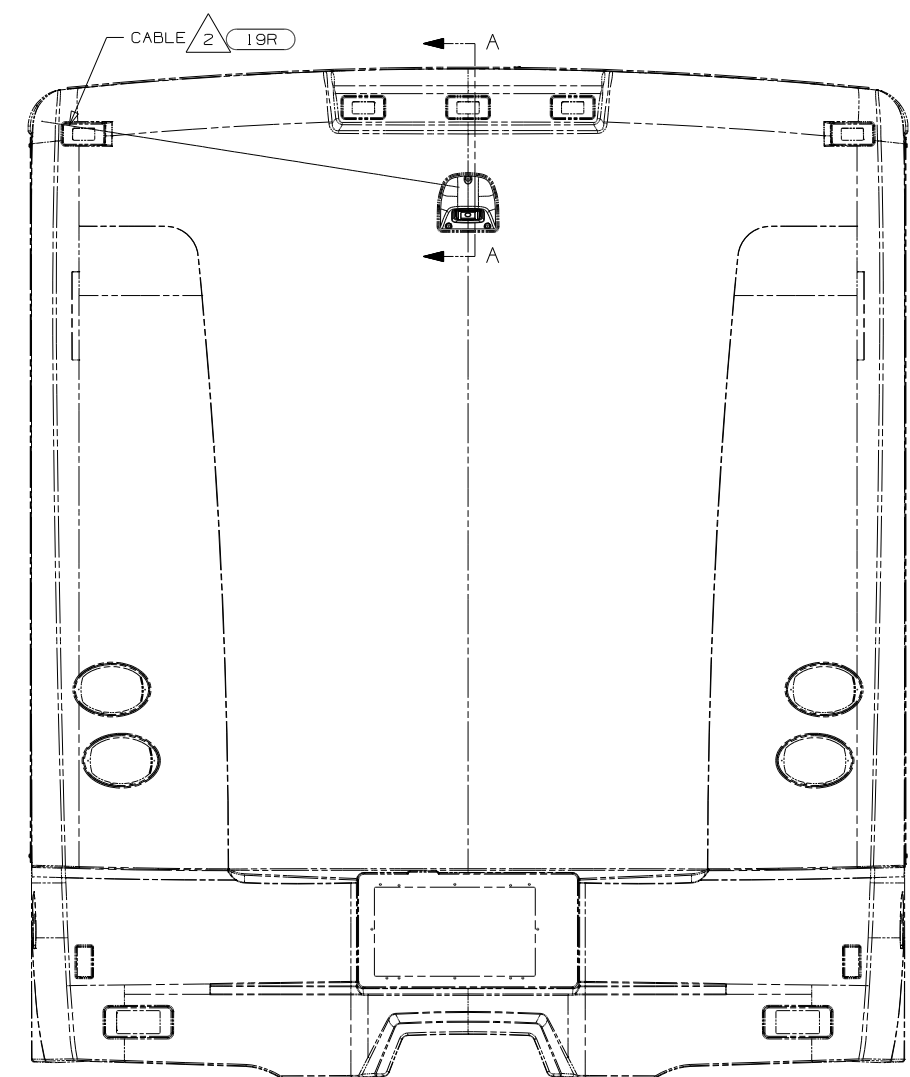
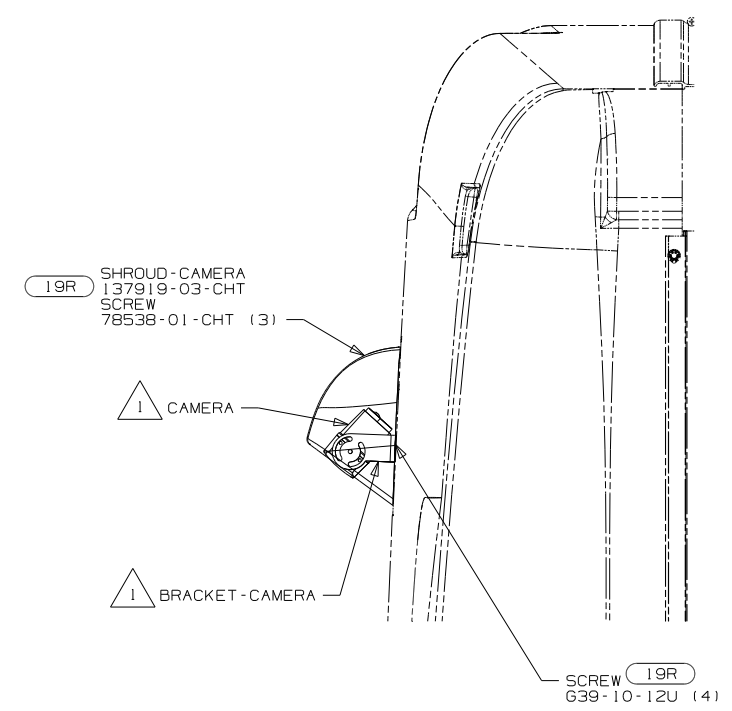
SECTION A - A

2 RUN CABLE THRU LEFT-HAND COVE TO REAR OF UNIT.  
STANDARD ON ALL UNITS.

1 PARTS SUPPLIED WITH CAMERA KIT P/N 144677-18-CHT 19R

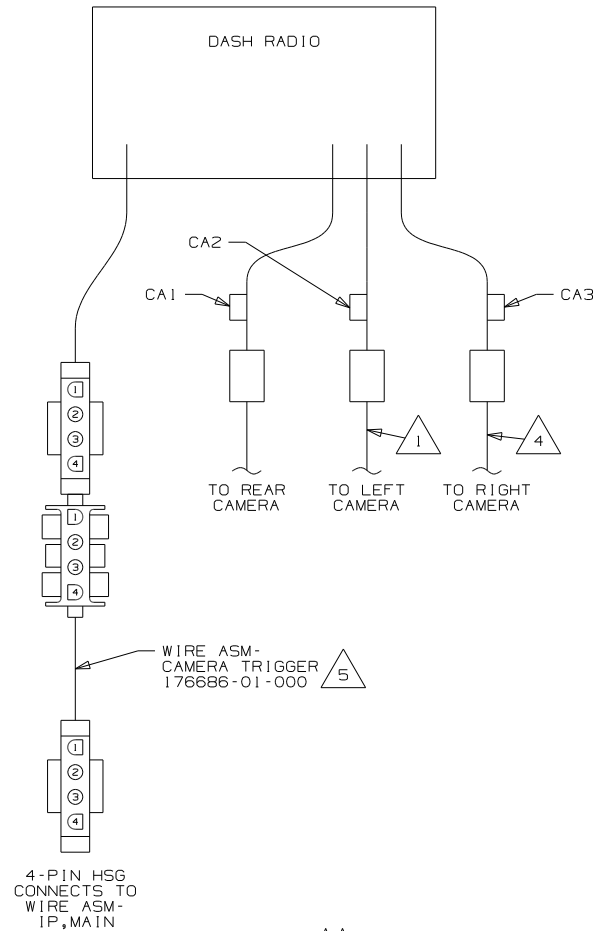
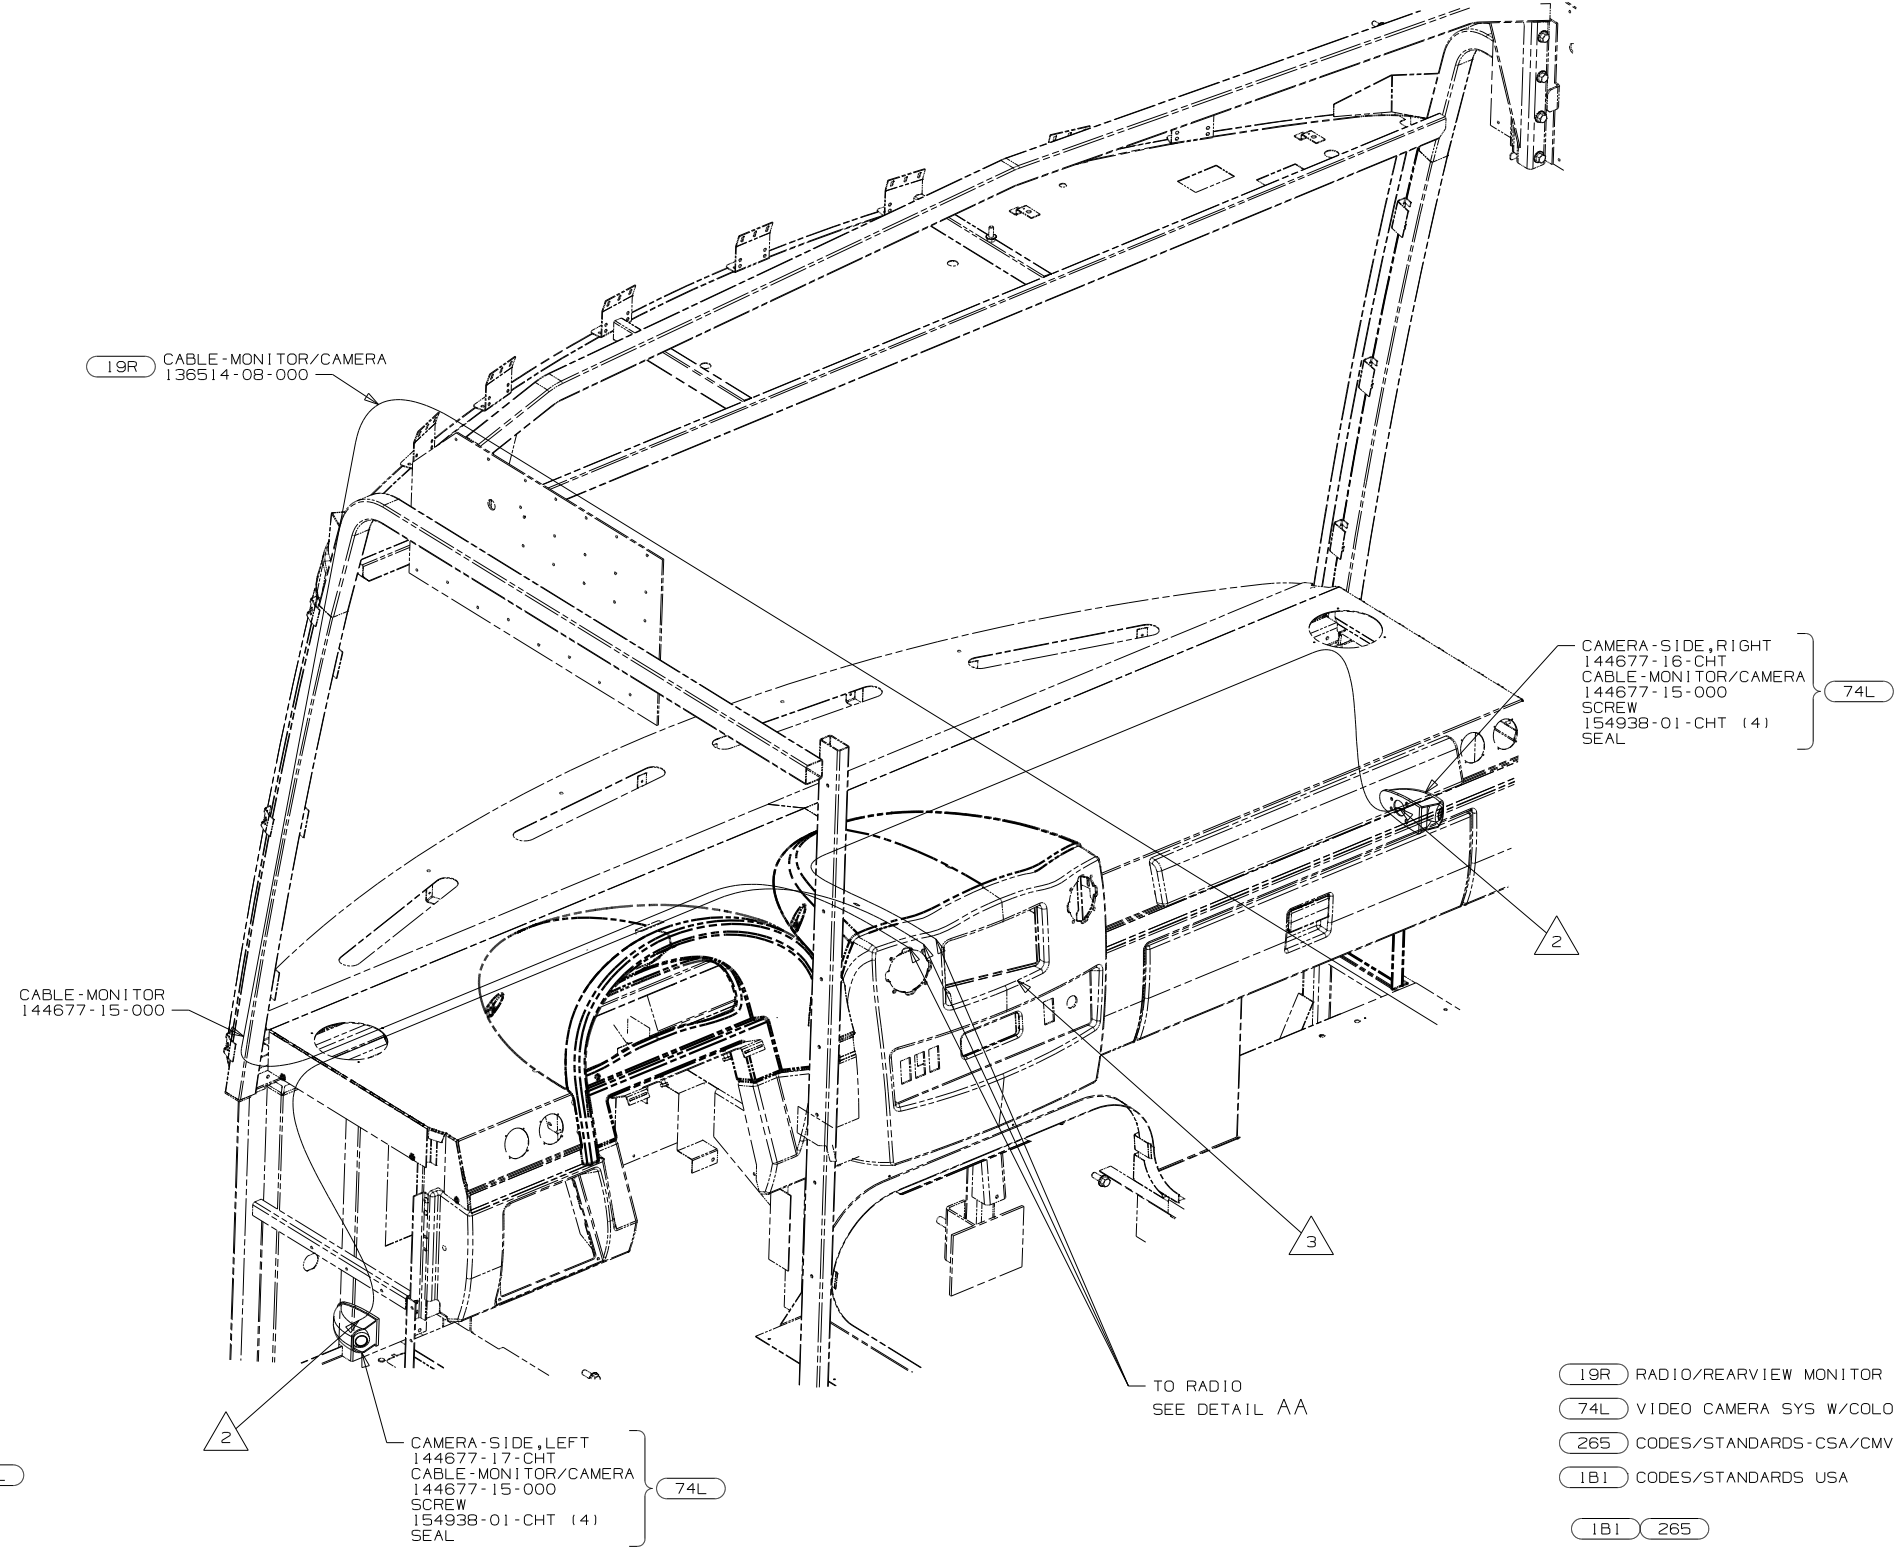
| SHEET 2 | PART NO | 174638 | REV |

- NOTES:
- 5 NOT USED WITH 74L  
CONNECT 4 PIN HOUSING FROM RADIO DIRECTLY TO WIRE ASM-IP,MAIN WITH 74L
  - 4 MARK RIGHT CABLE WITH WHITE TAPE 900000-08-000 NEXT TO CONNECTOR.
  - 3 SEE RADIO INSTL FOR ADDITIONAL INFORMATION.
  - 2 CONNECT CAMERA THRU HOLE IN SIDEWALL, PUSH CONNECTOR BACK THRU SIDEWALL, AND SEAL HOLE.
  - 1 MARK LEFT CABLE WITH YELLOW TAPE 900000-07-000 NEXT TO CONNECTOR.
