WINNEBAGO		COPYRIGHT 2010 WINNEBAGO INDUSTRIES, INC.	
DFTR	ORIG. DATE	ALL DIMENSIONS ARE IN MILLIMETERS	
CHKR		FIRST USED	
P.E.		11 D33C	
M.E.			
DSNR			
UNSPECIFIED TOLERANCES ARE:		MATERIAL:	
WHOLE DIM (X)	: 3		
ONE-PLACE (X.X)	: 1.5		
TWO-PLACE (X.XX)	: 0.50		
ANGLE	: 1°		
THIRD ANGLE PROJECTION			
DO NOT SCALE DRAWING			
TITLE: WIRING DIAGRAM-BODY, 110V			
SHEET 1 OF 1	PART NO	175836	REV
REF:		16/16/2010

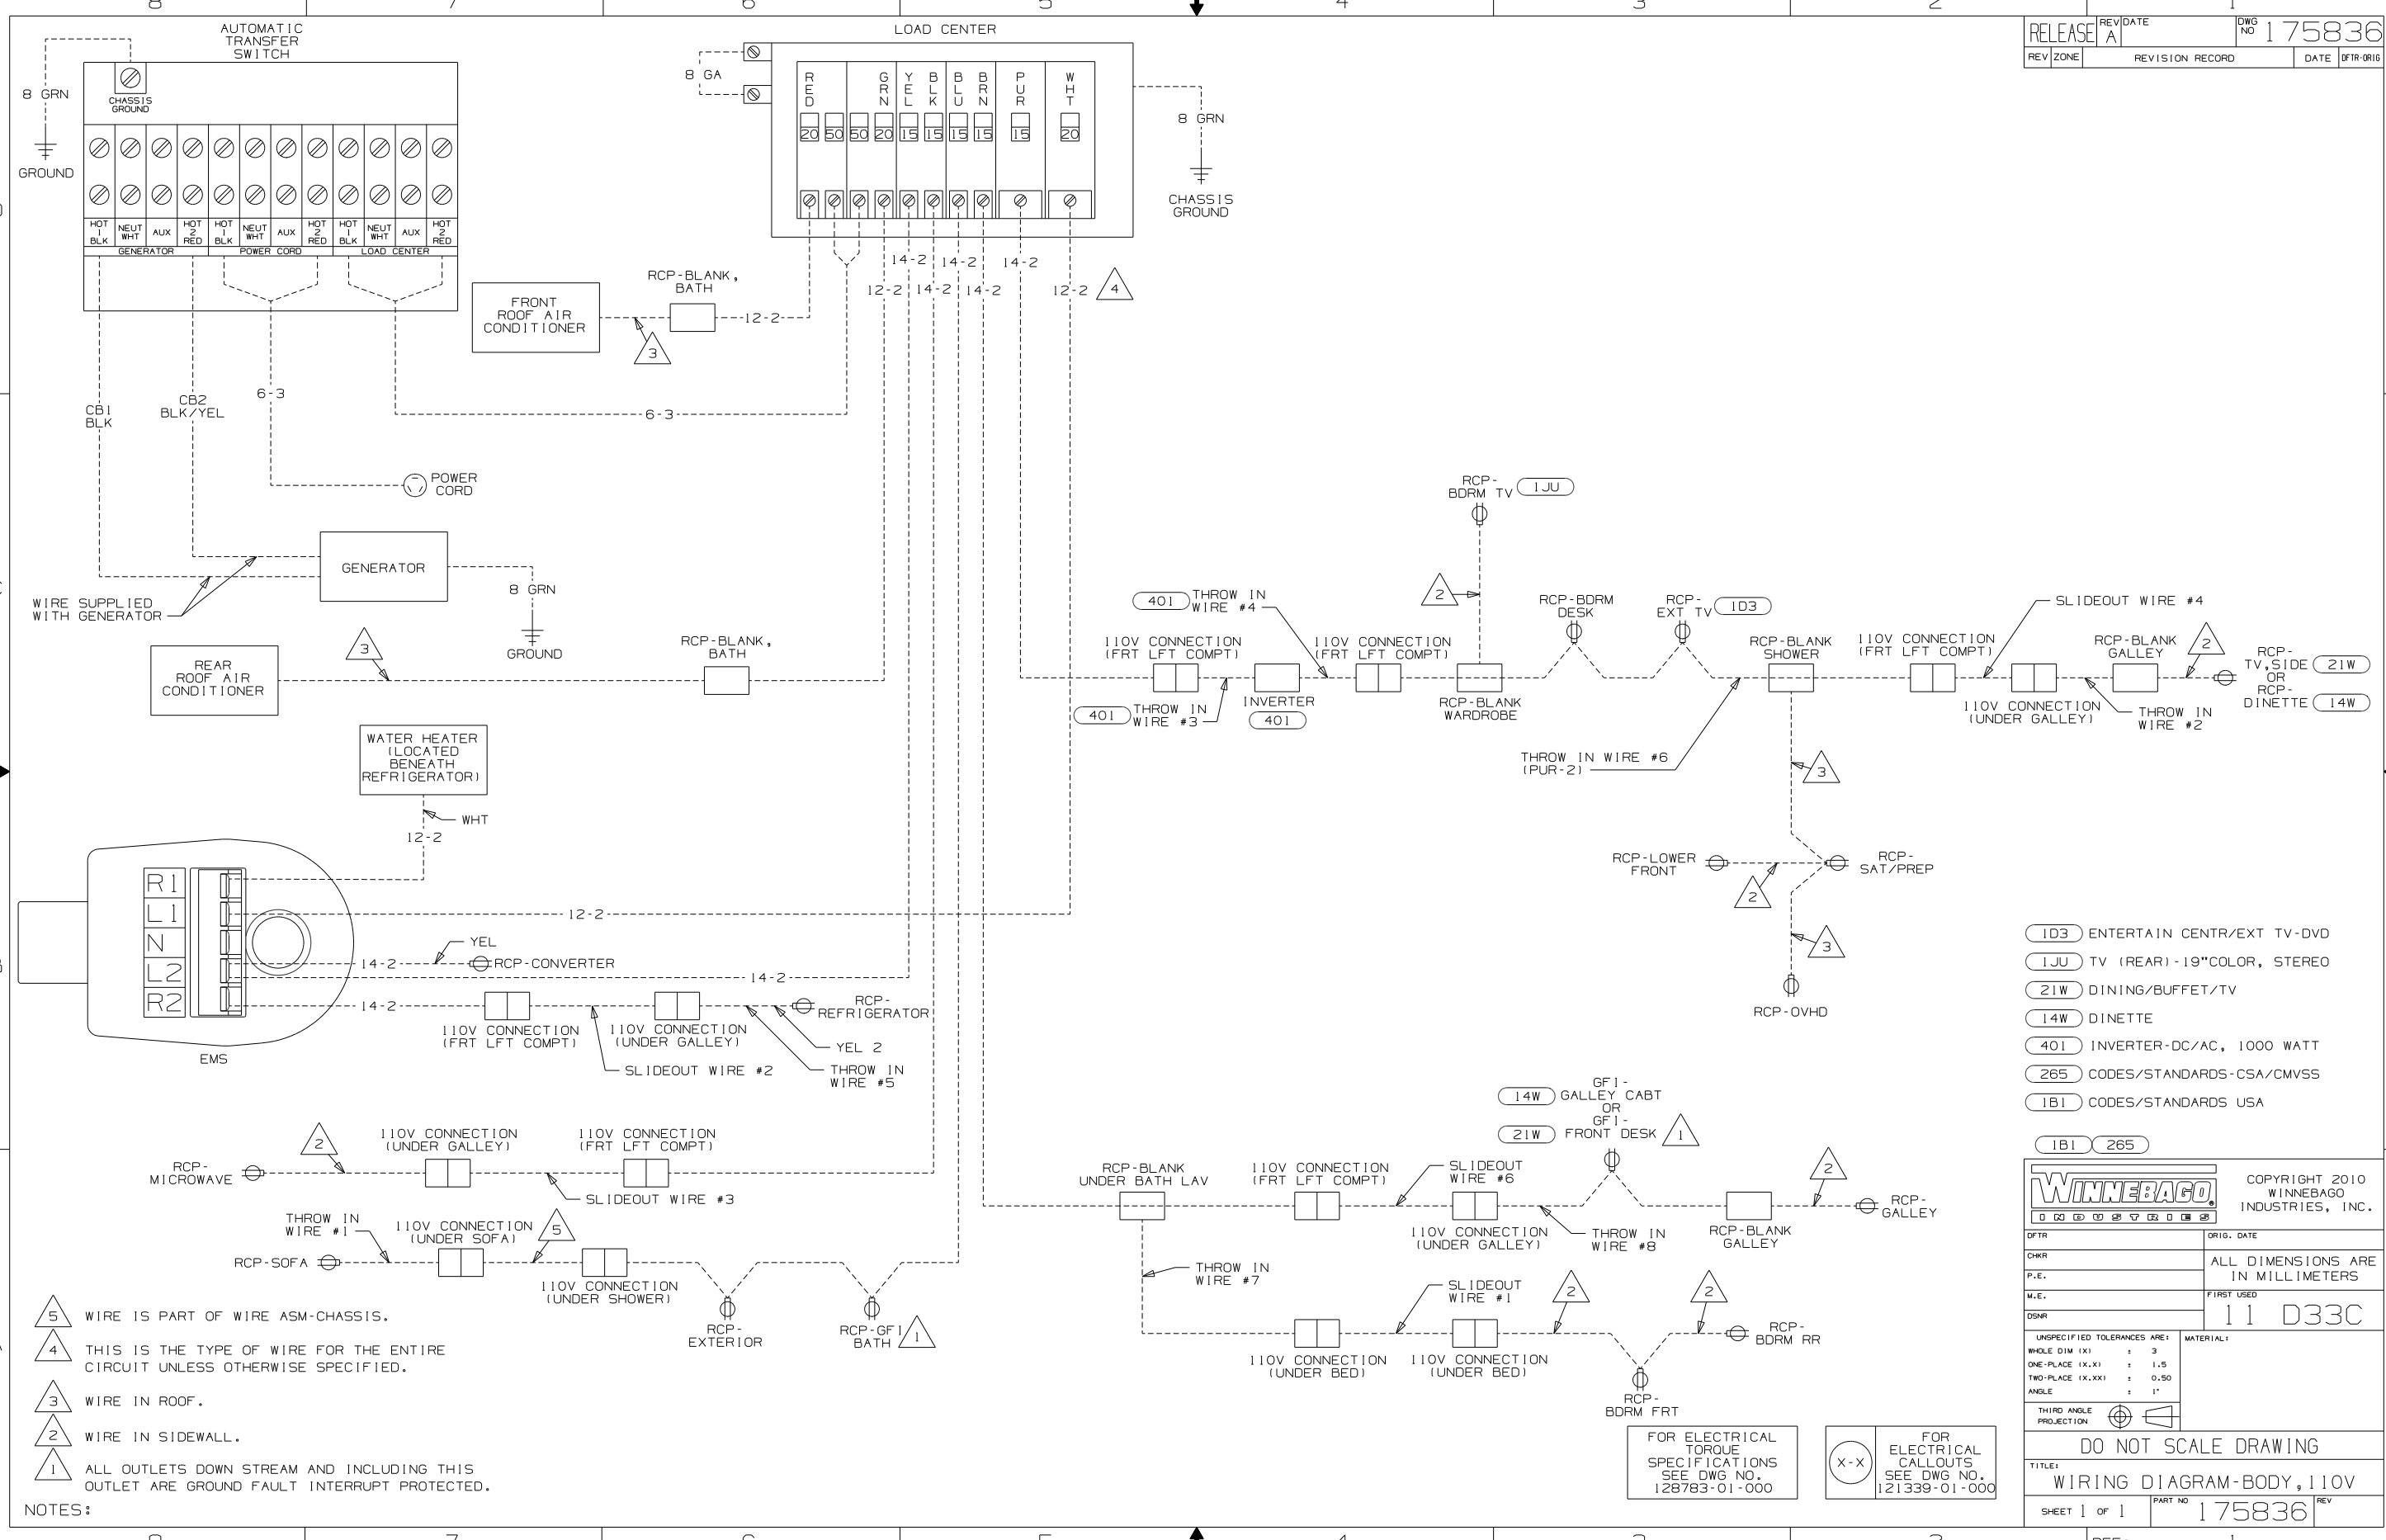
- 1D3 ENTERTAIN CENTR/EXT TV-DVD
- 1JU TV (REAR)-19"COLOR, STEREO
- 21W DINING/BUFFET/TV
- 14W DINETTE
- 401 INVERTER-DC/AC, 1000 WATT
- 265 CODES/STANDARDS-CSA/CMVSS
- 1B1 CODES/STANDARDS USA
