WINNEBAGO		COPYRIGHT 2011 WINNEBAGO INDUSTRIES, INC.	
DTR	ORIG. DATE	ALL DIMENSIONS ARE IN MILLIMETERS	
CHR		FIRST USED	
P.E.		12 524J	
M.E.		UNSPECIFIED TOLERANCES ARE:	
DSNR		WHOLE DIM (X) : ONE-PLACE (X.X) : TWO-PLACE (X.XX) : ANGLE :	
THIRD ANGLE PROJECTION		MATERIAL:	
DO NOT SCALE DRAWING			
TITLE: WIRING DIAGRAM-BODY, 110V			
SHEET 1 OF 1	PART NO	REV	
	179343		
REF:	1	6/13/2011

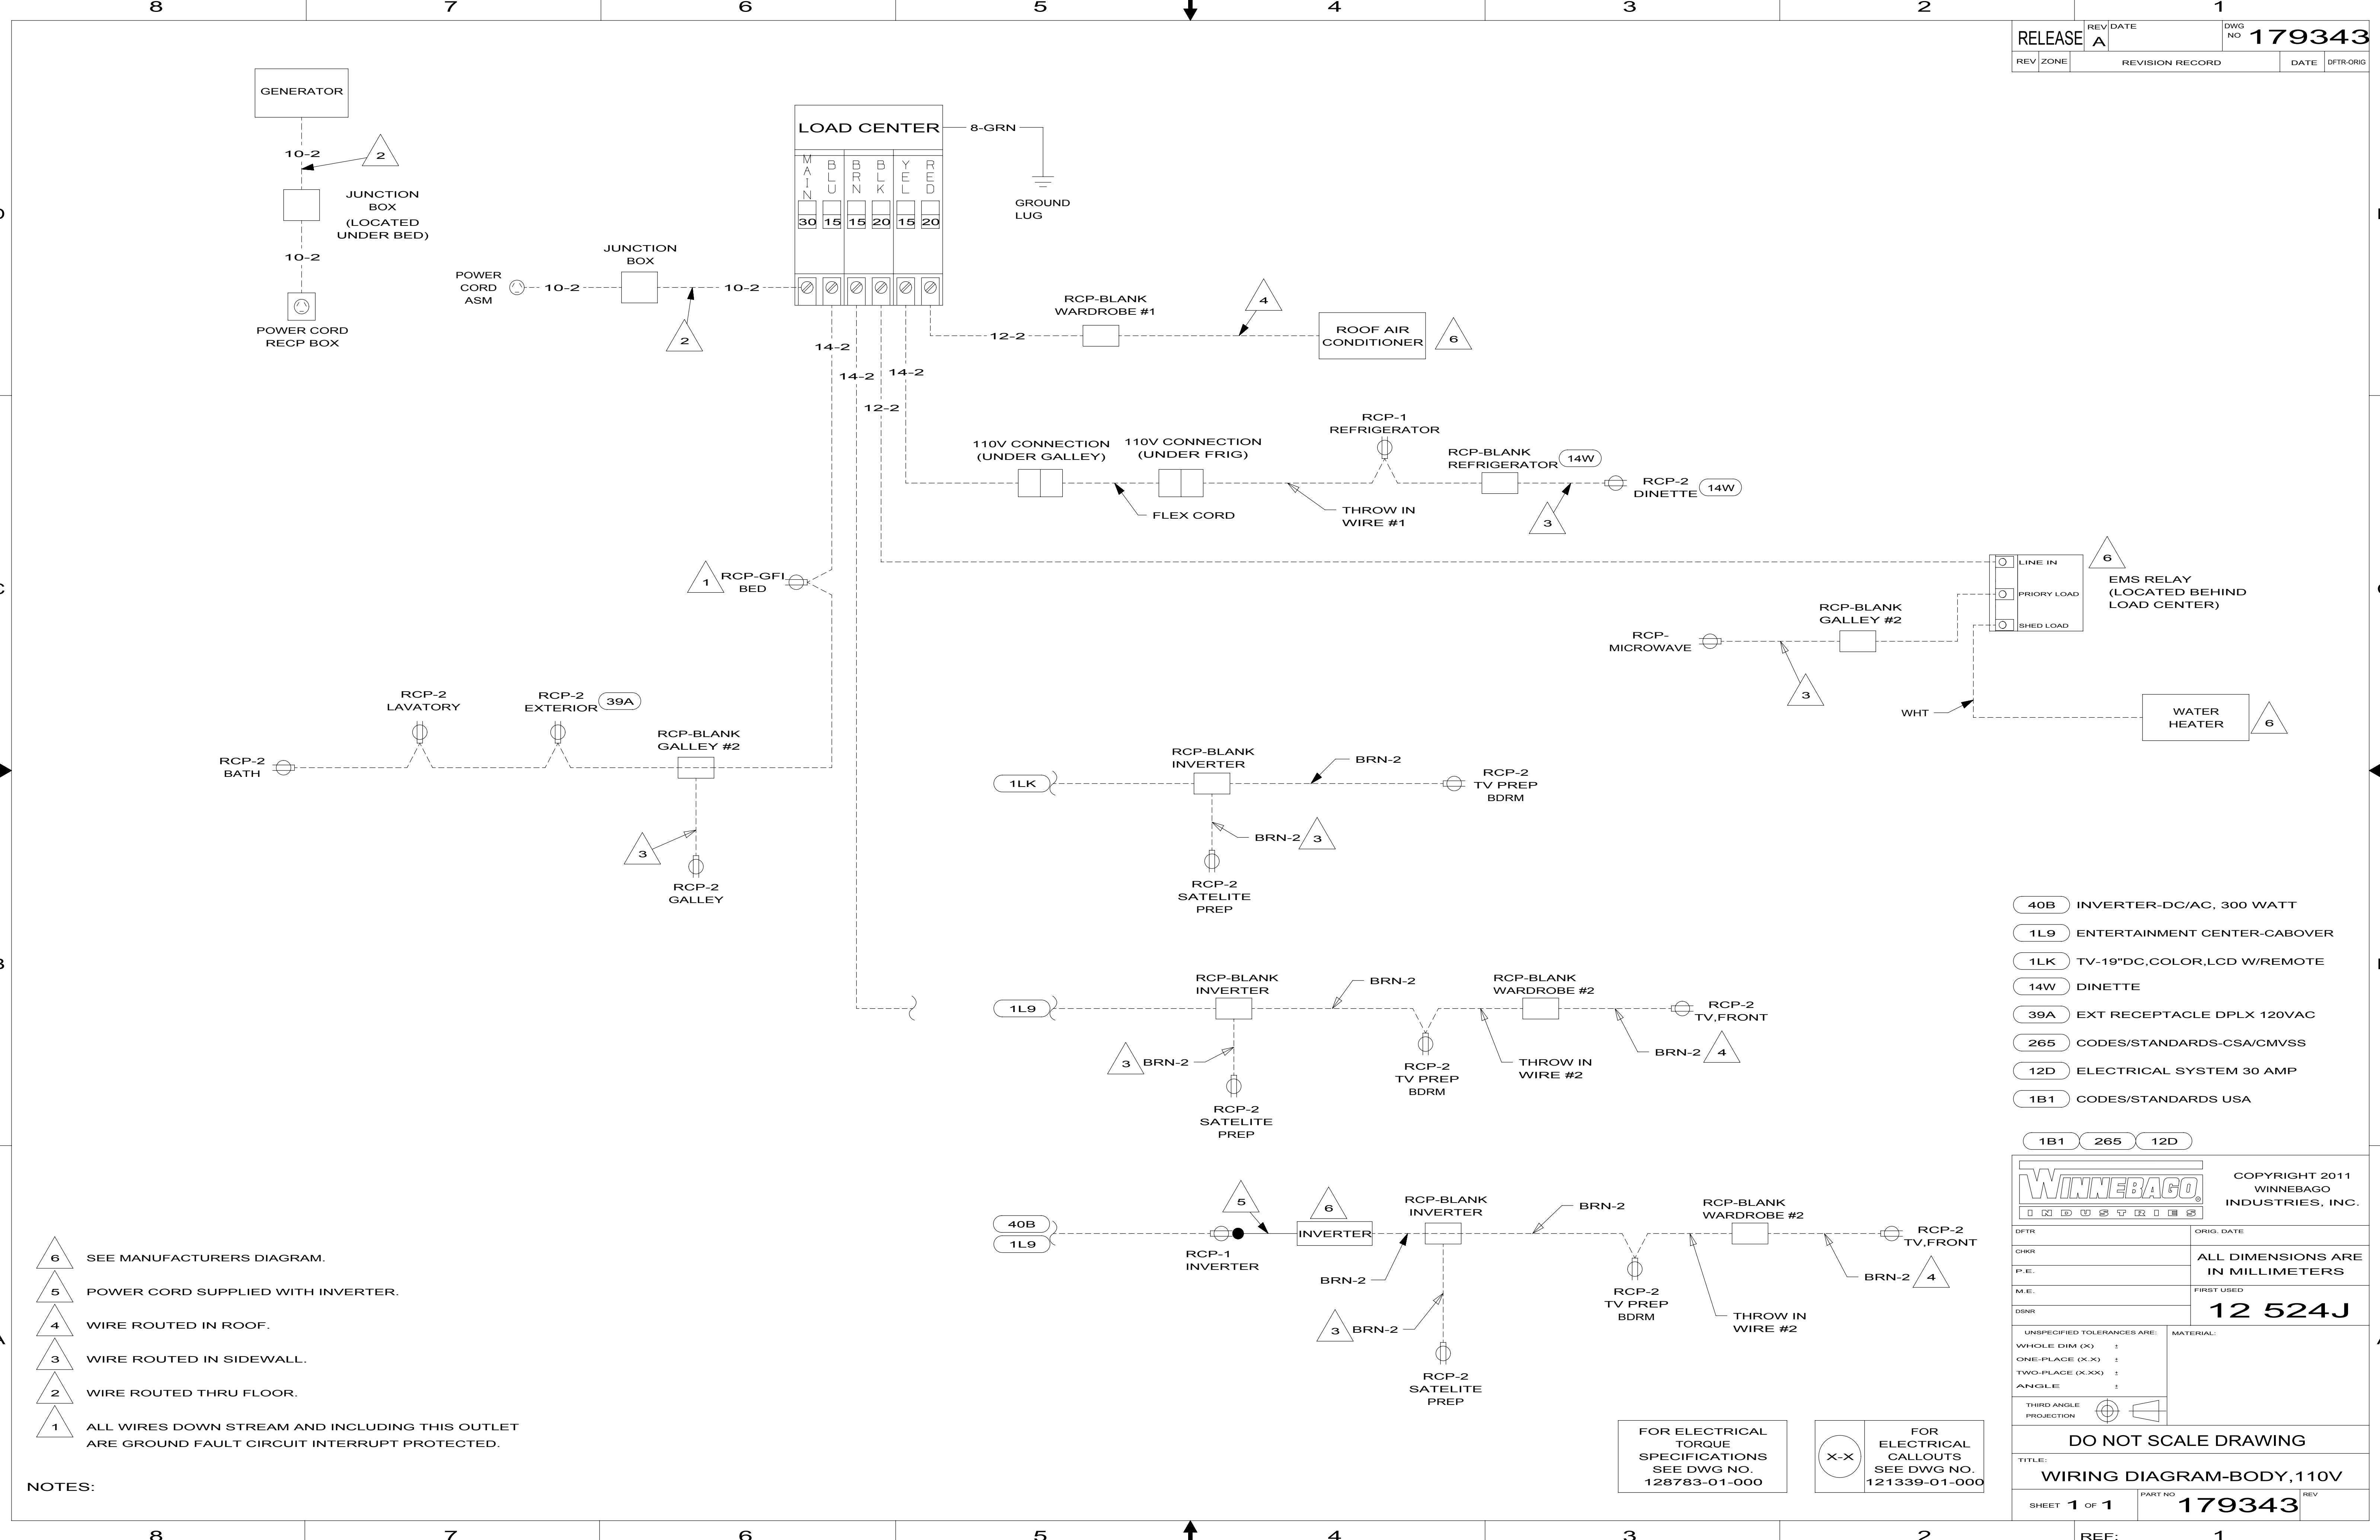
- 40B INVERTER-DC/AC, 300 WATT
- 1L9 ENTERTAINMENT CENTER-CABOVER
- 1LK TV-19"DC,COLOR,LCD W/REMOTE
- 14W DINETTE
- 39A EXT RECEPTACLE DPLX 120VAC
- 265 CODES/STANDARDS-CSA/CMVSS
- 12D ELECTRICAL SYSTEM 30 AMP
- 1B1 CODES/STANDARDS USA
