WINNEBAGO		COPYRIGHT 2011 WINNEBAGO INDUSTRIES, INC.	
DFT-ORIG	ORIG. DATE	13 D33C	
CHKR	ALL DIMENSIONS ARE IN MILLIMETERS		
P.E.	FIRST USED		
M.E.			
DSNR			
UNSPECIFIED TOLERANCES ARE:		MATERIAL:	
WHOLE DIM (X)	: 3		
ONE-PLACE (X.X)	: 1.5		
TWO-PLACE (X.XX)	: 0.50		
ANGLE	: 1'		
THIRD ANGLE PROJECTION			
DO NOT SCALE DRAWING		REFER TO ES0018 FOR FASTENER TIGHTENING GUIDELINES	
TITLE: WIRING DIAGRAM-BODY,110V			
SHEET 1 OF 1	PART NO	180741	REV

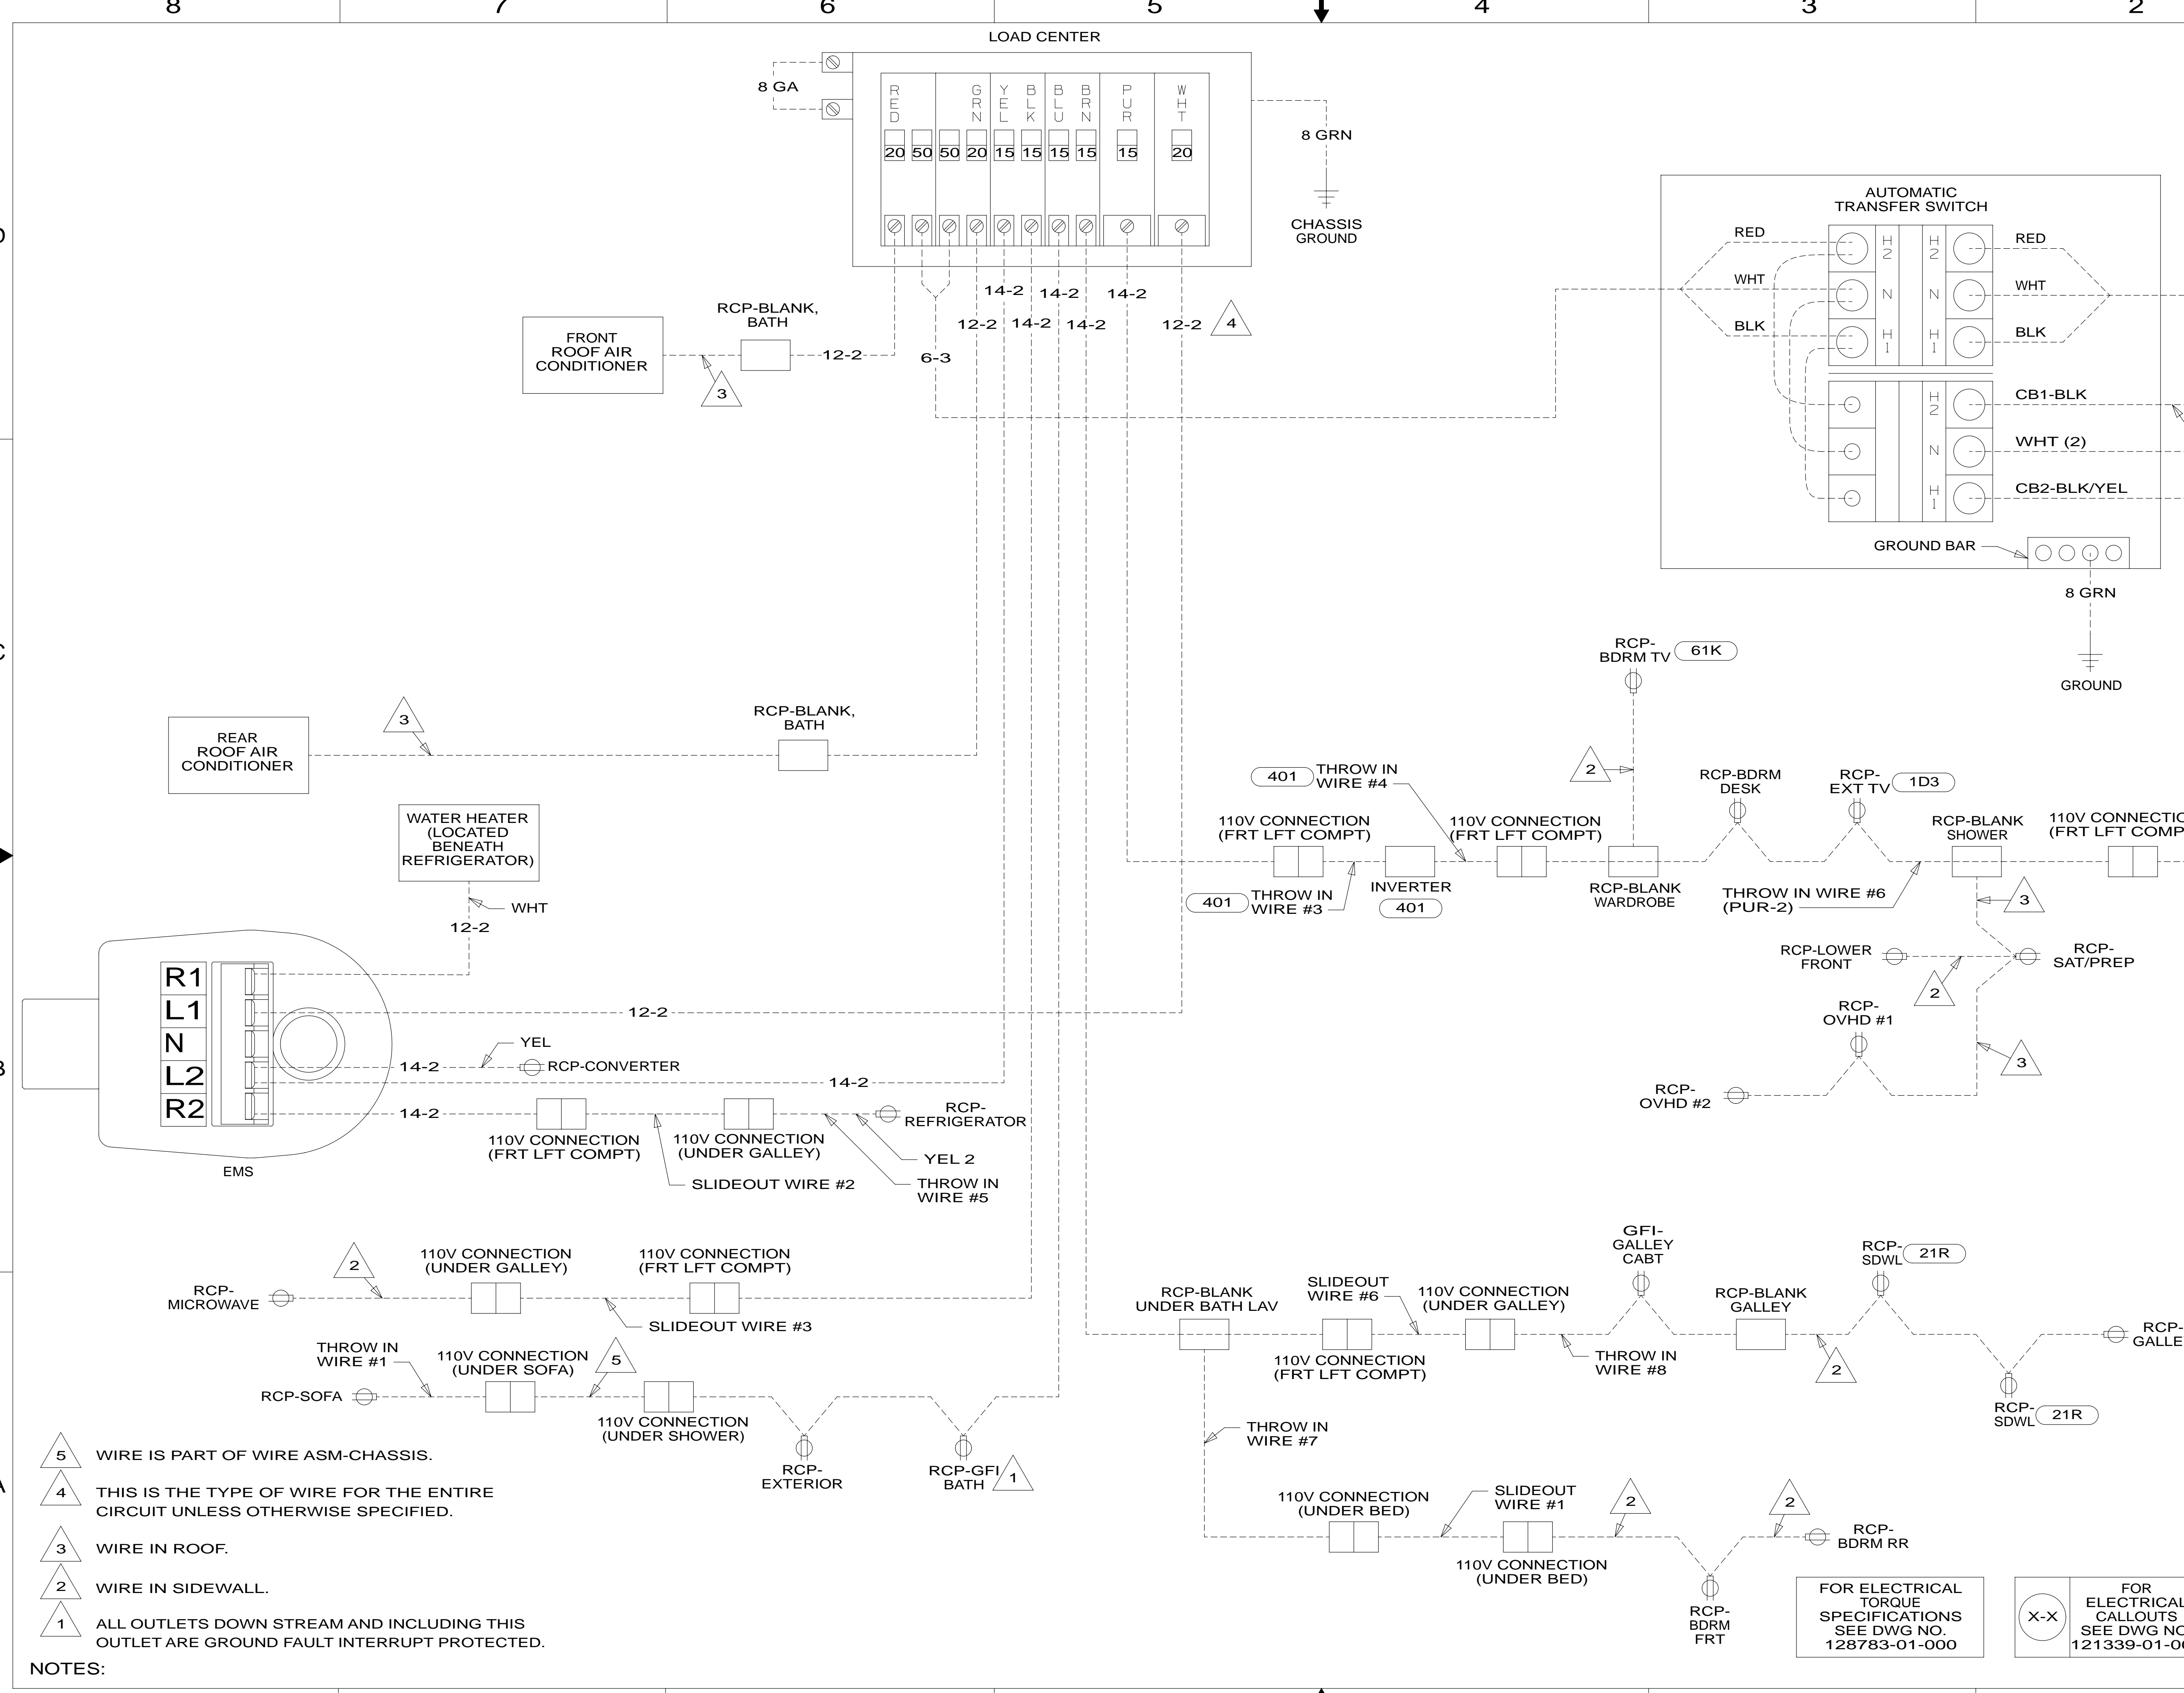
- NOTES:**
- 5 WIRE IS PART OF WIRE ASM-CHASSIS.
 - 4 THIS IS THE TYPE OF WIRE FOR THE ENTIRE CIRCUIT UNLESS OTHERWISE SPECIFIED.
 - 3 WIRE IN ROOF.
 - 2 WIRE IN SIDEWALL.
 - 1 ALL OUTLETS DOWN STREAM AND INCLUDING THIS OUTLET ARE GROUND FAULT INTERRUPT PROTECTED.

- 1D3 ENTERTAIN CENTR/EXT TV-DVD
- 61K TV(REAR)-26" COLOR STEREO
- 21R DINING/BUFFET/POWERED TV
- 14W DINETTE
- 401 INVERTER-DC/AC, 1000 WATT
- 265 CODES/STANDARDS-CSA/CMVSS
- 1B1 CODES/STANDARDS USA
