TITLE: **WIRING DIAGRAM-BODY, 110V**

SHEET **1** OF **1** PART NO **181581** REV

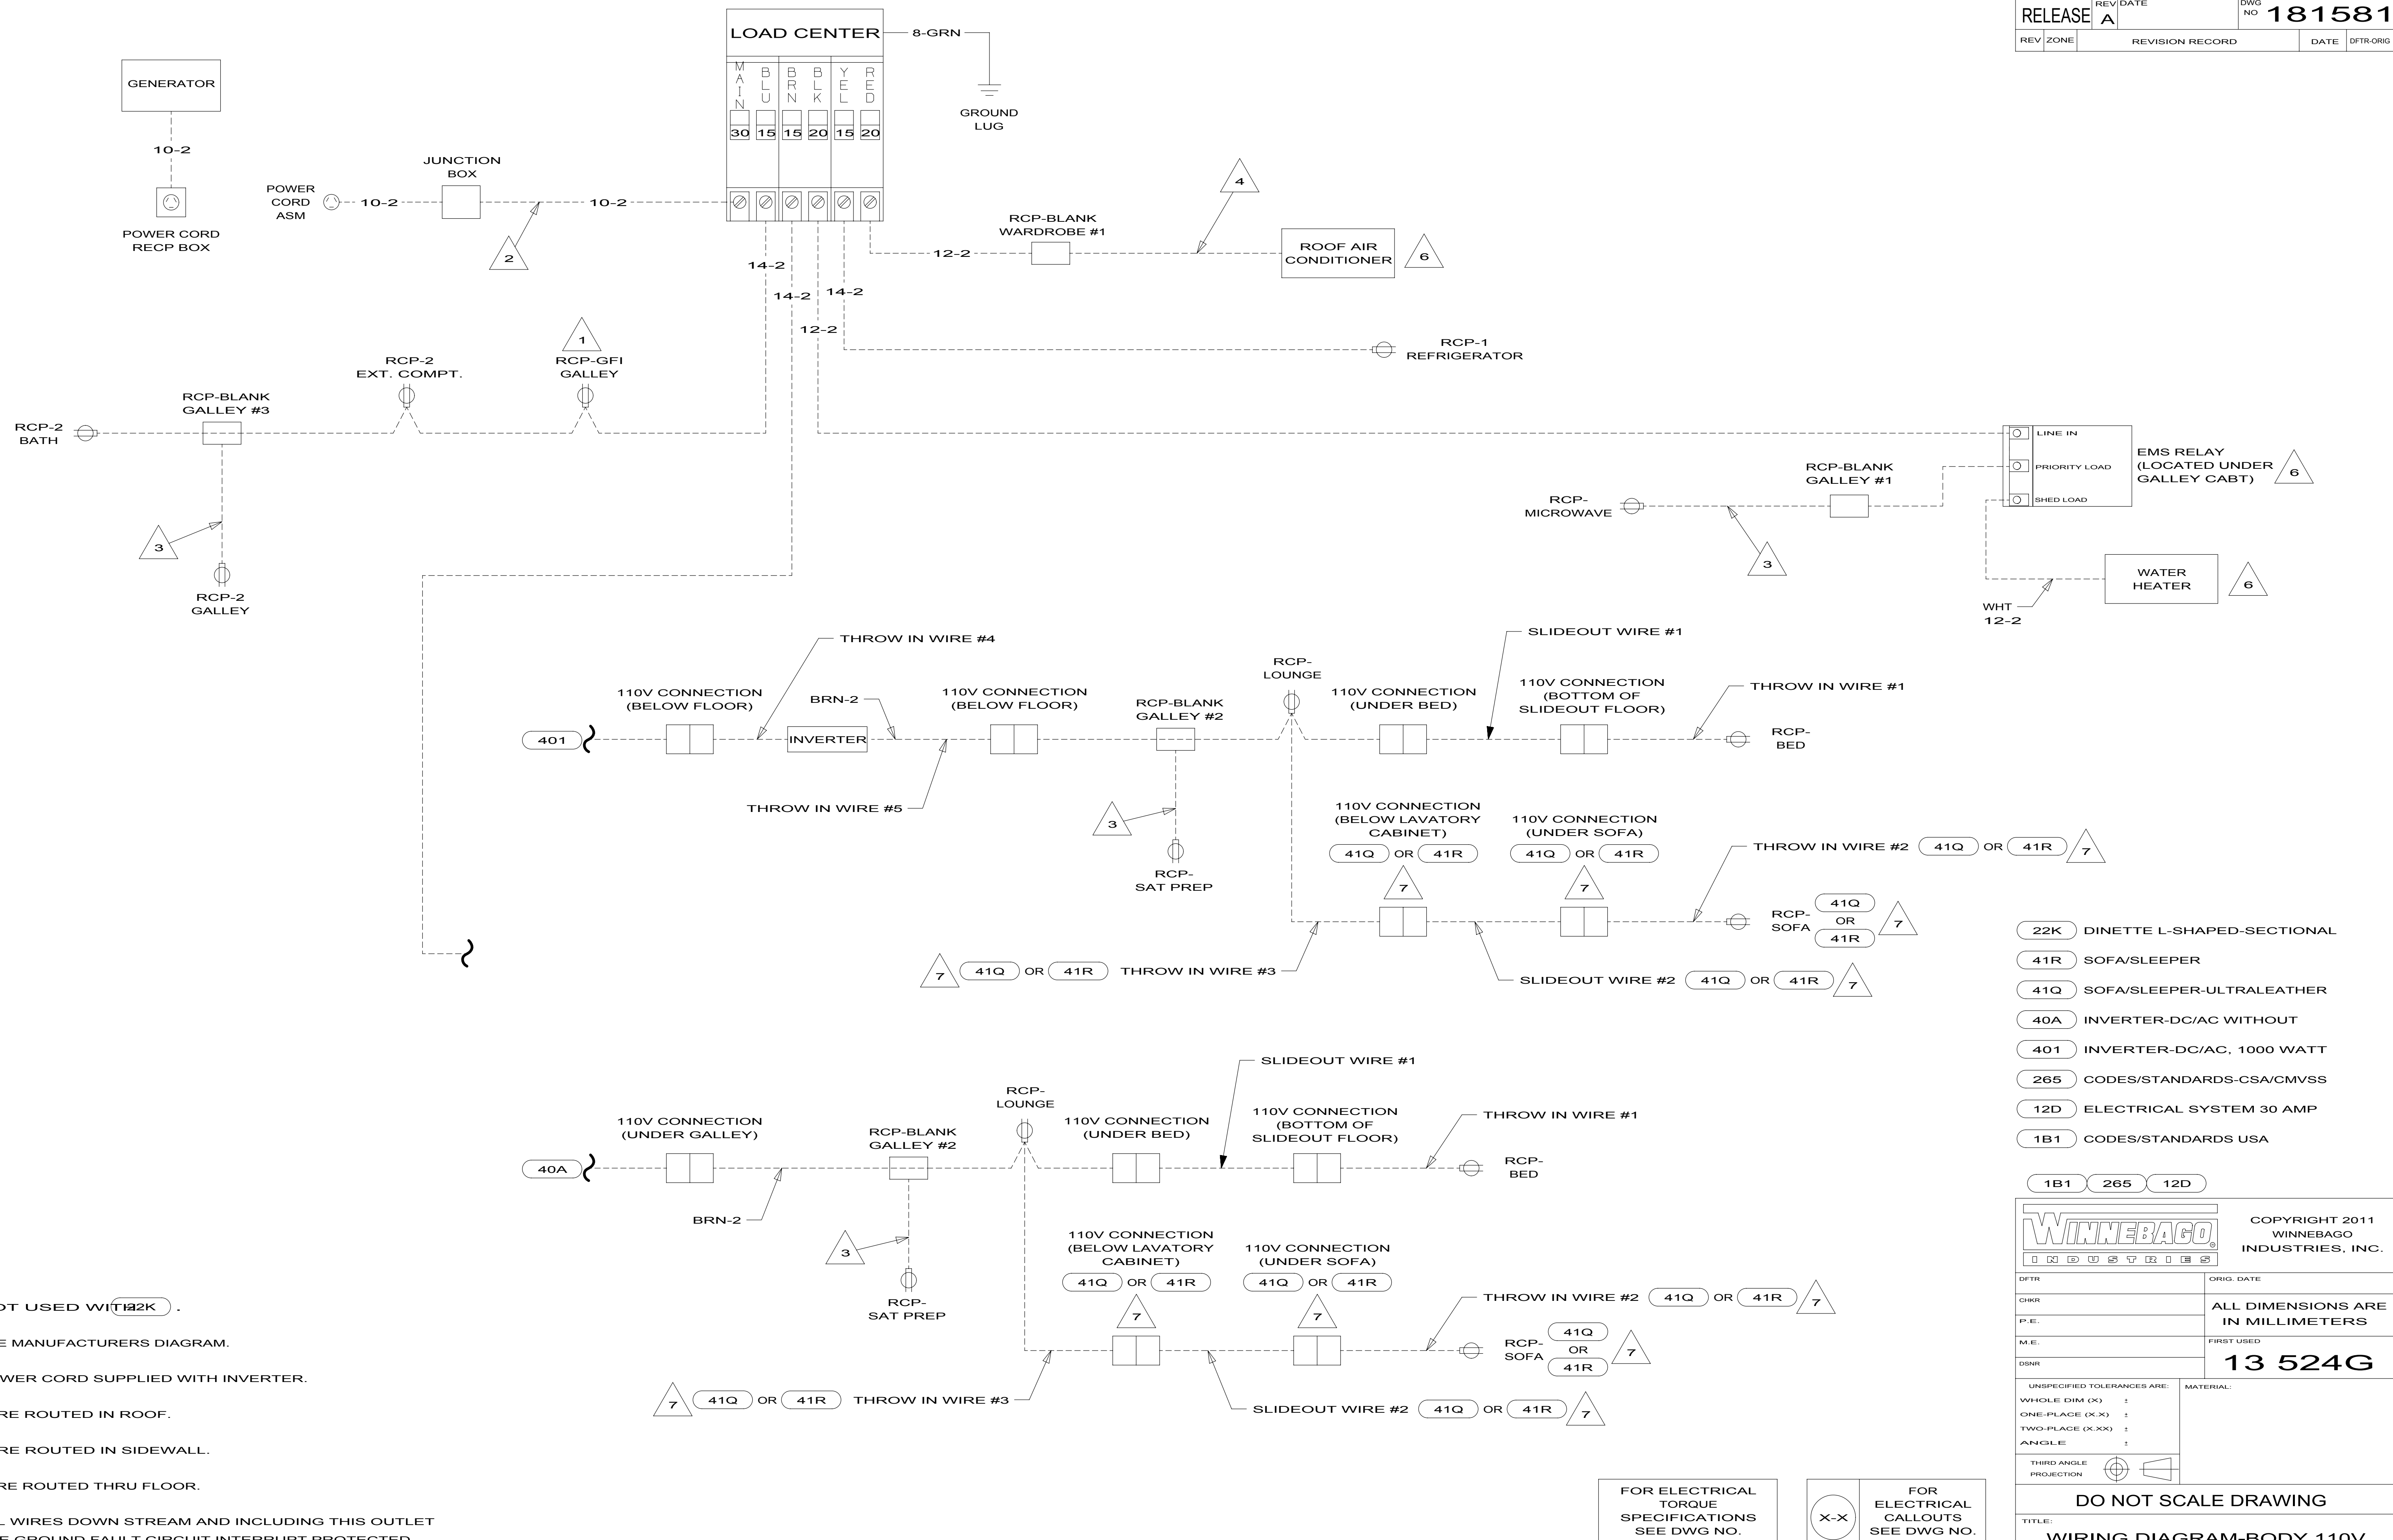
- NOTES:
- 7 NOT USED WITH 22K
 - 6 SEE MANUFACTURERS DIAGRAM.
 - 5 POWER CORD SUPPLIED WITH INVERTER.
 - 4 WIRE ROUTED IN ROOF.
 - 3 WIRE ROUTED IN SIDEWALL.
 - 2 WIRE ROUTED THRU FLOOR.
 - 1 ALL WIRES DOWN STREAM AND INCLUDING THIS OUTLET ARE GROUND FAULT CIRCUIT INTERRUPT PROTECTED.
