| TITLE: WIRING DIAGRAM-BODY,110V | | | |
| SHEET 1 OF 1 | PART NO | 182297 | REV |

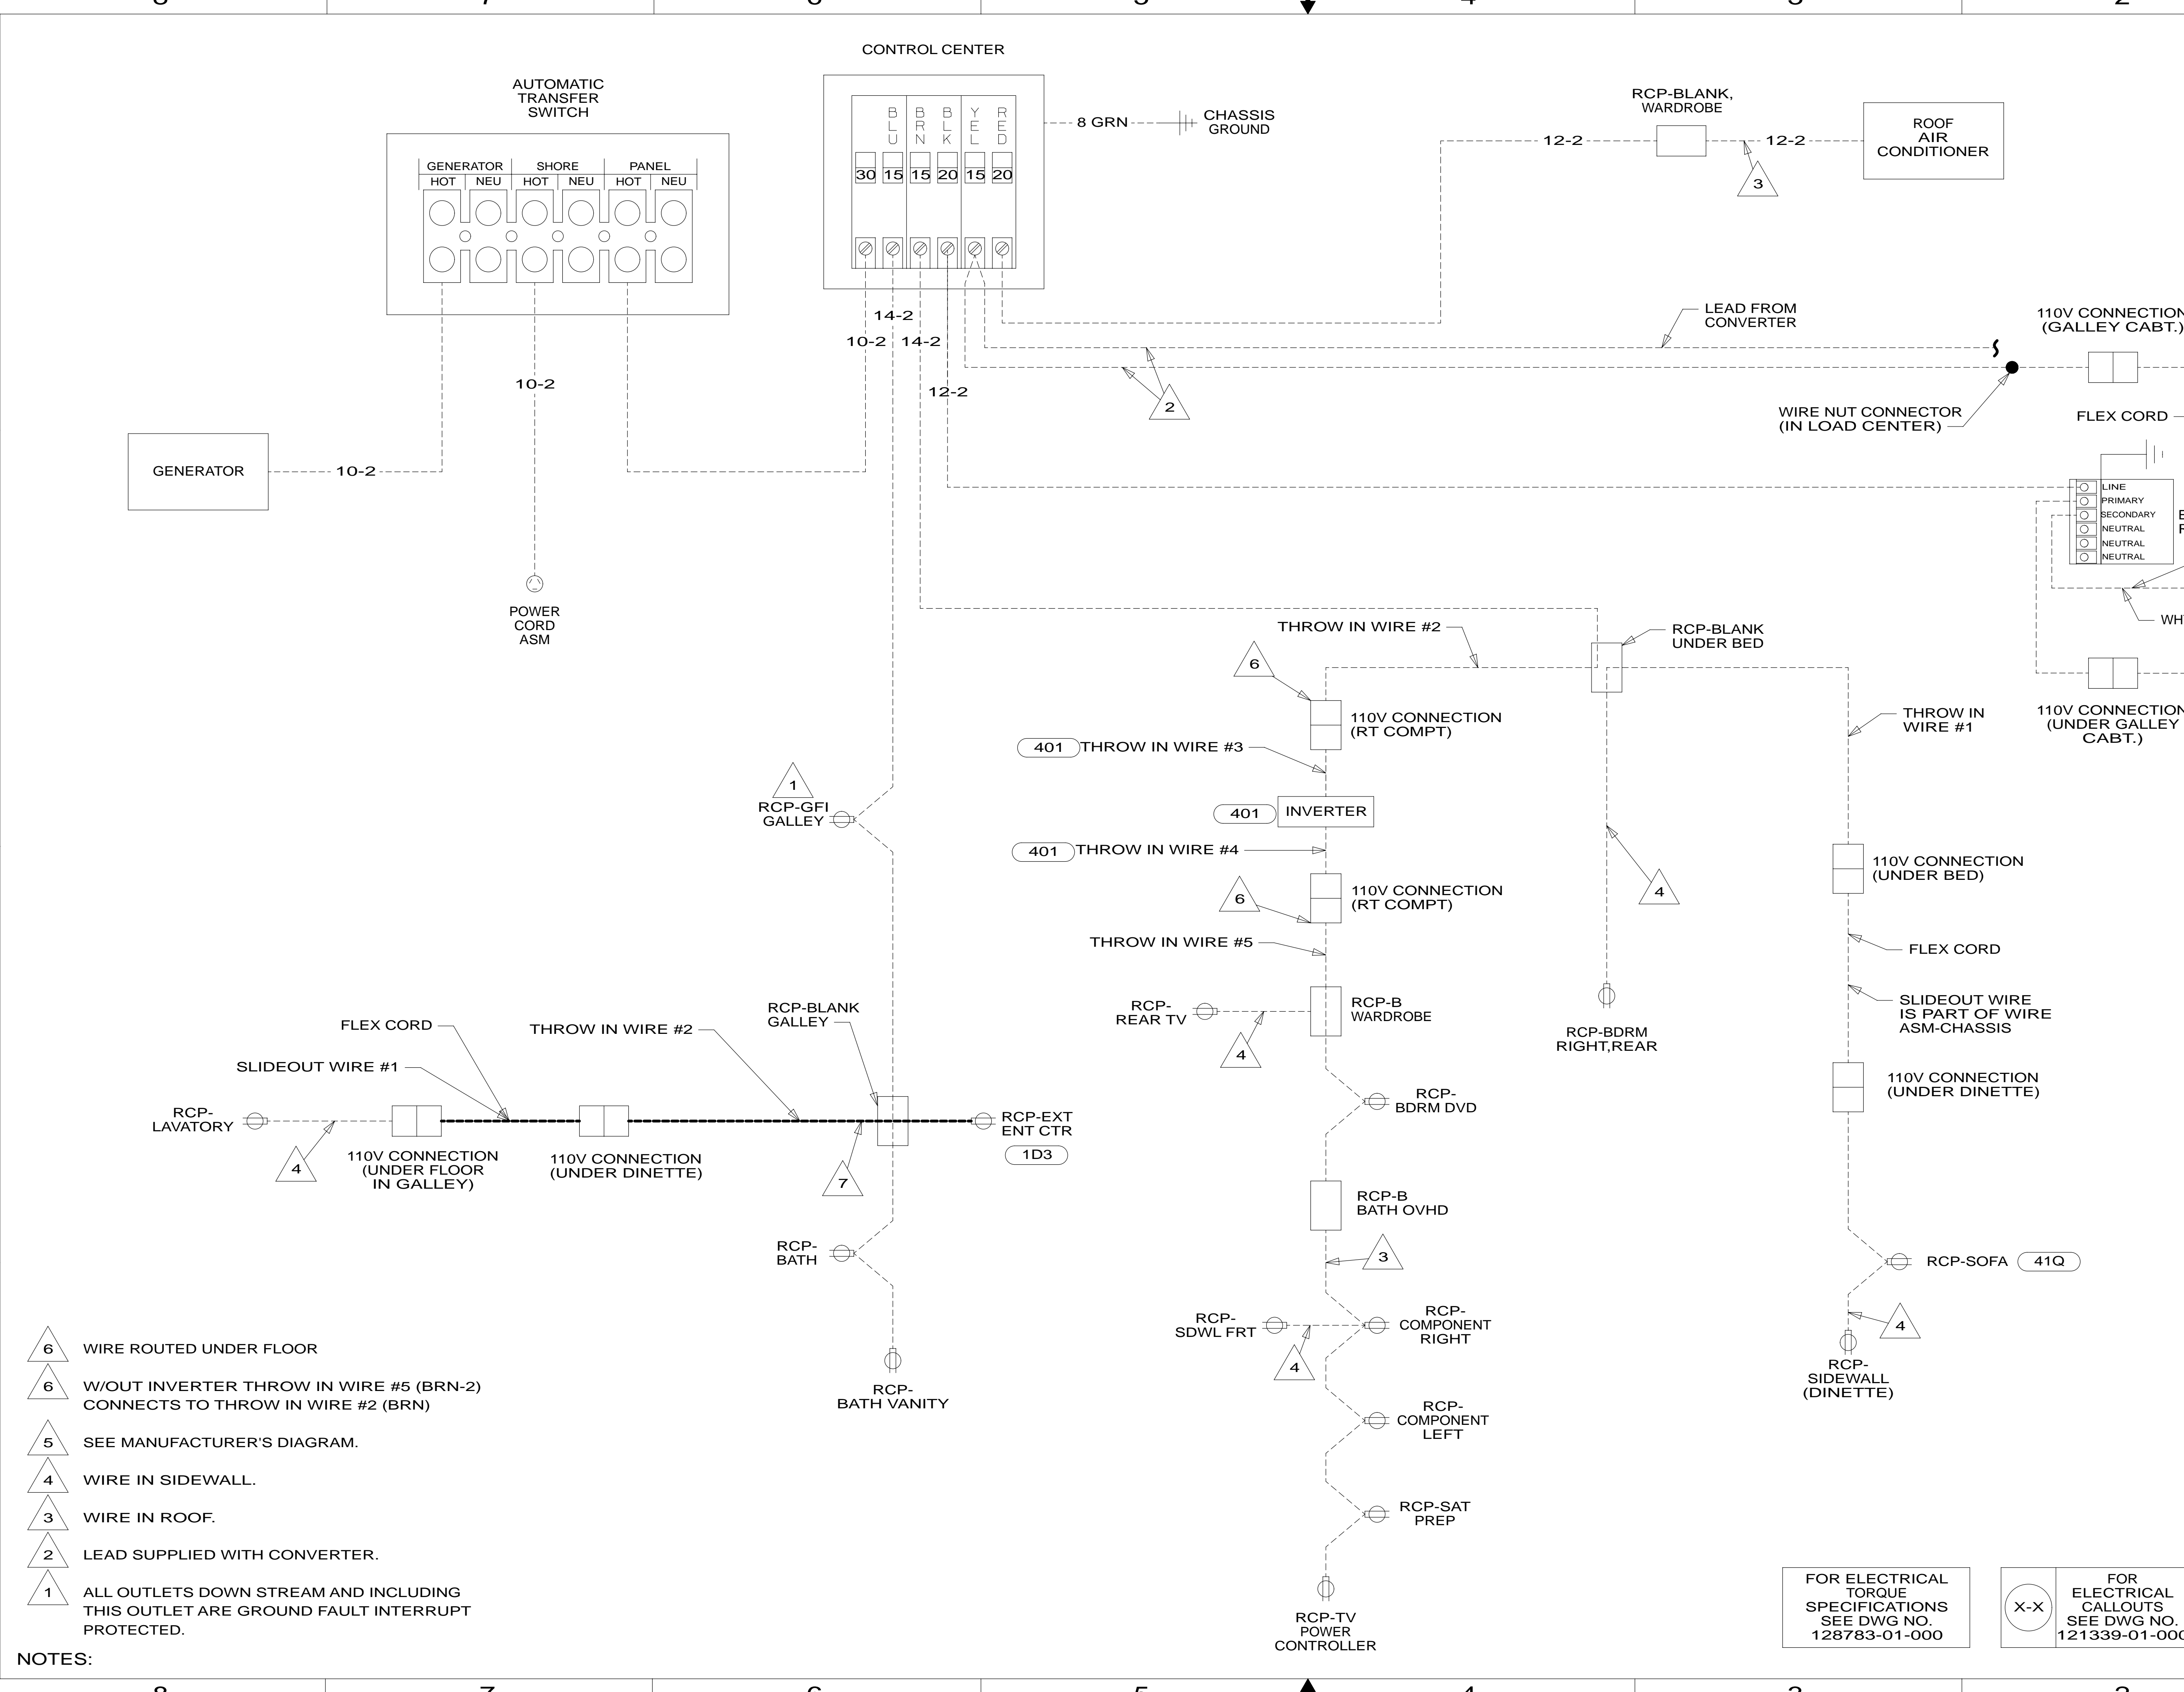
- NOTES:**
- 6 WIRE ROUTED UNDER FLOOR
 - 6 W/O/W INVERTER THROW IN WIRE #5 (BRN-2) CONNECTS TO THROW IN WIRE #2 (BRN)
 - 5 SEE MANUFACTURER'S DIAGRAM.
 - 4 WIRE IN SIDEWALL.
 - 3 WIRE IN ROOF.
 - 2 LEAD SUPPLIED WITH CONVERTER.
 - 1 ALL OUTLETS DOWN STREAM AND INCLUDING THIS OUTLET ARE GROUND FAULT INTERRUPT PROTECTED.
