COPYRIGHT 2014 WINNEBAGO INDUSTRIES, INC.
DFT-ORIG	ORIG. DATE	ALL DIMENSIONS ARE IN MILLIMETERS
CHKR		
P.E.		
M.E.	FIRST USED	
DSNR	93 MOTORHAMES	
UNSPECIFIED TOLERANCES ARE: WHOLE DIM (X) : ONE-PLACE (X.X) : TWO-PLACE (X.XX) : ANGLE :		MATERIAL:
THIRD ANGLE PROJECTION		
DO NOT SCALE DRAWING		REFER TO ES0018 FOR FASTENER TIGHTENING GUIDELINES
TITLE: WIRING DIAGRAM-TV COAX		
SHEET 1 OF 2	PART NO	110138
REF:	1	20-Jan-2014

FIRST USED	93 MOTORHAMES
DO NOT SCALE DRAWING	
TITLE: WIRING DIAGRAM-TV COAX	
SHEET 2	PART NO 110138
20-Jan-2014

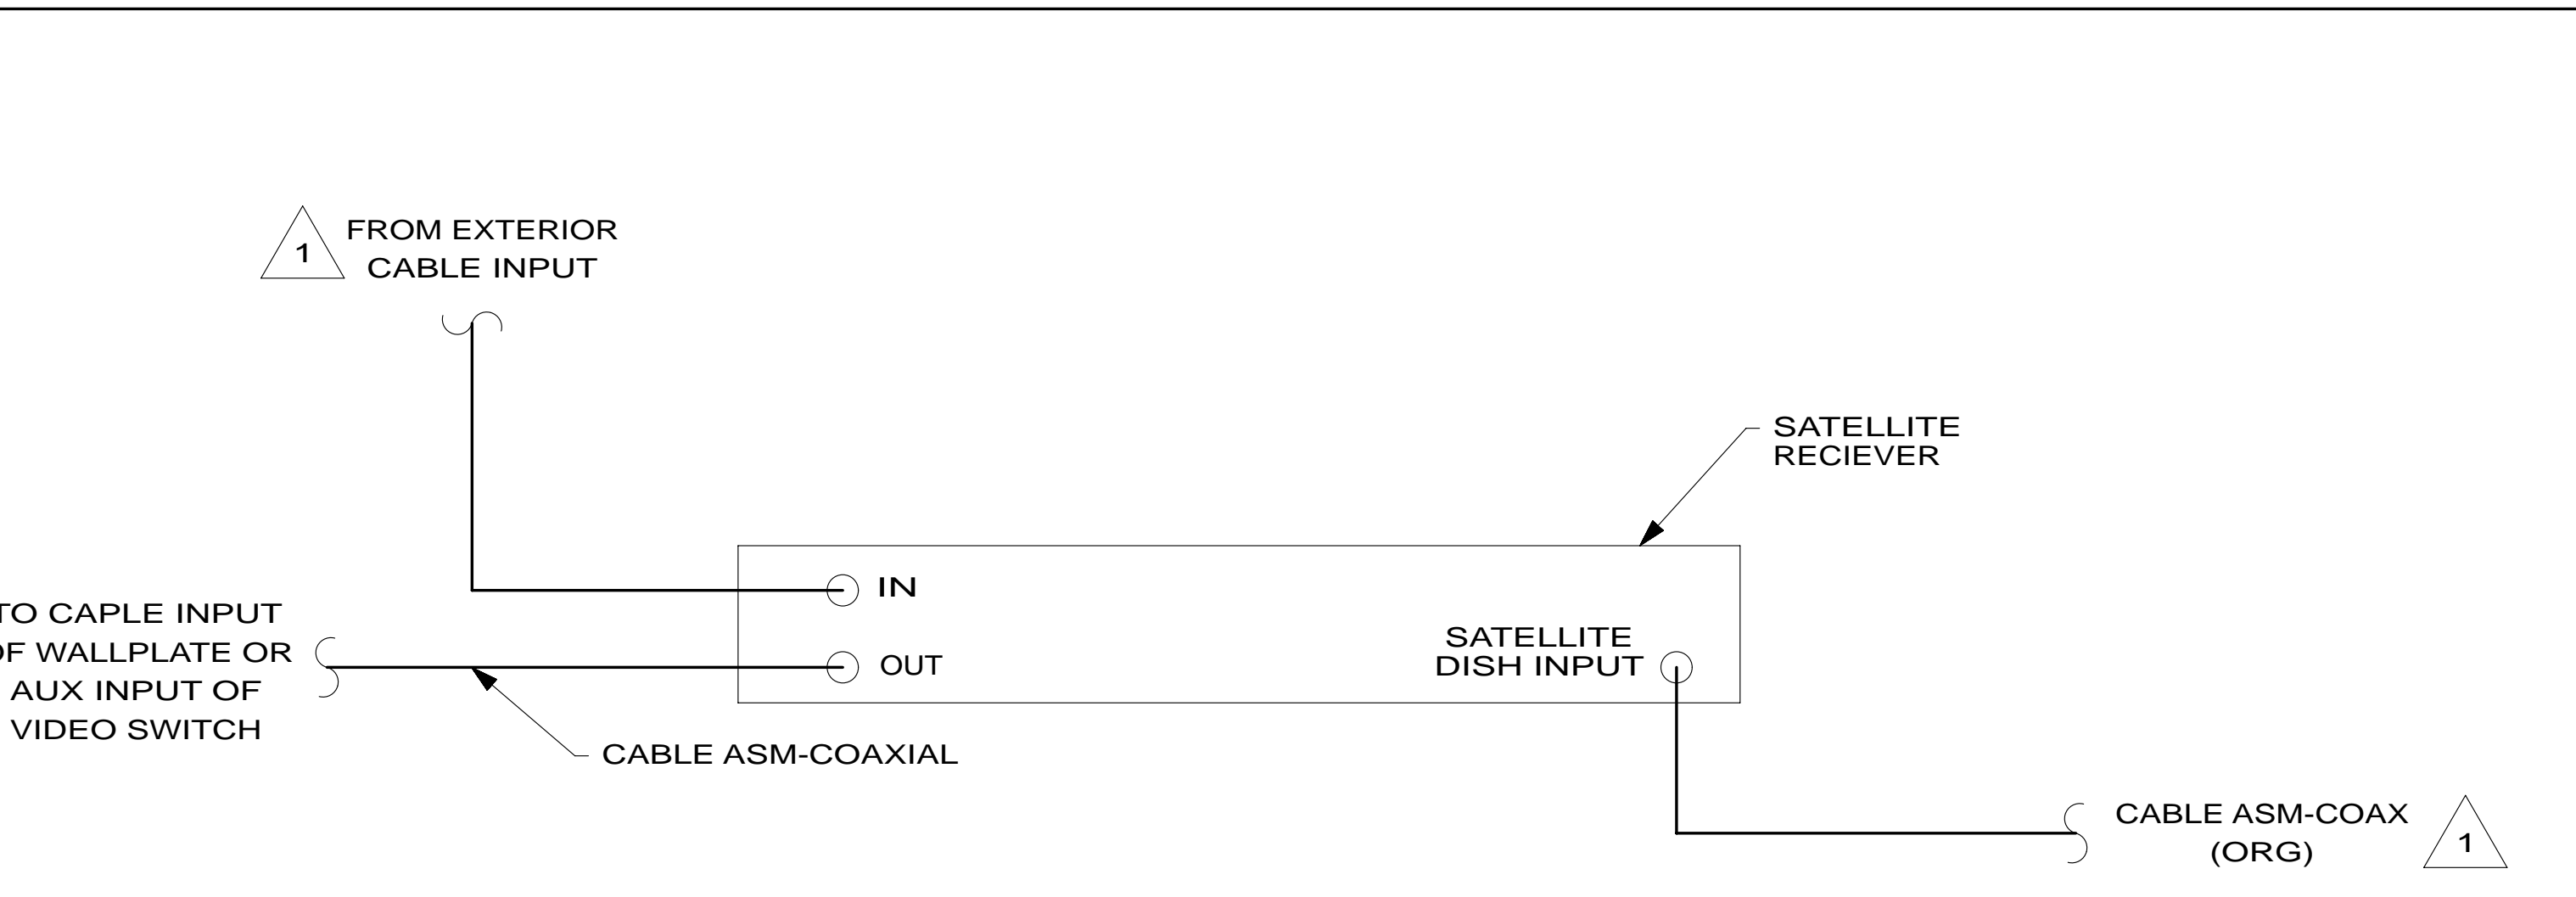
- NOTES:
- 2 WITH SATELLITE DISH SEE SATELLITE DISH VIEW BOTTOM LEFT.
 - 1 CONNECT TV COAX TO JACK ON FRONT OF WALLPLATE.
