FIRST USED	<b>14 524J</b>	
TITLE:	<b>DO NOT SCALE DRAWING</b>	
	<b>WIRING INSTL-CHASSIS</b>	
SHEET 3	PART NO <b>186404</b>	REV

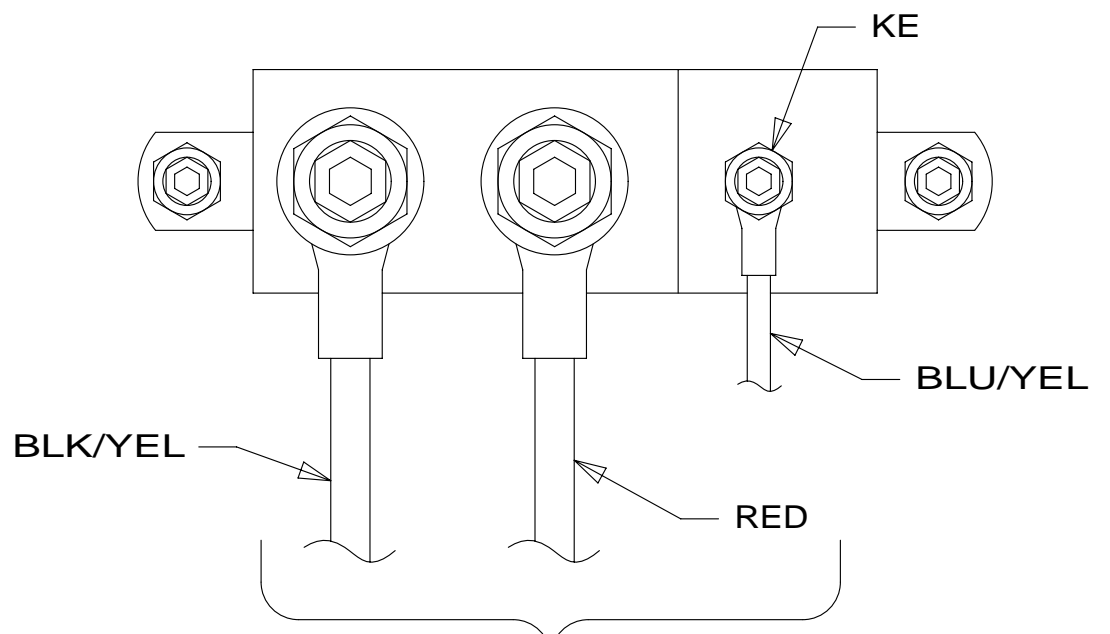
CHASSIS SUPPLIED WIRING  
DETAIL CC 3
