DESCRIPTION: <b>RADIO/MONITOR INSTL</b>		
SHEET: 1 OF 5	ITEM/PART NO: 000208692 / 30073901000	REV:
REF:		1 24-Oct-2016

DESCRIPTION:	1B1 265 19V	
<b>RADIO/MONITOR INSTL</b>		
SHEET:	ITEM/PART NO:	REV
2 OF 5	000208692 / 30073901000

DESCRIPTION: <b>RADIO/MONITOR INSTL</b>		
SHEET: <b>3 OF 5</b>	ITEM/PART NO: <b>000208692 / 30073901000</b>	REV

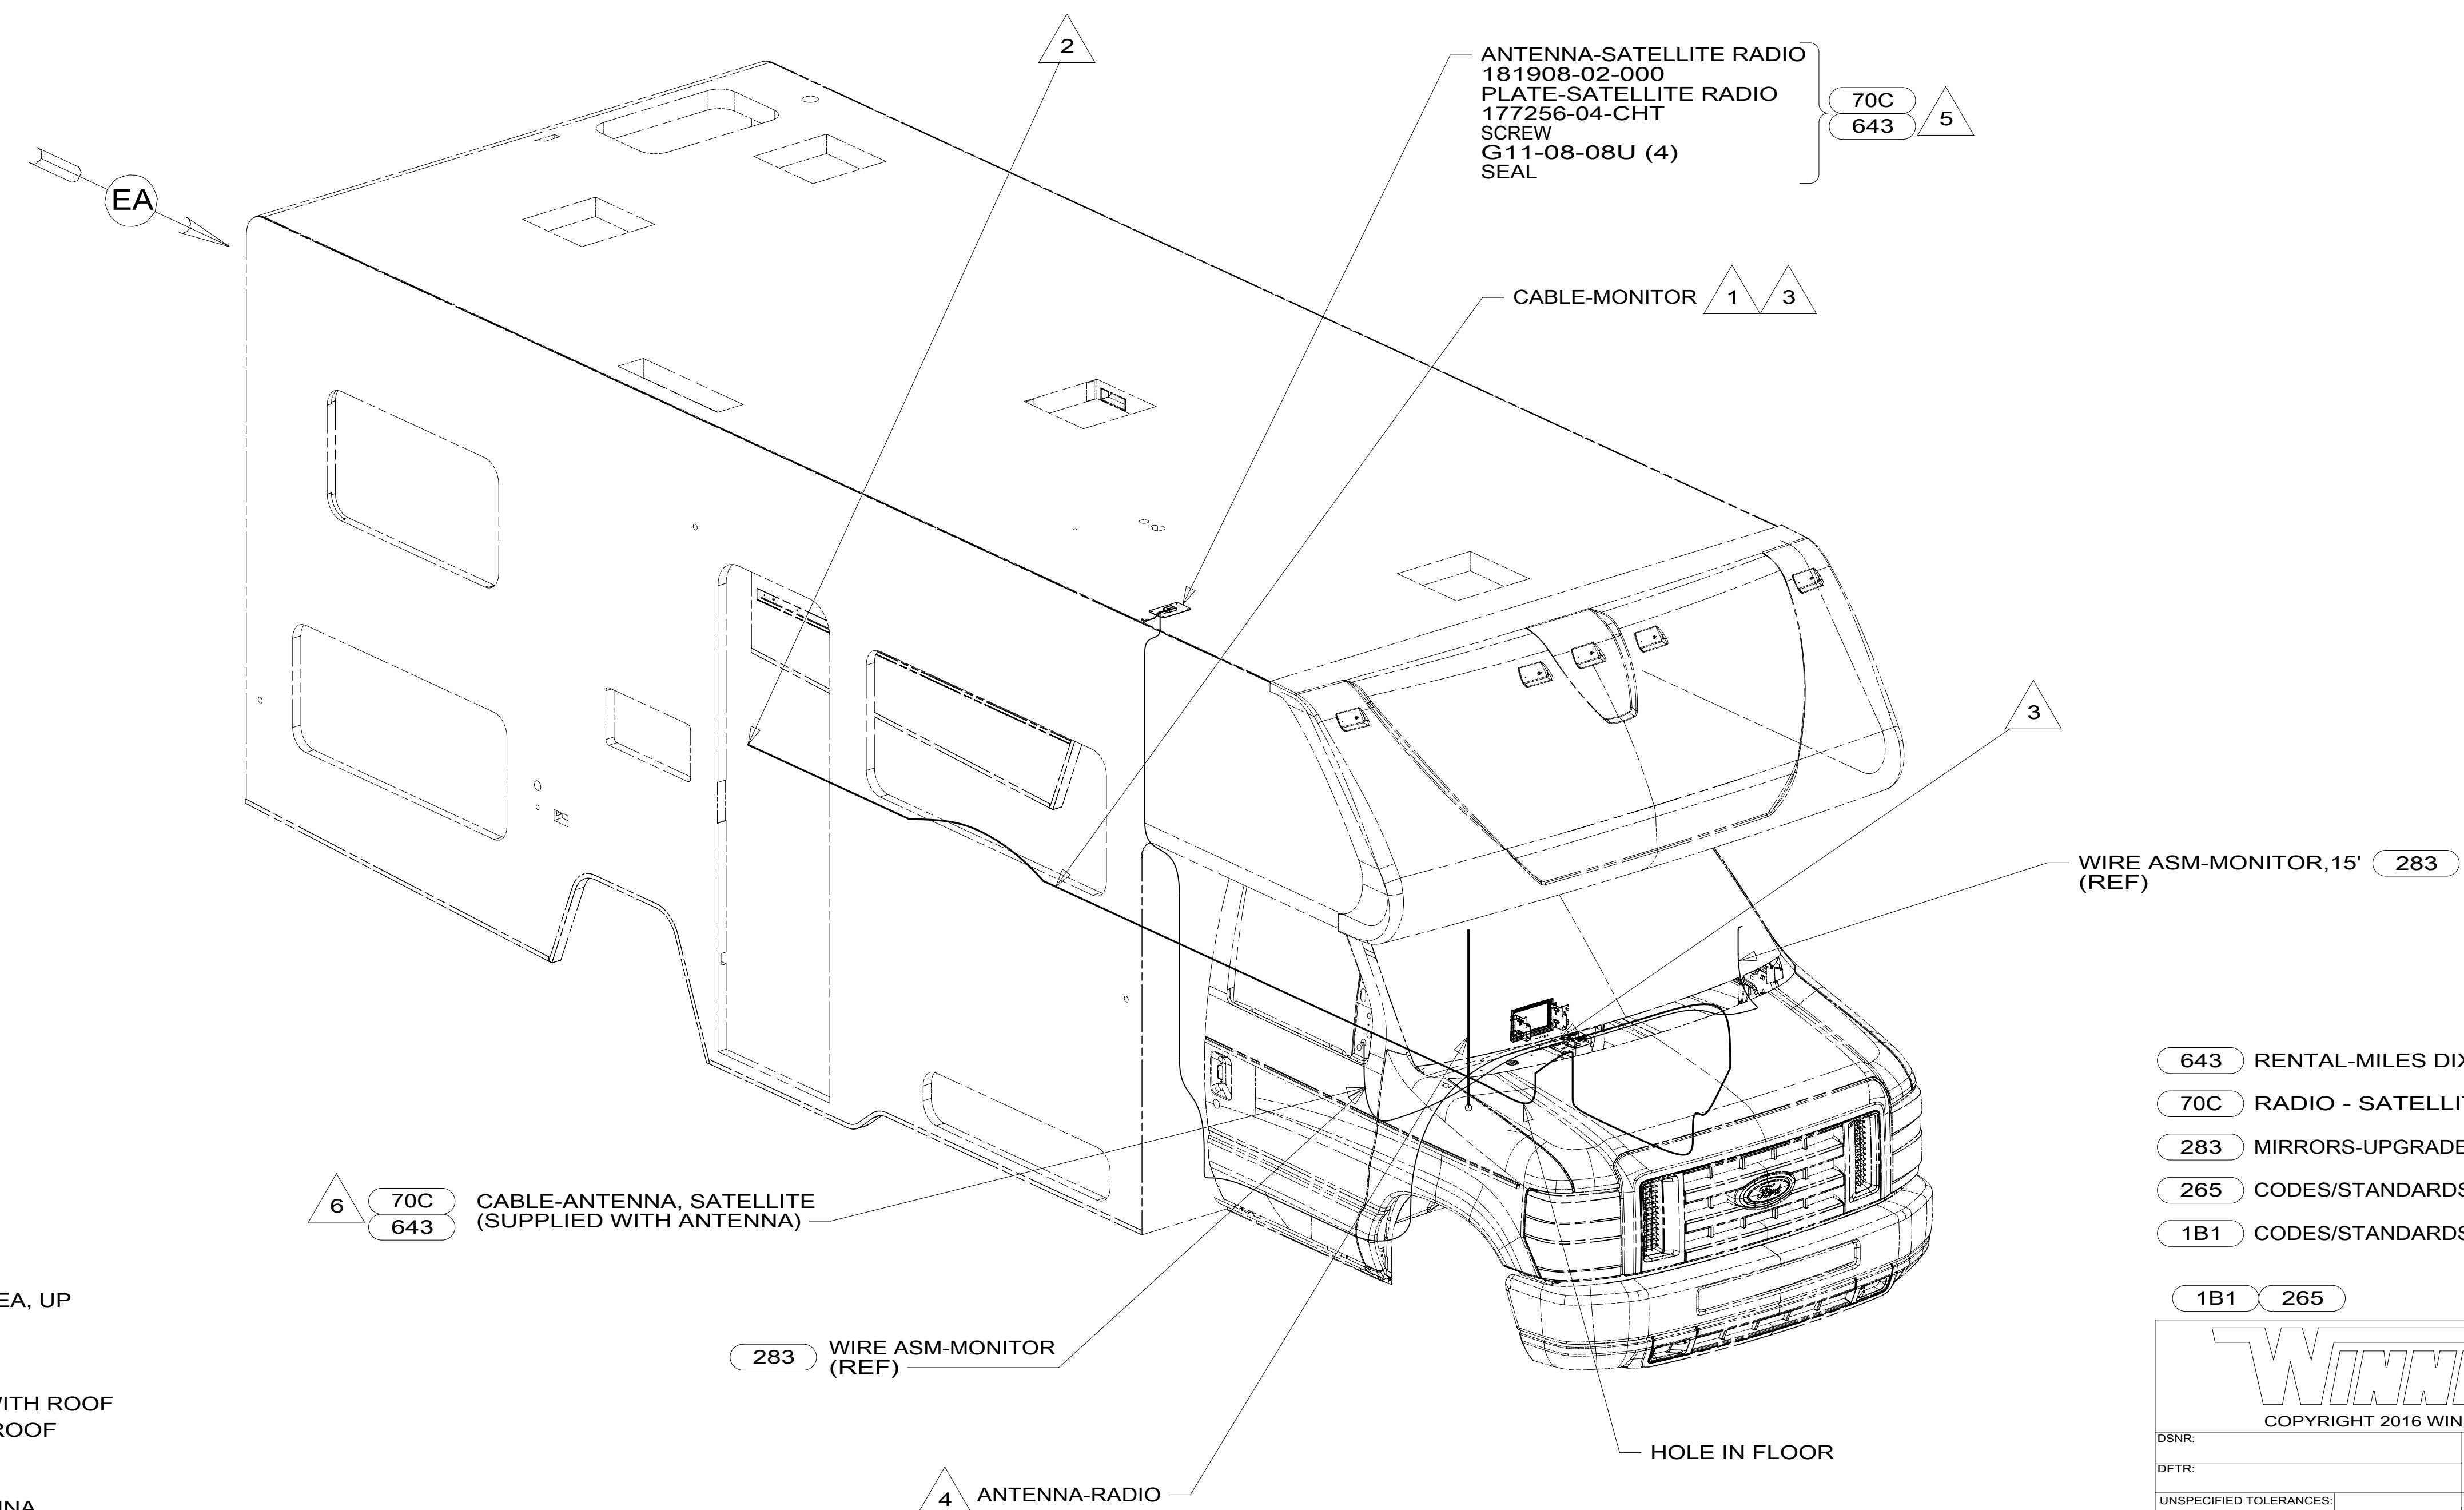
- 6 ROUTE CABLE FROM RADIO TO PASSENGER'S STEPWELL AREA, UP WINGWALL, THROUGH SLEEPER BOARD ASM, UNDER TRIM TO ANTENNA PLATE ON ROOF.
- 5 MOUNT ANTENNA AND PLATE SUCH THAT BASE IS SQUARE WITH ROOF AND DIRECTLY OVER HOLE IN ROOF. SEAL BOTH HOLE IN ROOF AND ANTENNA BASE AT SCREWS.
- 4 SUPPLIED WITH CHASSIS. USE SHORTEST SUPPLIED ANTENNA.
- 3 ROUTE CABLE TO DASH RADIO.
- 2 WIRING IS ROUTED DIFFERENTLY FOR EACH UNIT FROM THIS POINT REARWARD.
- 1 REAR MONITOR CAMERA CABLE IS PART OF WIRE ASM-CHASSIS AND RUNS ALONG LEFT FRAME RAIL.

ANTENNA-SATELLITE RADIO  
181908-02-000  
PLATE-SATELLITE RADIO  
177256-04-CHT  
SCREW  
G-11-08-08U (4)  
SEAL

70C  
643 CABLE-ANTENNA, SATELLITE  
(SUPPLIED WITH ANTENNA)

4 ANTENNA-RADIO

HOLE IN FLOOR

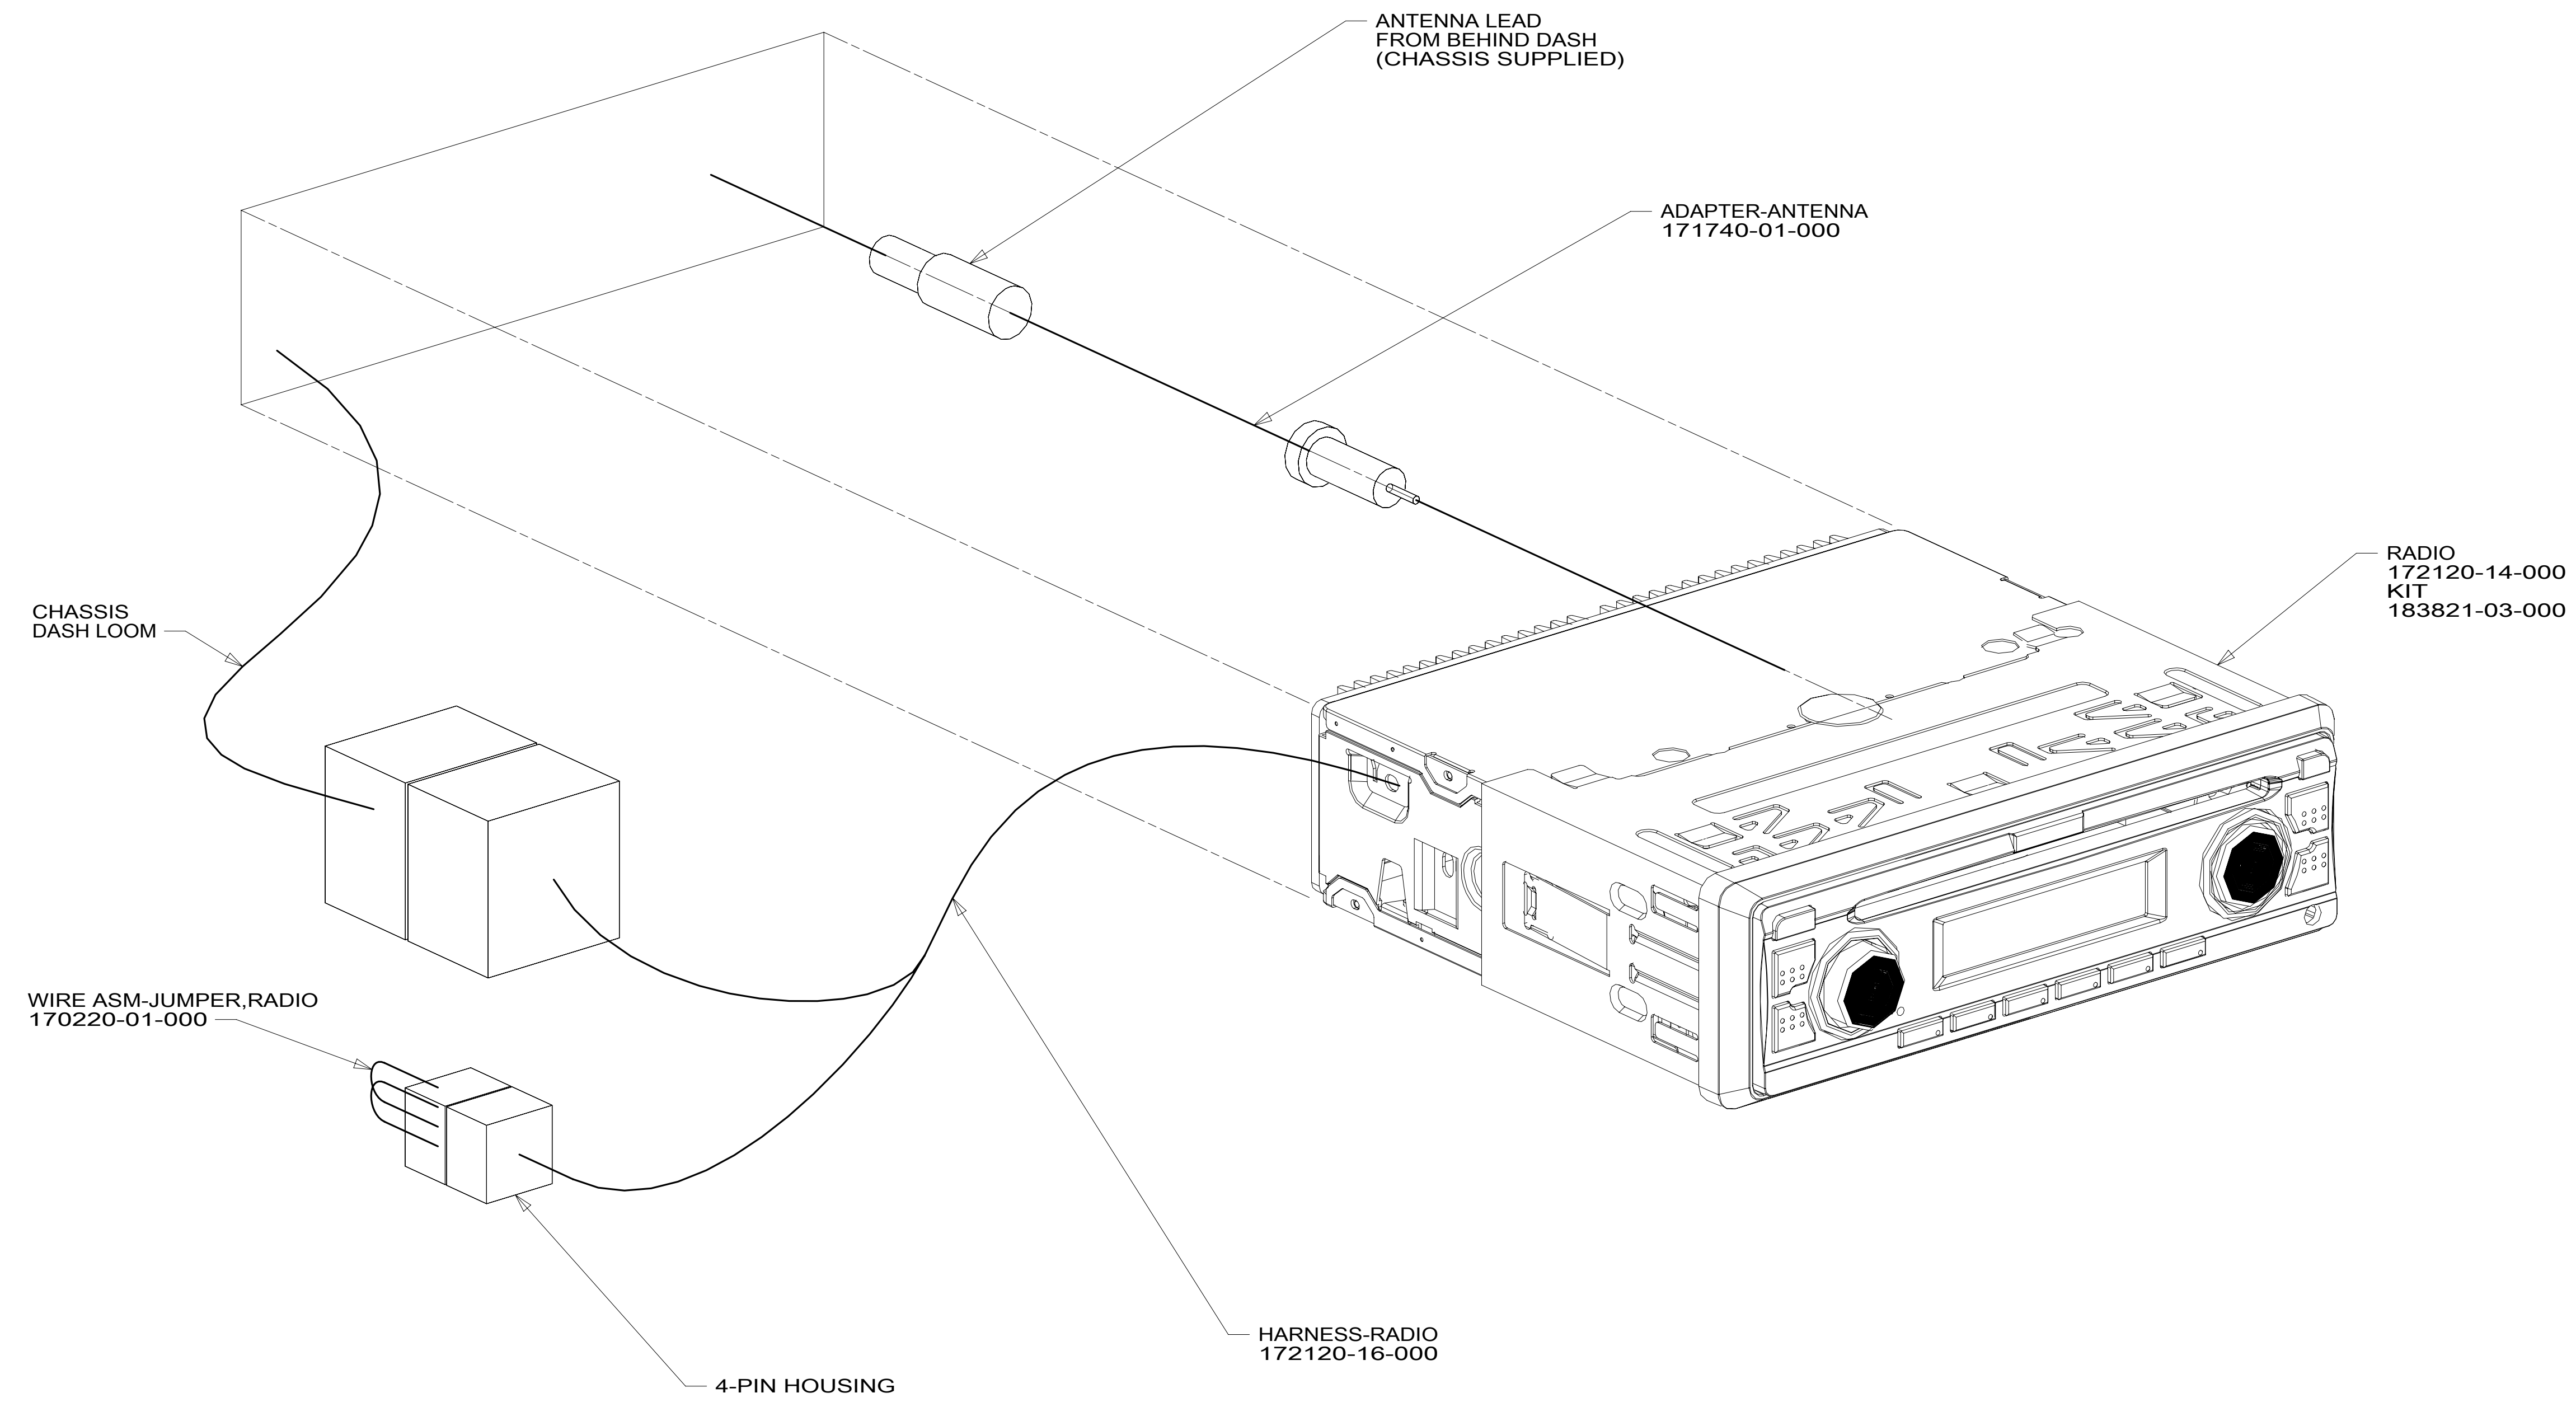
- 19V RADIO-AM/FM STEREO CD PLAYER
- 265 CODES/STANDARDS-CSA/CMVSS
- 1B1 CODES/STANDARDS USA

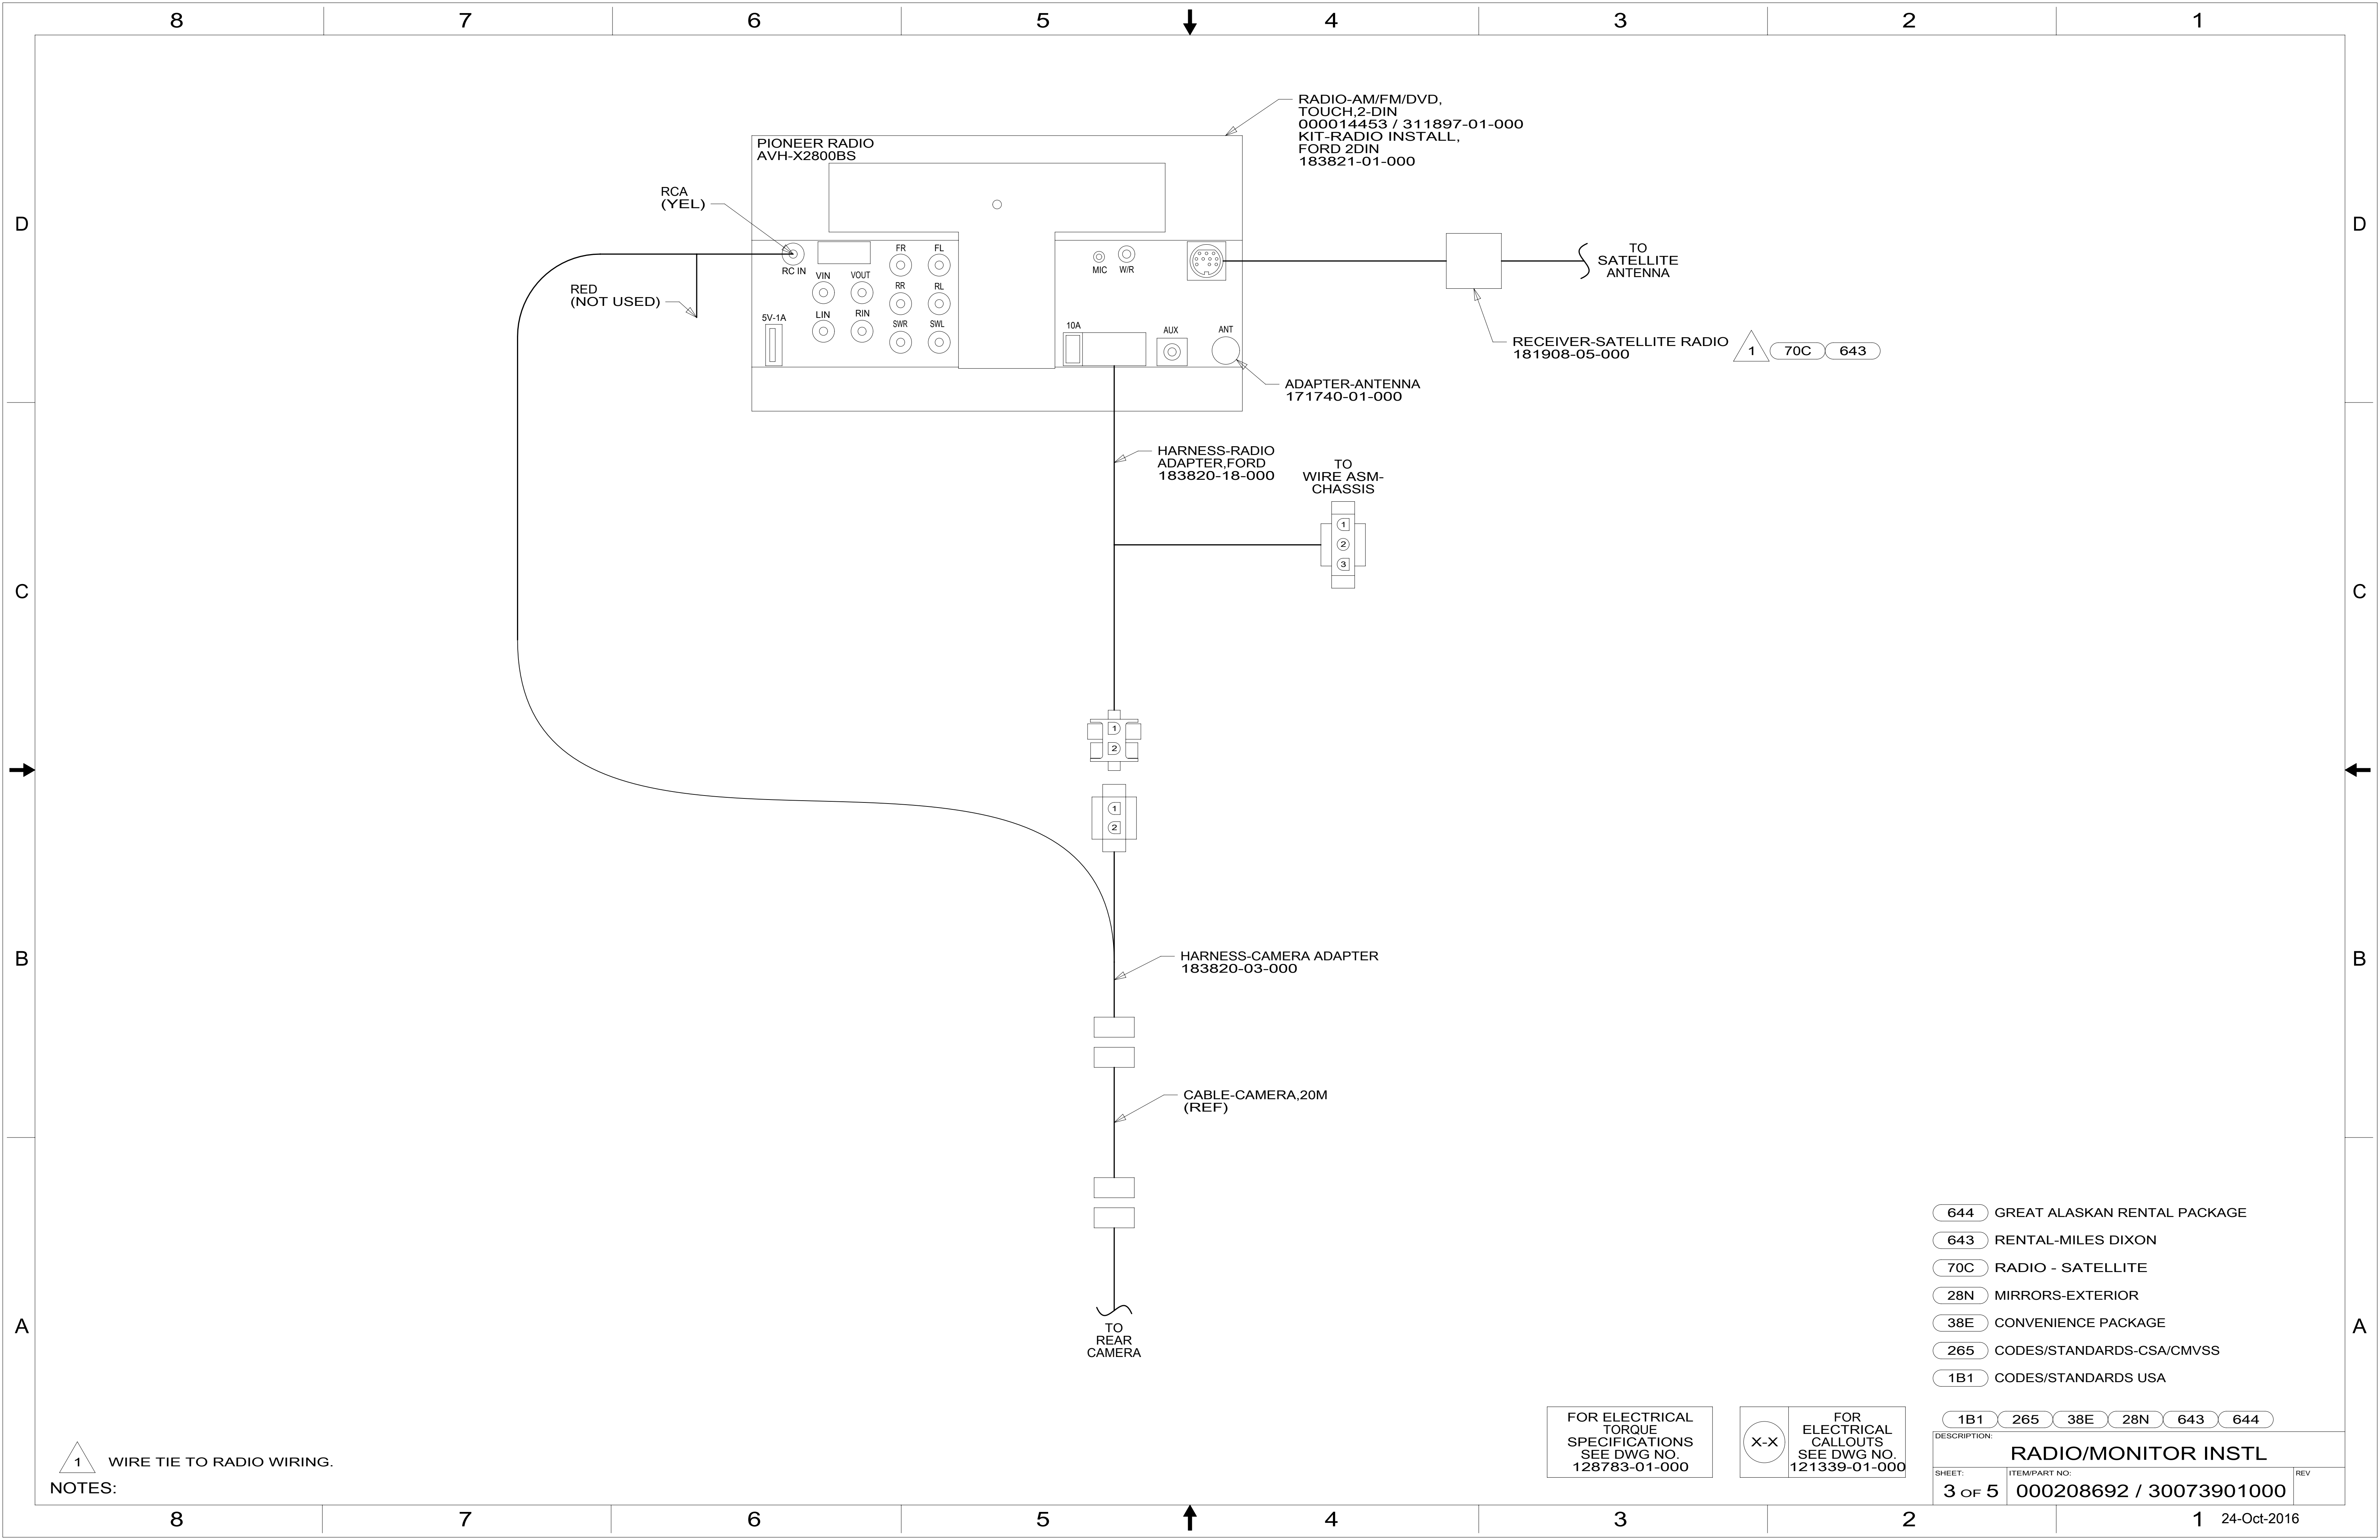
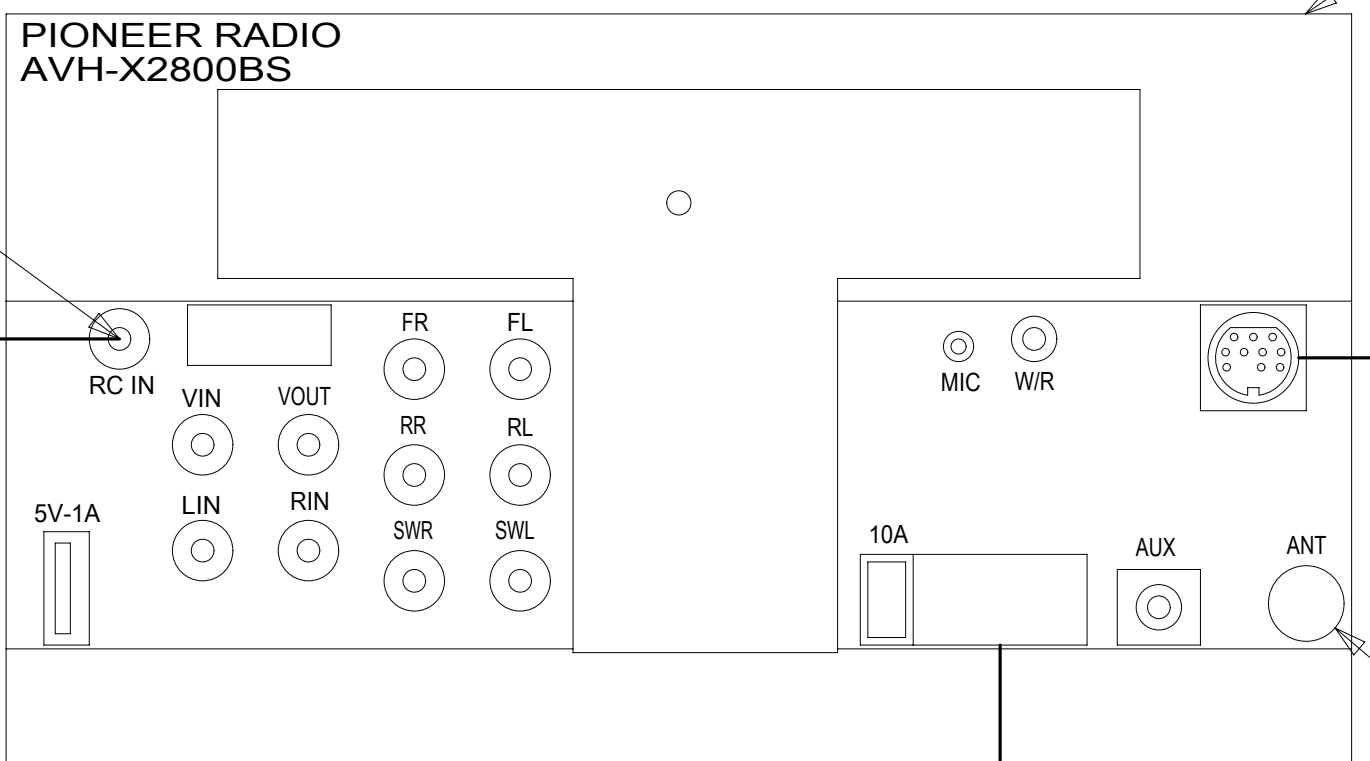
RADIO-AM/FM/DVD,  
TOUCH,2-DIN  
000014453 / 311897-01-000  
KIT-RADIO INSTALL,  
FORD 2DIN  
183821-01-000

RECEIVER-SATELLITE RADIO  
181908-05-000

ADAPTER-ANTENNA  
171740-01-000

HARNESS-RADIO  
ADAPTER,FORD  
183820-18-000

HARNESS-CAMERA ADAPTER  
183820-03-000

NOTES:  
1 WIRE TIE TO RADIO WIRING.

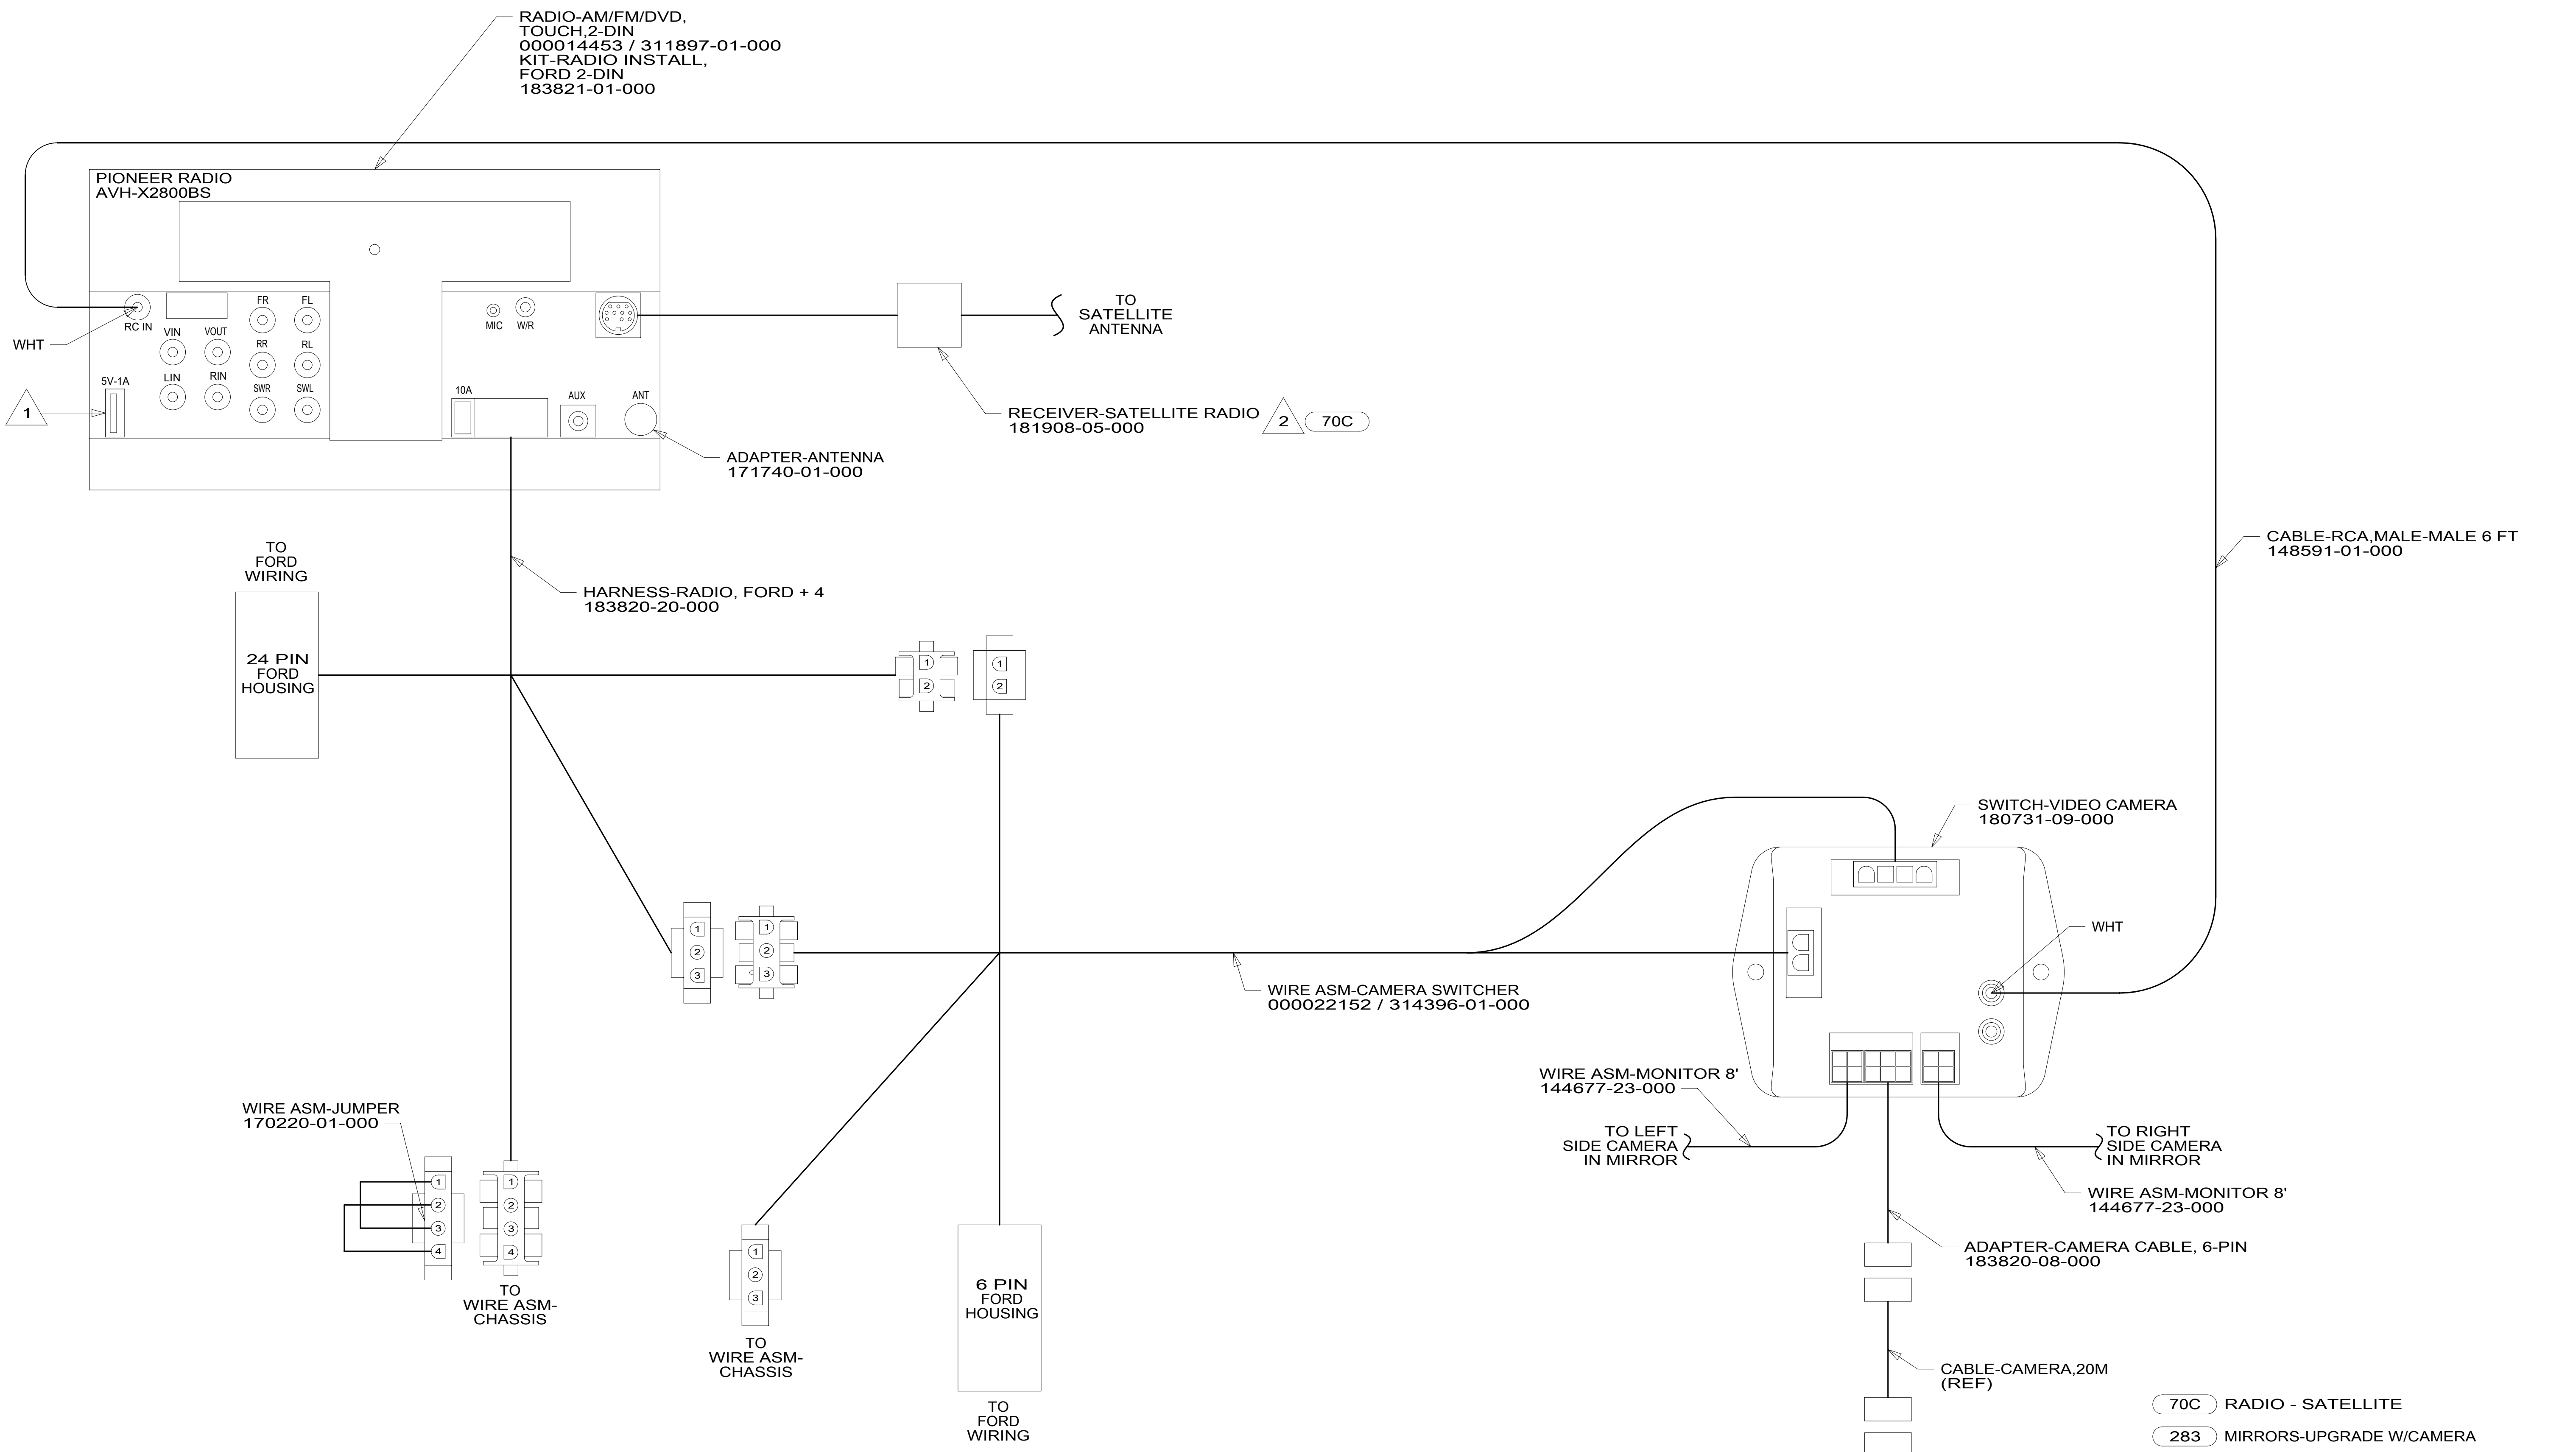
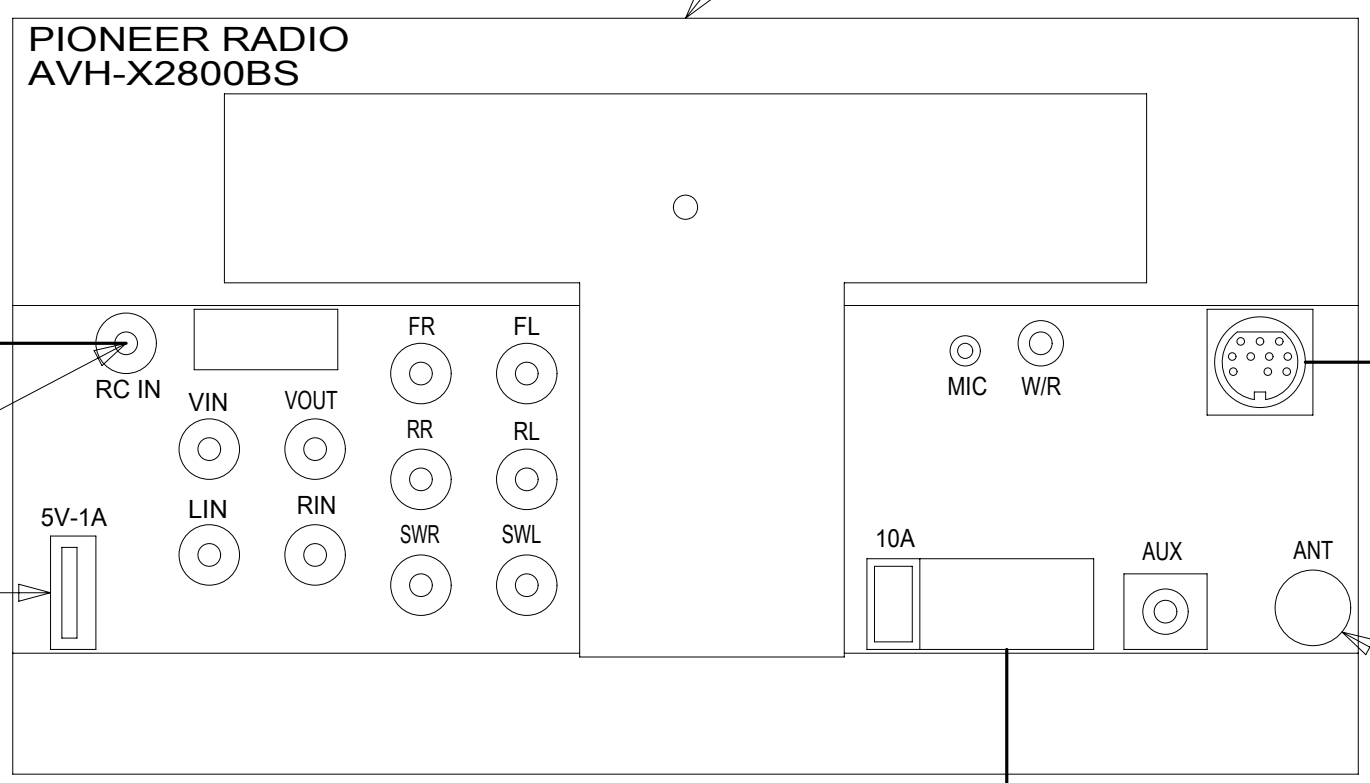
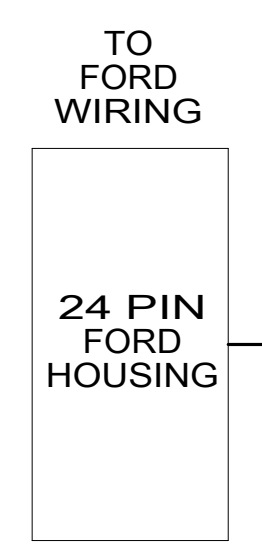
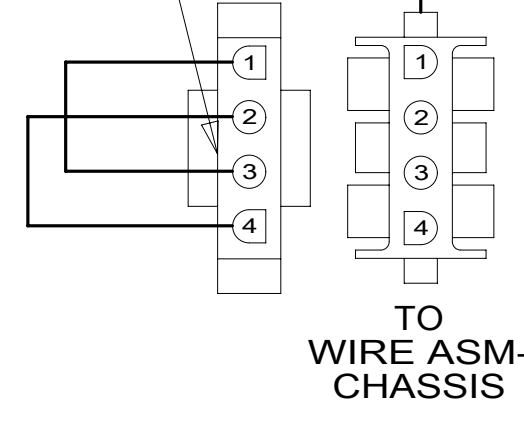
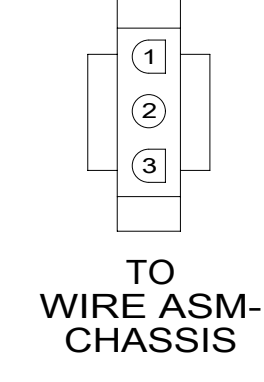
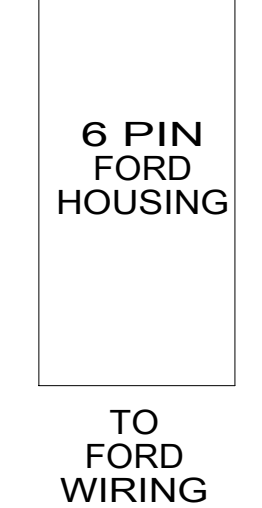
DESCRIPTION: <b>RADIO/MONITOR INSTL</b>		
SHEET: 4 OF 5	ITEM/PART NO: 000208692 / 30073901000	REV

RADIO-AM/FM/DVD,  
TOUCH,2-DIN  
000014453 / 311897-01-000  
KIT-RADIO INSTALL,  
FORD 2-DIN  
183821-01-000

WIRE ASM-JUMPER  
170220-01-000

WIRE ASM-MONITOR 8'  
144677-23-000

ADAPTER-CAMERA CABLE, 6-PIN  
183820-08-000

2 WIRE TIE TO RADIO WIRING.

1 PLUG USB CABLE SUPPLIED WITH RADIO INTO LEAD ON BACK OF RADIO MARKED 'USB'. ROUTE CABLE TO THE LEFT OF RADIO. WIRE TIE EXCESS CABLE UNDER DASH IN THE AREA LEFT OF THE RADIO. LEAVE 200 MM OF CABLE IN THE MOTOR COVER BEVERAGE TRAY. MAKE SURE CABLE DOES NOT GET PINCHED BY MOTOR COVER.
