DESCRIPTION: <b>RADIO/MONITOR INSTL</b>		
SHEET: 1 OF 5	ITEM/PART NO: 000208692 / 30073901000	REV:
REF:		1 24-Oct-2016

DESCRIPTION:	1B1 265 19V	
<b>RADIO/MONITOR INSTL</b>		
SHEET:	ITEM/PART NO:	REV
2 OF 5	000208692 / 30073901000

DESCRIPTION: <b>RADIO/MONITOR INSTL</b>		
SHEET: <b>3 OF 5</b>	ITEM/PART NO: <b>000208692 / 30073901000</b>	REV

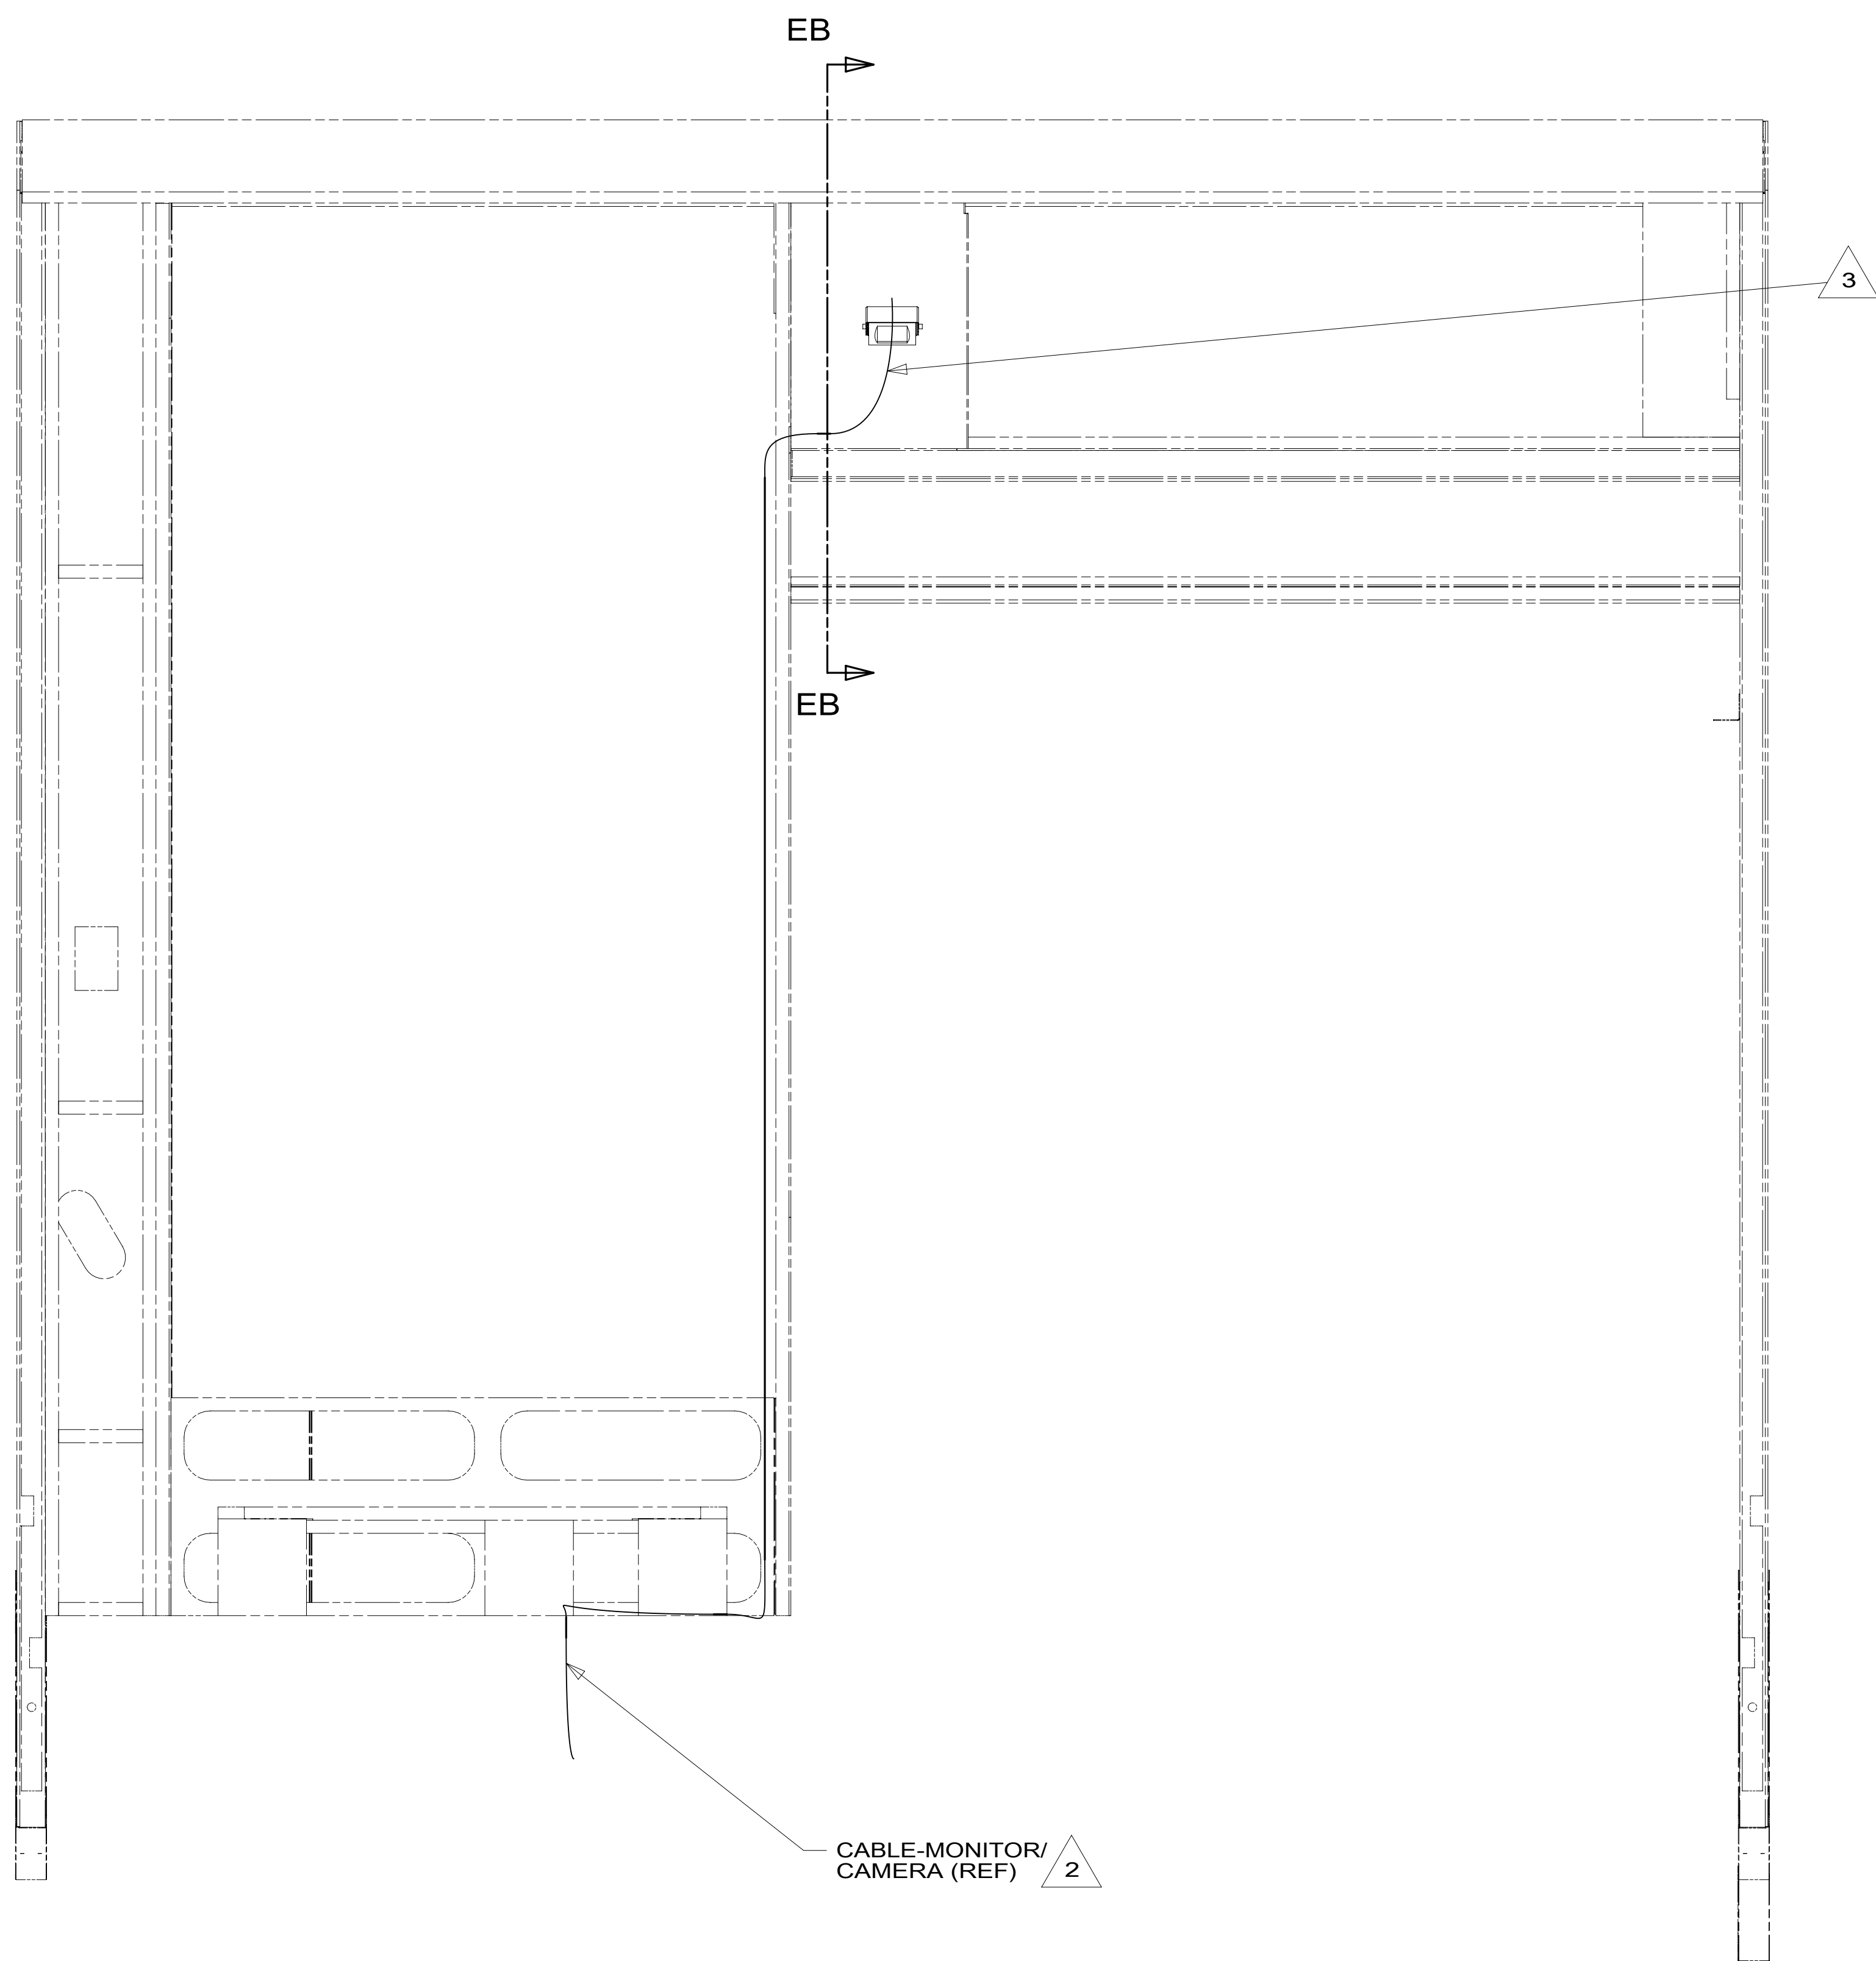
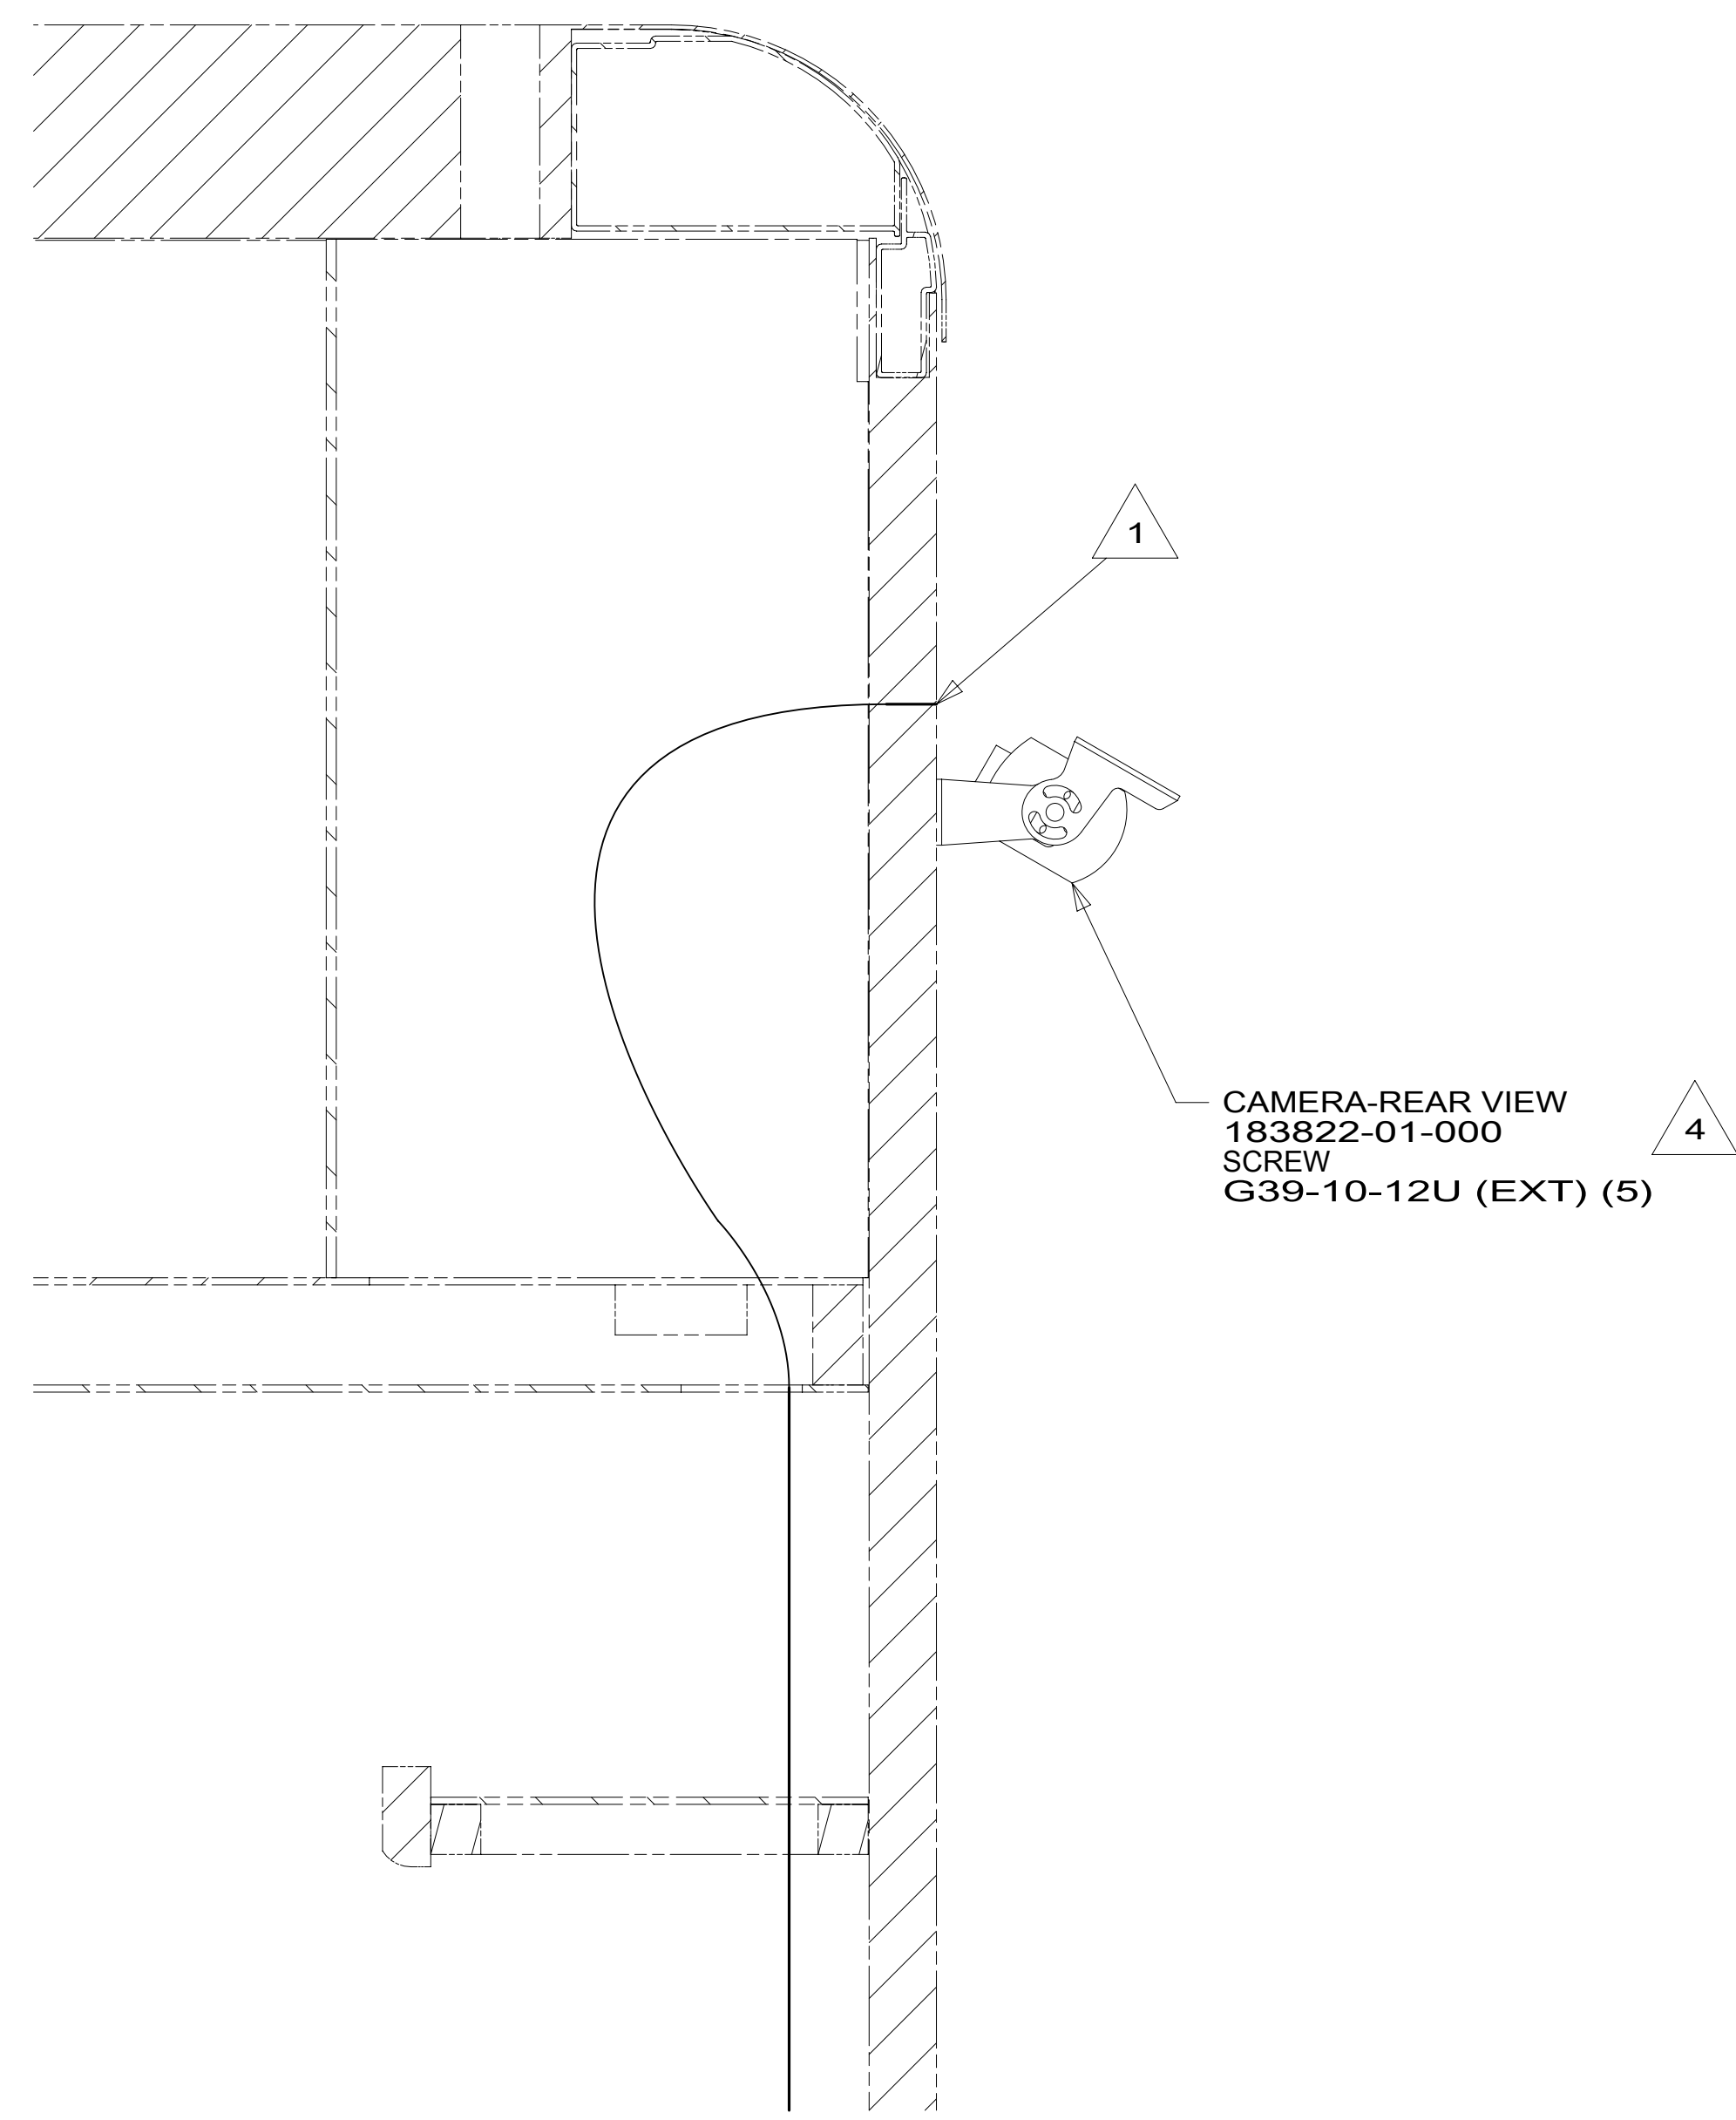
SECTION EB-EB 38E 643

- NOTES:
- 4 ADJUST CAMERA AFTER MOUNTING SO BACKWALL IS JUST VISIBLE ON BOTTOM OF THE SCREEN.
  - 3 LEAVE CAMERA CABLE IN BOTTOM OF OVHD CABT WITHOUT 38E
  - 2 REAR MONITOR CABLE IS PART OF THE WIRE ASM-CHASSIS.
  - 1 CABLE ROUTED THRU BACKWALL.
