RADIO/MONITOR INSTL

SHEET: 1 OF 5 ITEM/PART NO: 000208870 / 30074201000 REF: 1 17-Apr-2017

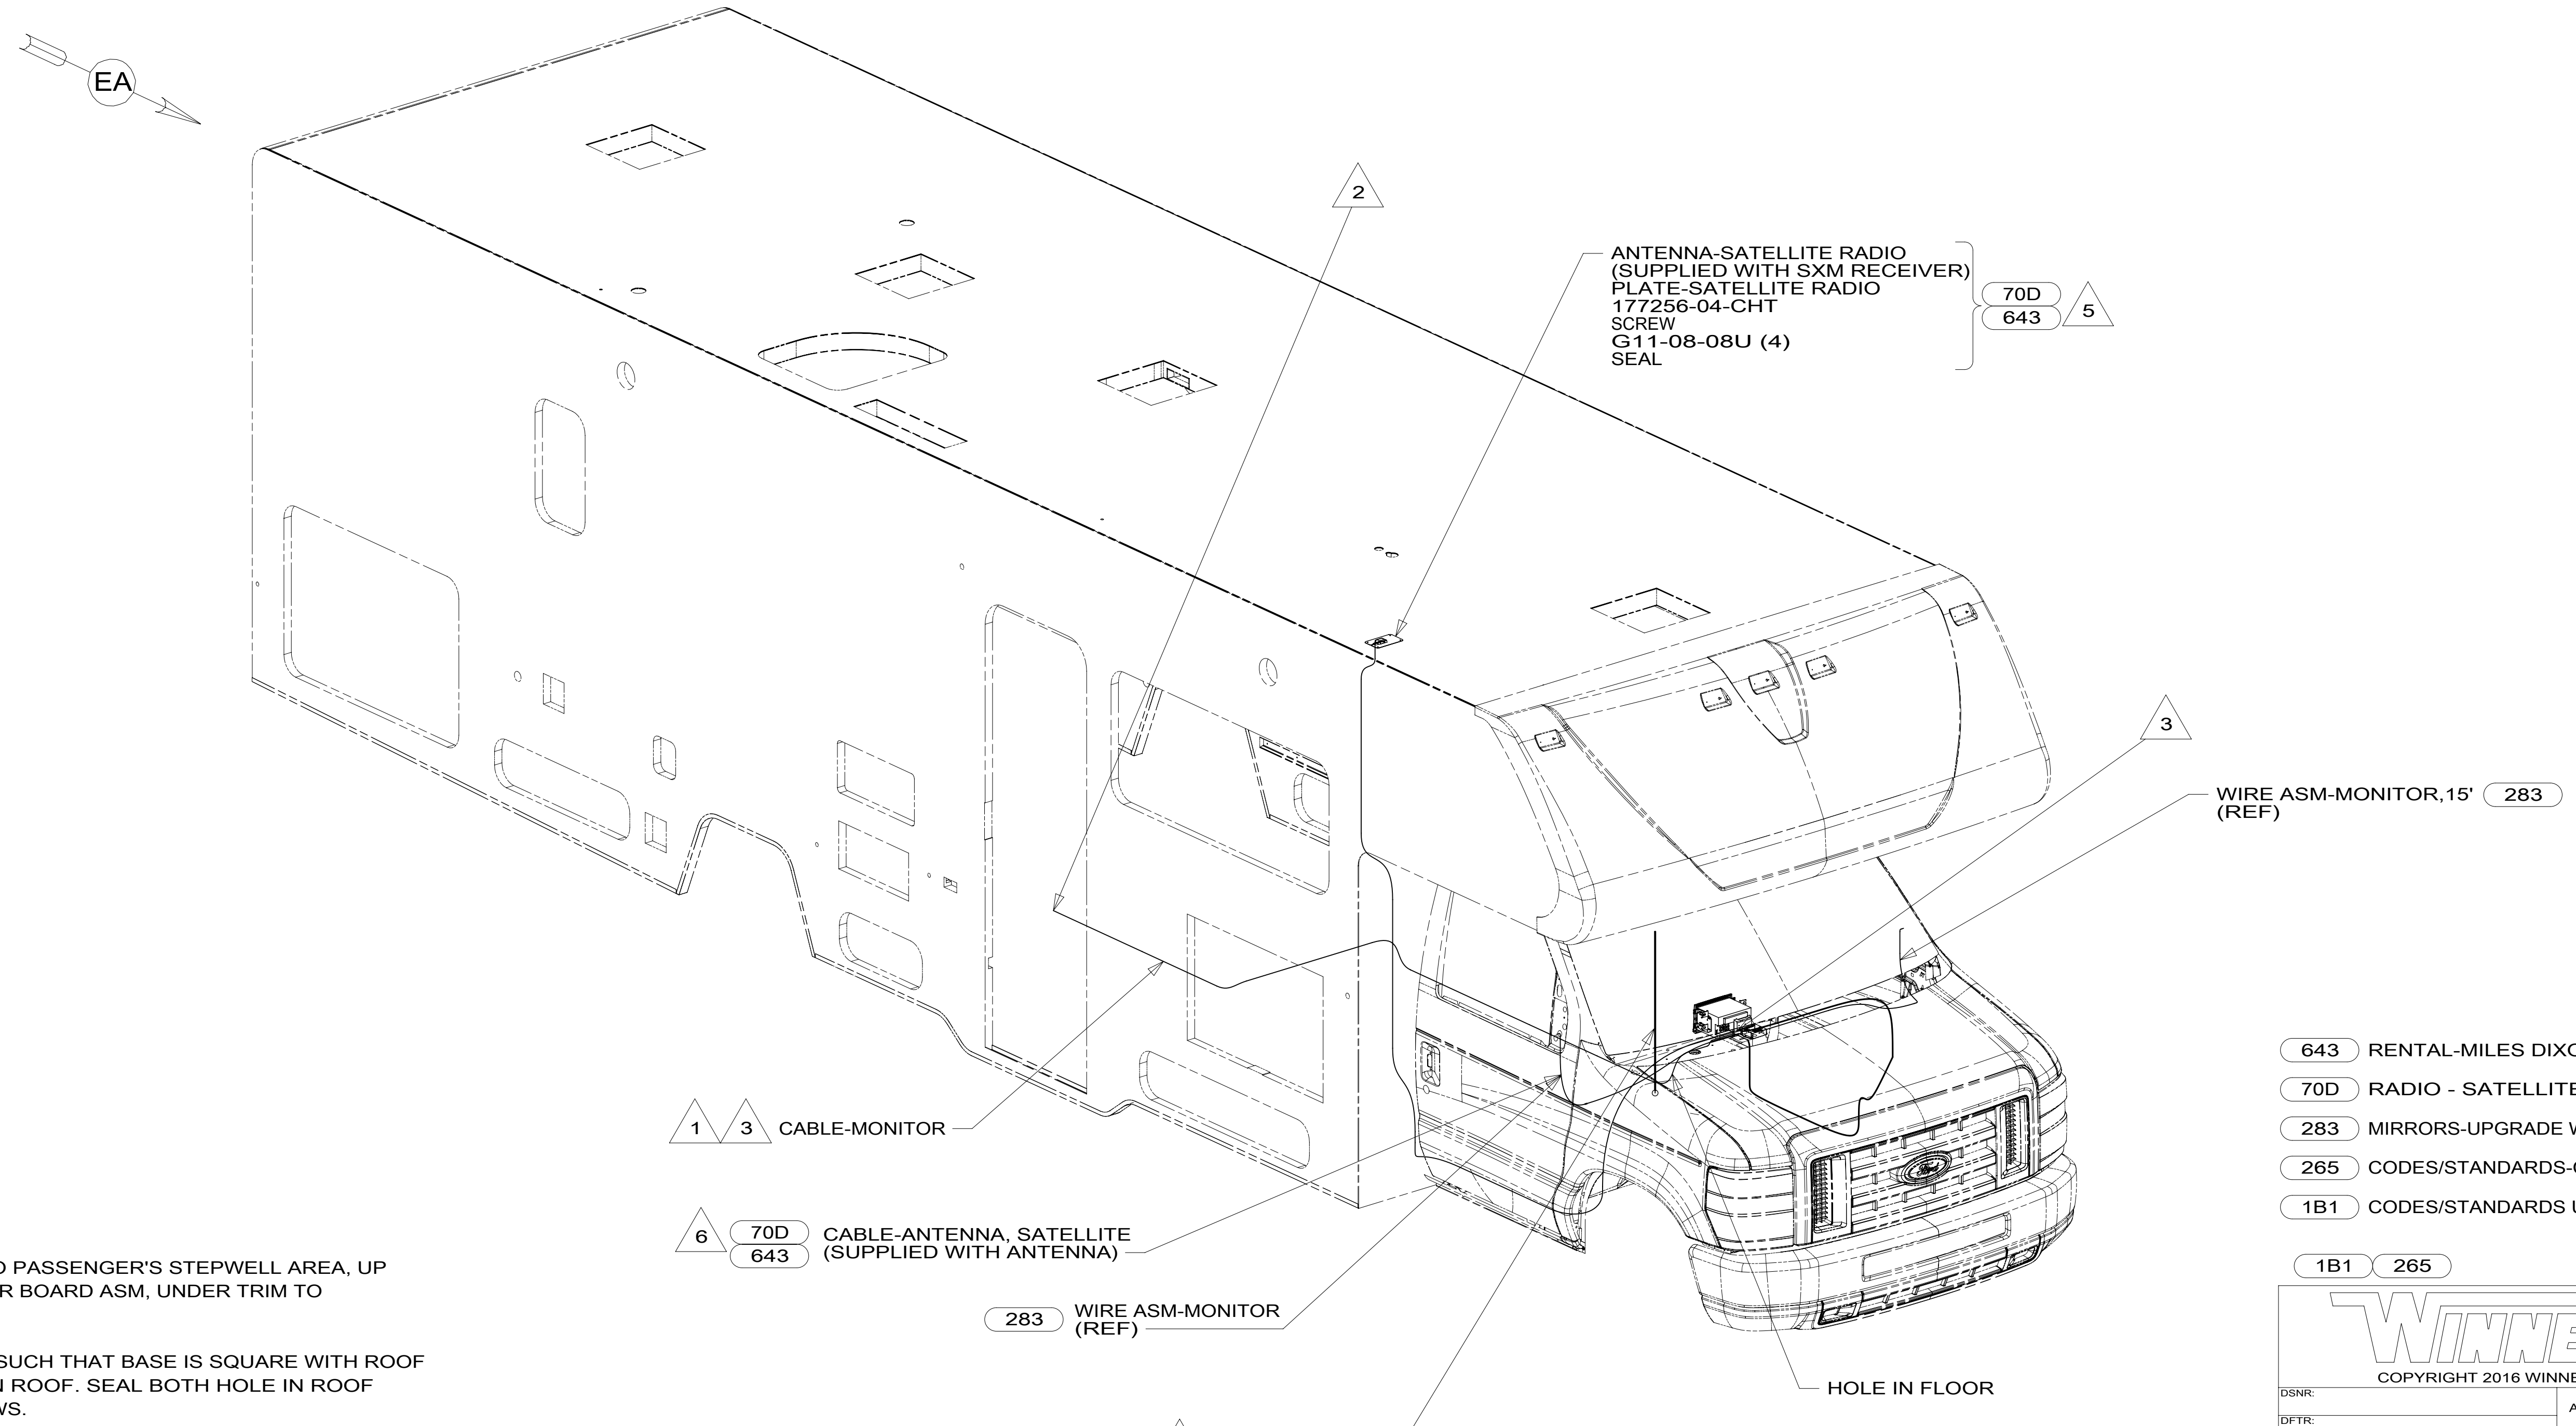
6 ROUTE CABLE FROM RADIO TO PASSENGER'S STEPWELL AREA, UP WINGWALL, THROUGH SLEEPER BOARD ASM, UNDER TRIM TO ANTENNA PLATE ON ROOF.

5 MOUNT ANTENNA AND PLATE SUCH THAT BASE IS SQUARE WITH ROOF AND DIRECTLY OVER HOLE IN ROOF. SEAL BOTH HOLE IN ROOF AND ANTENNA BASE AT SCREWS.

4 SUPPLIED WITH CHASSIS. USE SHORTEST SUPPLIED ANTENNA.

3 ROUTE CABLE TO DASH RADIO.

2 WIRING IS ROUTED DIFFERENTLY FOR EACH UNIT FROM THIS POINT REARWARD.

1 REAR MONITOR CAMERA CABLE IS PART OF WIRE ASM-CHASSIS AND RUNS ALONG LEFT FRAME RAIL.
