DESCRIPTION: RADIO/MONITOR INSTL

SHEET: 1 OF 5 ITEM/PART NO.: 000213650 / 30257801000 REV:

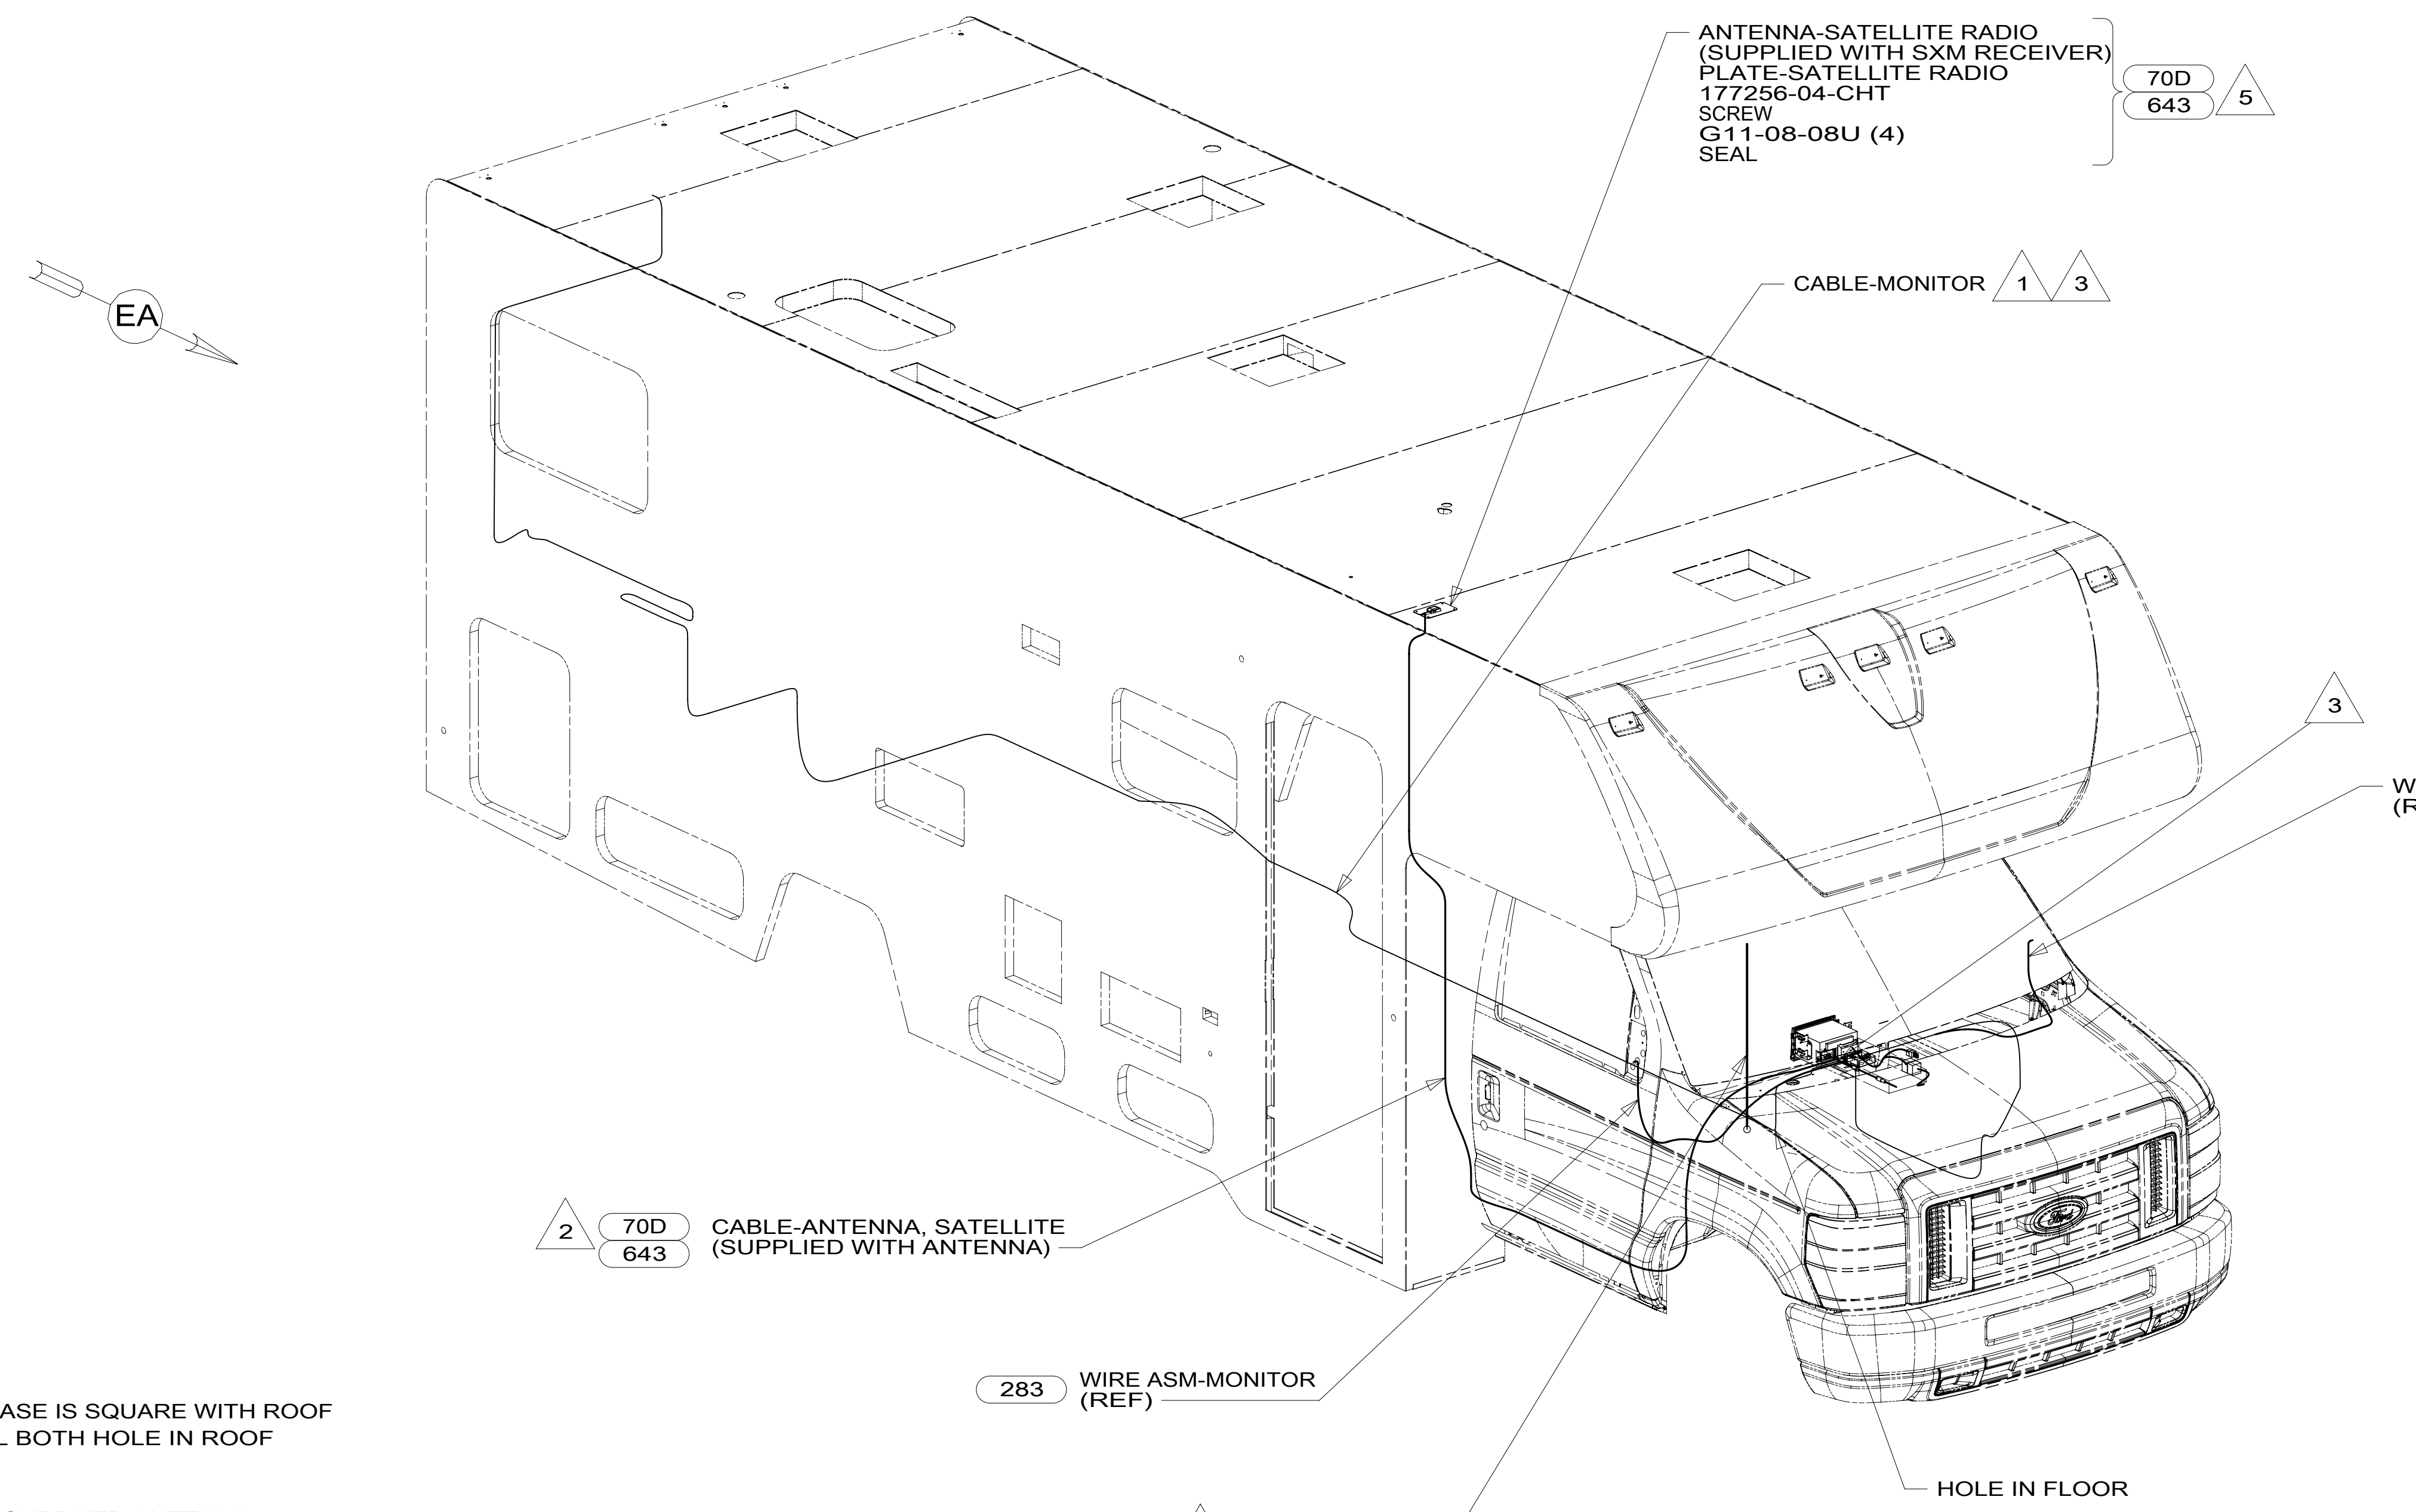
- 5 MOUNT ANTENNA AND PLATE SUCH THAT BASE IS SQUARE WITH ROOF AND DIRECTLY OVER HOLE IN ROOF. SEAL BOTH HOLE IN ROOF AND ANTENNA BASE AT SCREWS.
- 4 SUPPLIED WITH CHASSIS. USE SHORTEST SUPPLIED ANTENNA.
- 3 ROUTE CABLE TO DASH RADIO.
- 2 ROUTE CABLE FROM RADIO TO PASSENGER'S STEPWELL AREA, UP WINGWALL, THROUGH SLEEPER BOARD ASM, UNDER TRIM TO ANTENNA PLATE ON ROOF.
- 1 REAR MONITOR CAMERA CABLE IS PART OF WIRE ASM-CHASSIS AND RUNS ALONG LEFT FRAME RAIL.

ANTENNA-SATELLITE RADIO (SUPPLIED WITH SXM RECEIVER)
 PLATE-SATELLITE RADIO
 177256-04-CHT
 SCREW
 G11-08-08U (4)
 SEAL

CABLE-MONITOR

WIRE ASM-MONITOR, 15' (REF)

CABLE-ANTENNA, SATELLITE (SUPPLIED WITH ANTENNA)

WIRE ASM-MONITOR (REF)

ANTENNA-RADIO

HOLE IN FLOOR
