WINNEBAGO
COPYRIGHT 2016 WINNEBAGO INDUSTRIES, INC.

DSNR:	ALL DIMENSIONS ARE IN MILLIMETERS	
DIFTR:	MATERIAL:	
UNSPECIFIED TOLERANCES:	WEIGHT: (LBS)	FIRST USED:
WHOLE DIM (X) : 3		18 300-SER
ONE-PLACE (X.X) : 1.5		
TWO-PLACE (X.XX) : 0.50		
ANGLE : 1°		
REFER TO ES0018 FOR FASTENER TIGHTENING GUIDELINES		
DESCRIPTION:	RADIO/MONITOR INSTL	
SHEET: 1 OF 4	ITEM/PART NO: 000039215 / 31900101000	REV:
REF:		1 27-Jul-2018

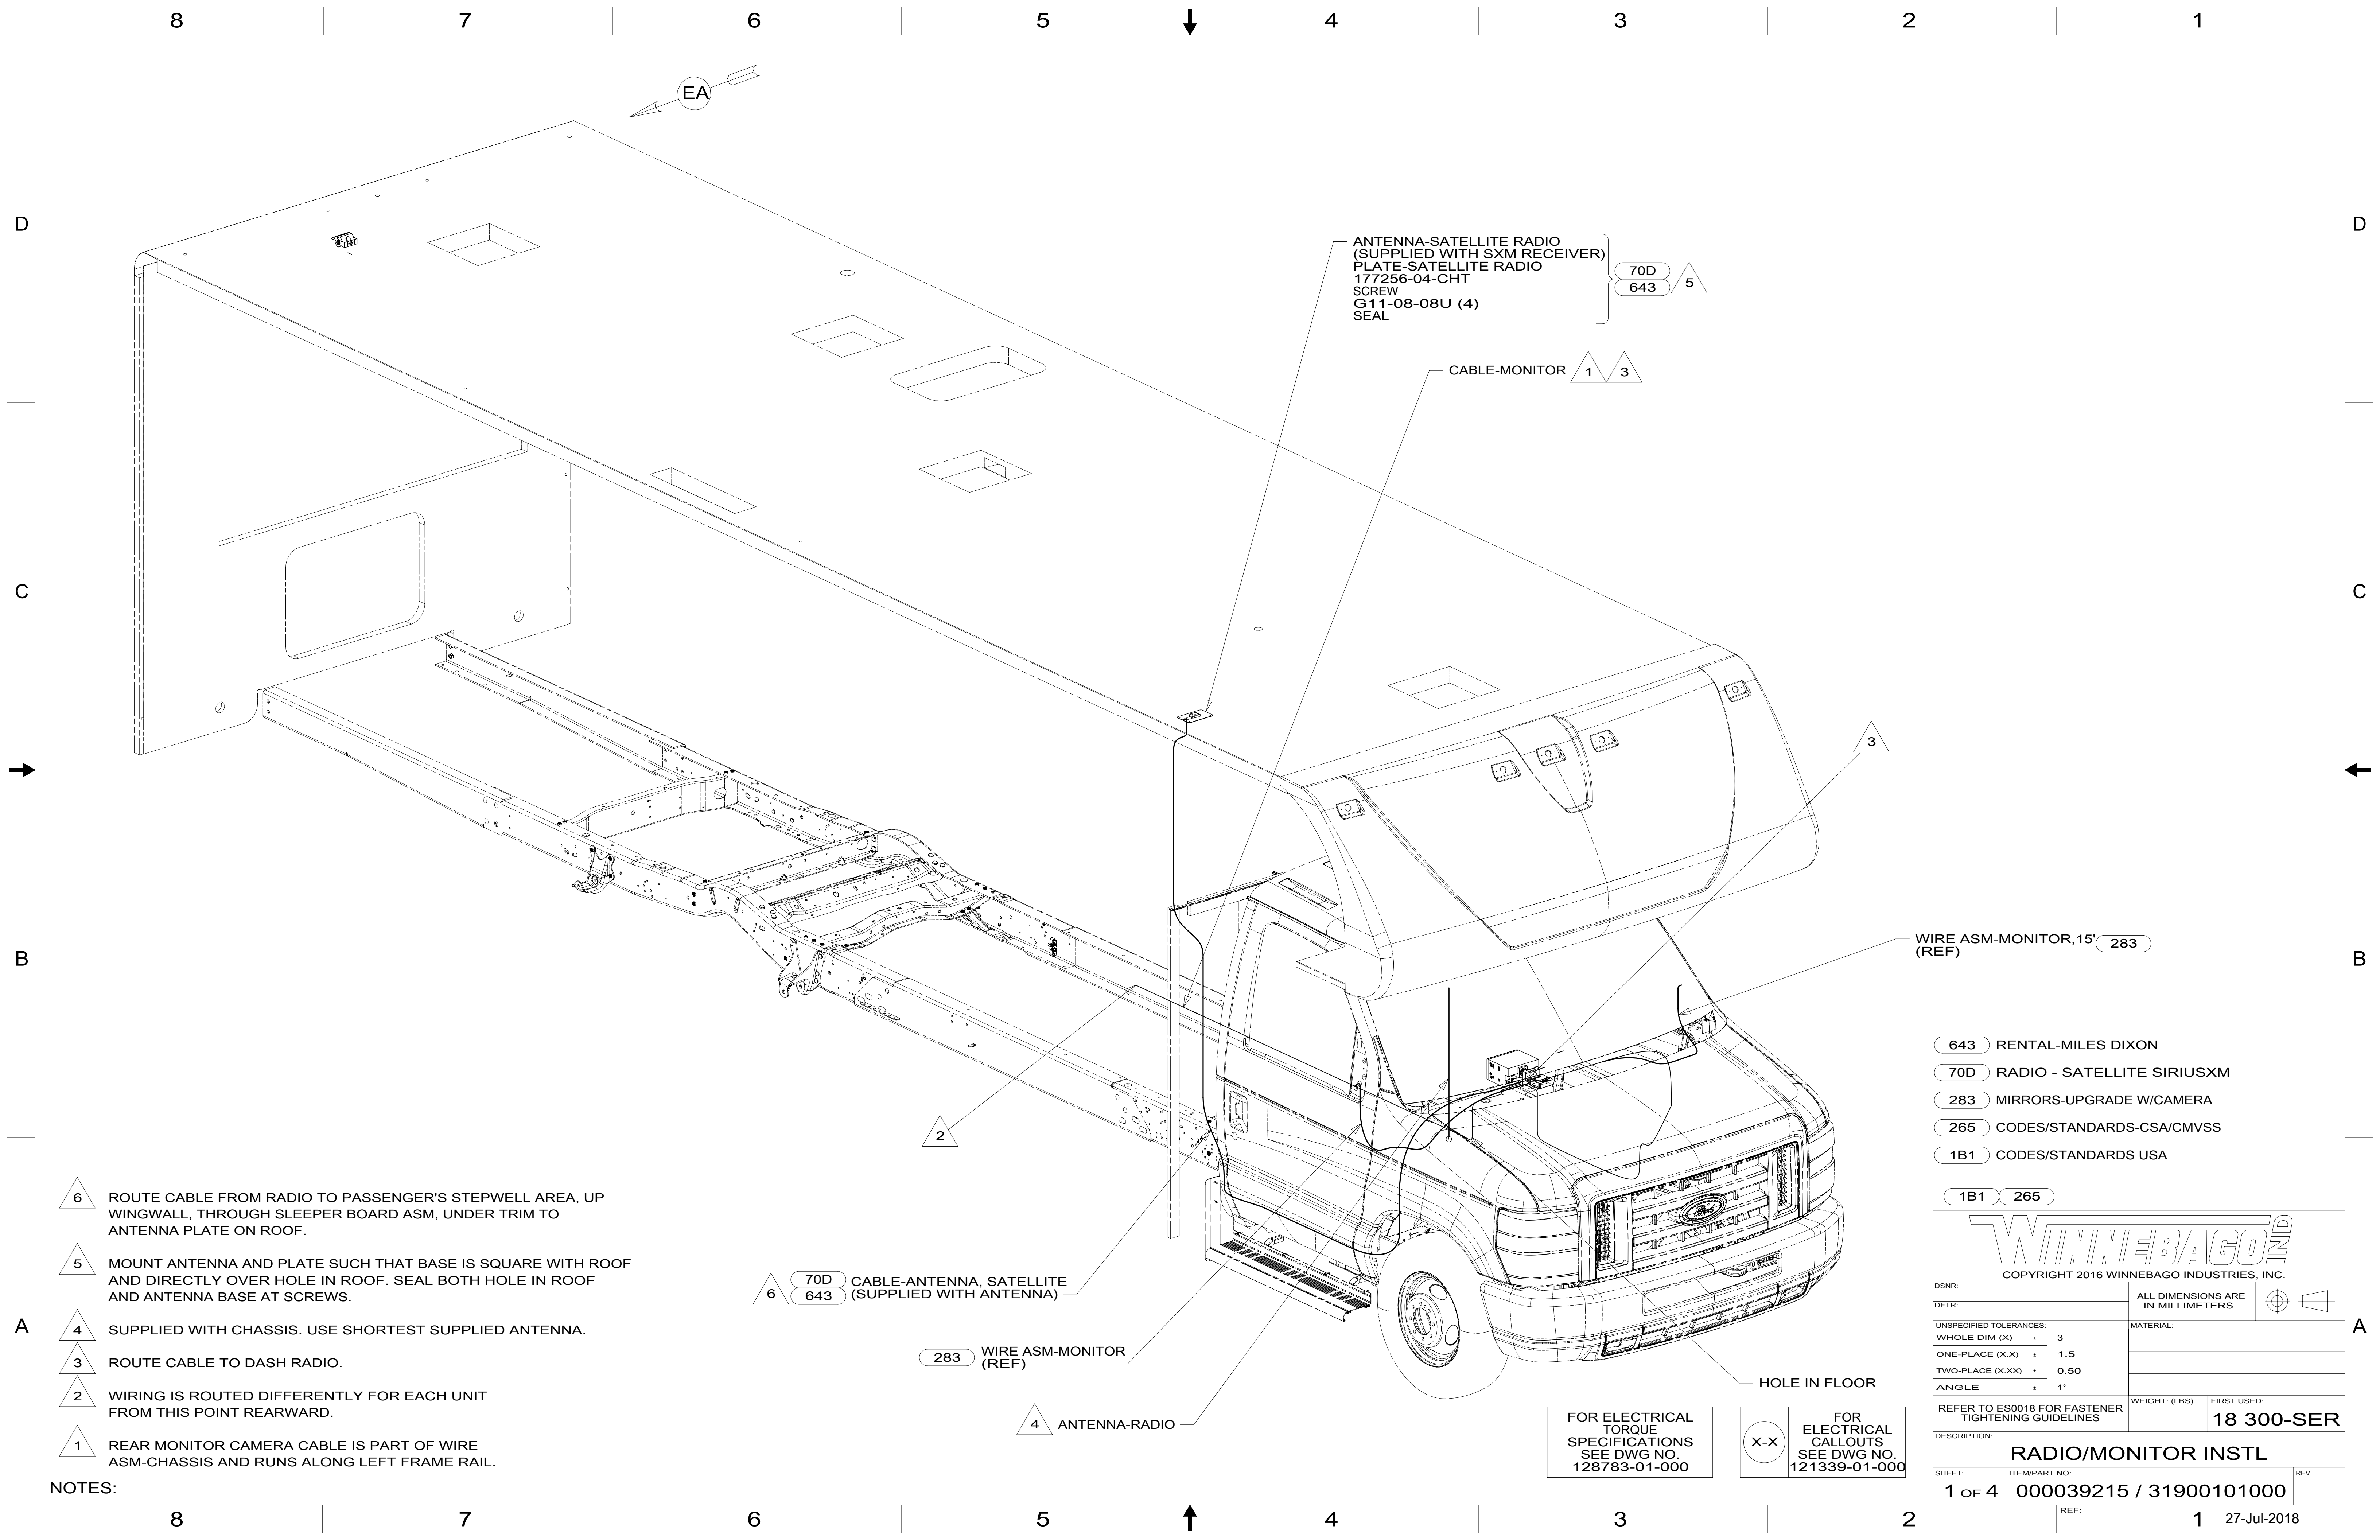
ANTENNA-SATELLITE RADIO
(SUPPLIED WITH SXM RECEIVER)
PLATE-SATELLITE RADIO
177256-04-CHT
SCREW
G11-08-08U (4)
SEAL

- NOTES:**
- 6 ROUTE CABLE FROM RADIO TO PASSENGER'S STEPWELL AREA, UP WINGWALL, THROUGH SLEEPER BOARD ASM, UNDER TRIM TO ANTENNA PLATE ON ROOF.
 - 5 MOUNT ANTENNA AND PLATE SUCH THAT BASE IS SQUARE WITH ROOF AND DIRECTLY OVER HOLE IN ROOF. SEAL BOTH HOLE IN ROOF AND ANTENNA BASE AT SCREWS.
 - 4 SUPPLIED WITH CHASSIS. USE SHORTEST SUPPLIED ANTENNA.
 - 3 ROUTE CABLE TO DASH RADIO.
 - 2 WIRING IS ROUTED DIFFERENTLY FOR EACH UNIT FROM THIS POINT REARWARD.
 - 1 REAR MONITOR CAMERA CABLE IS PART OF WIRE ASM-CHASSIS AND RUNS ALONG LEFT FRAME RAIL.

70D CABLE-ANTENNA, SATELLITE
643 (SUPPLIED WITH ANTENNA)

283 WIRE ASM-MONITOR
(REF)

4 ANTENNA-RADIO

HOLE IN FLOOR

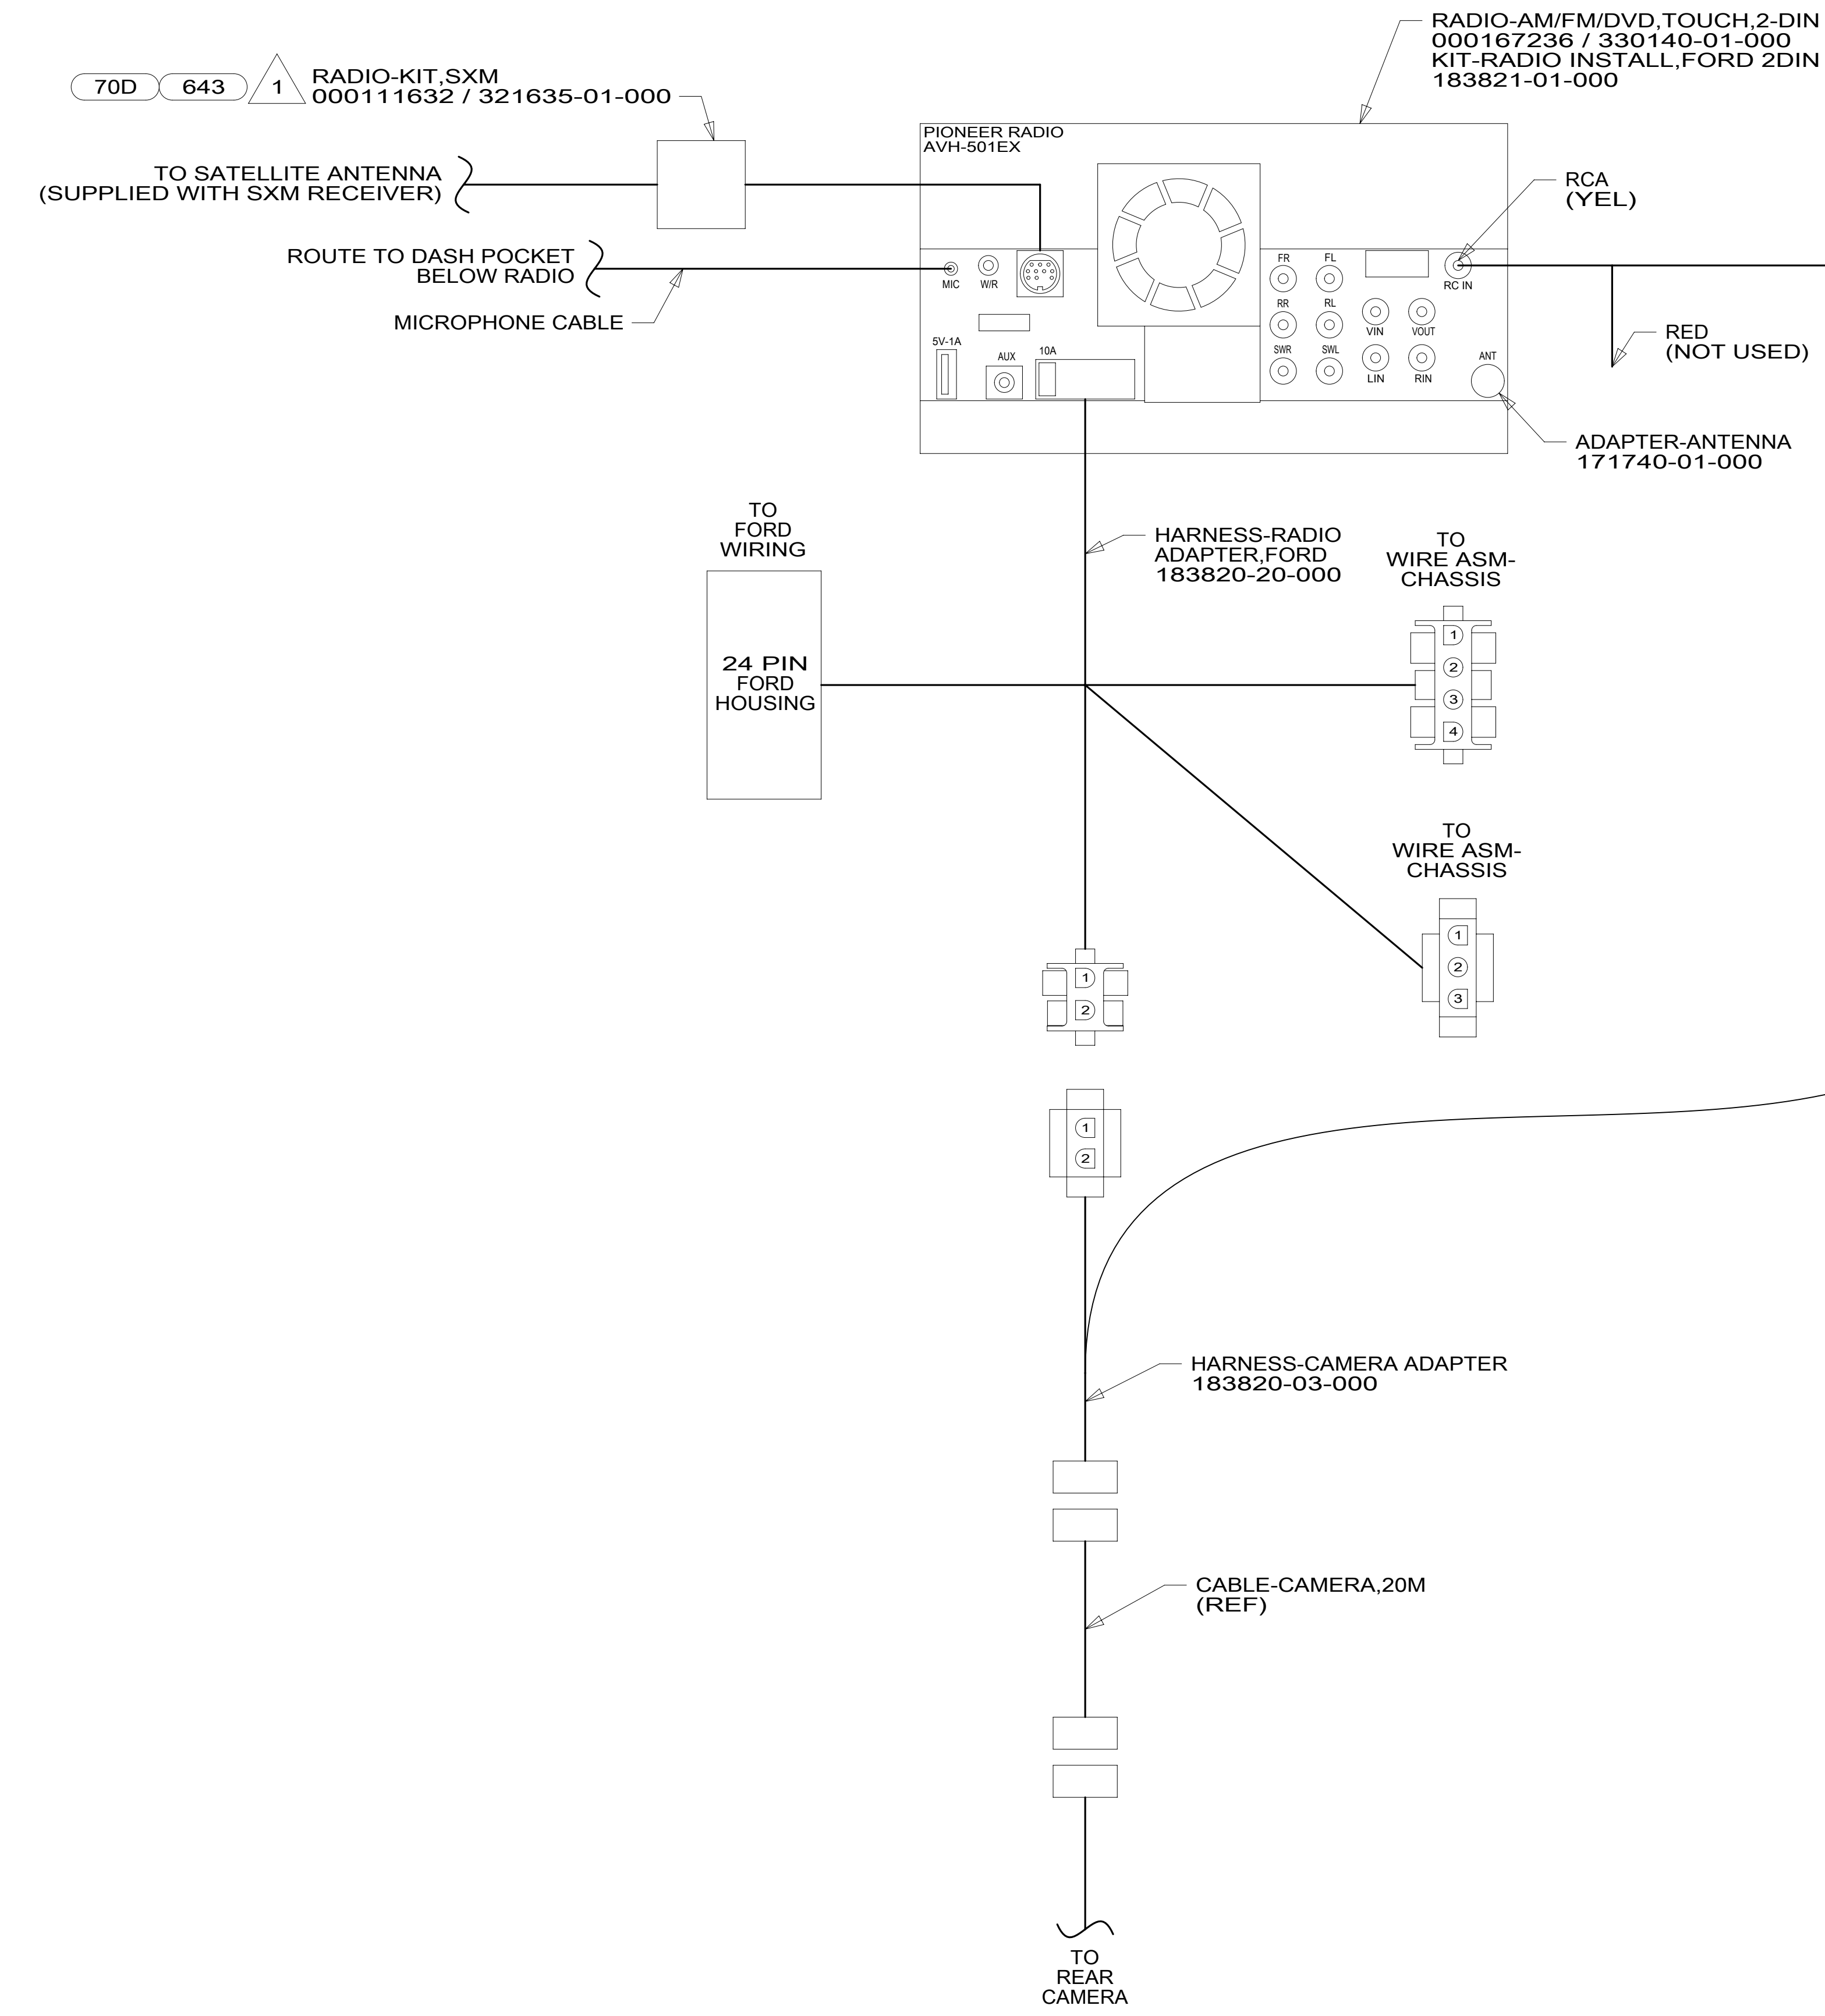
1 WIRE TIE TO RADIO WIRING.

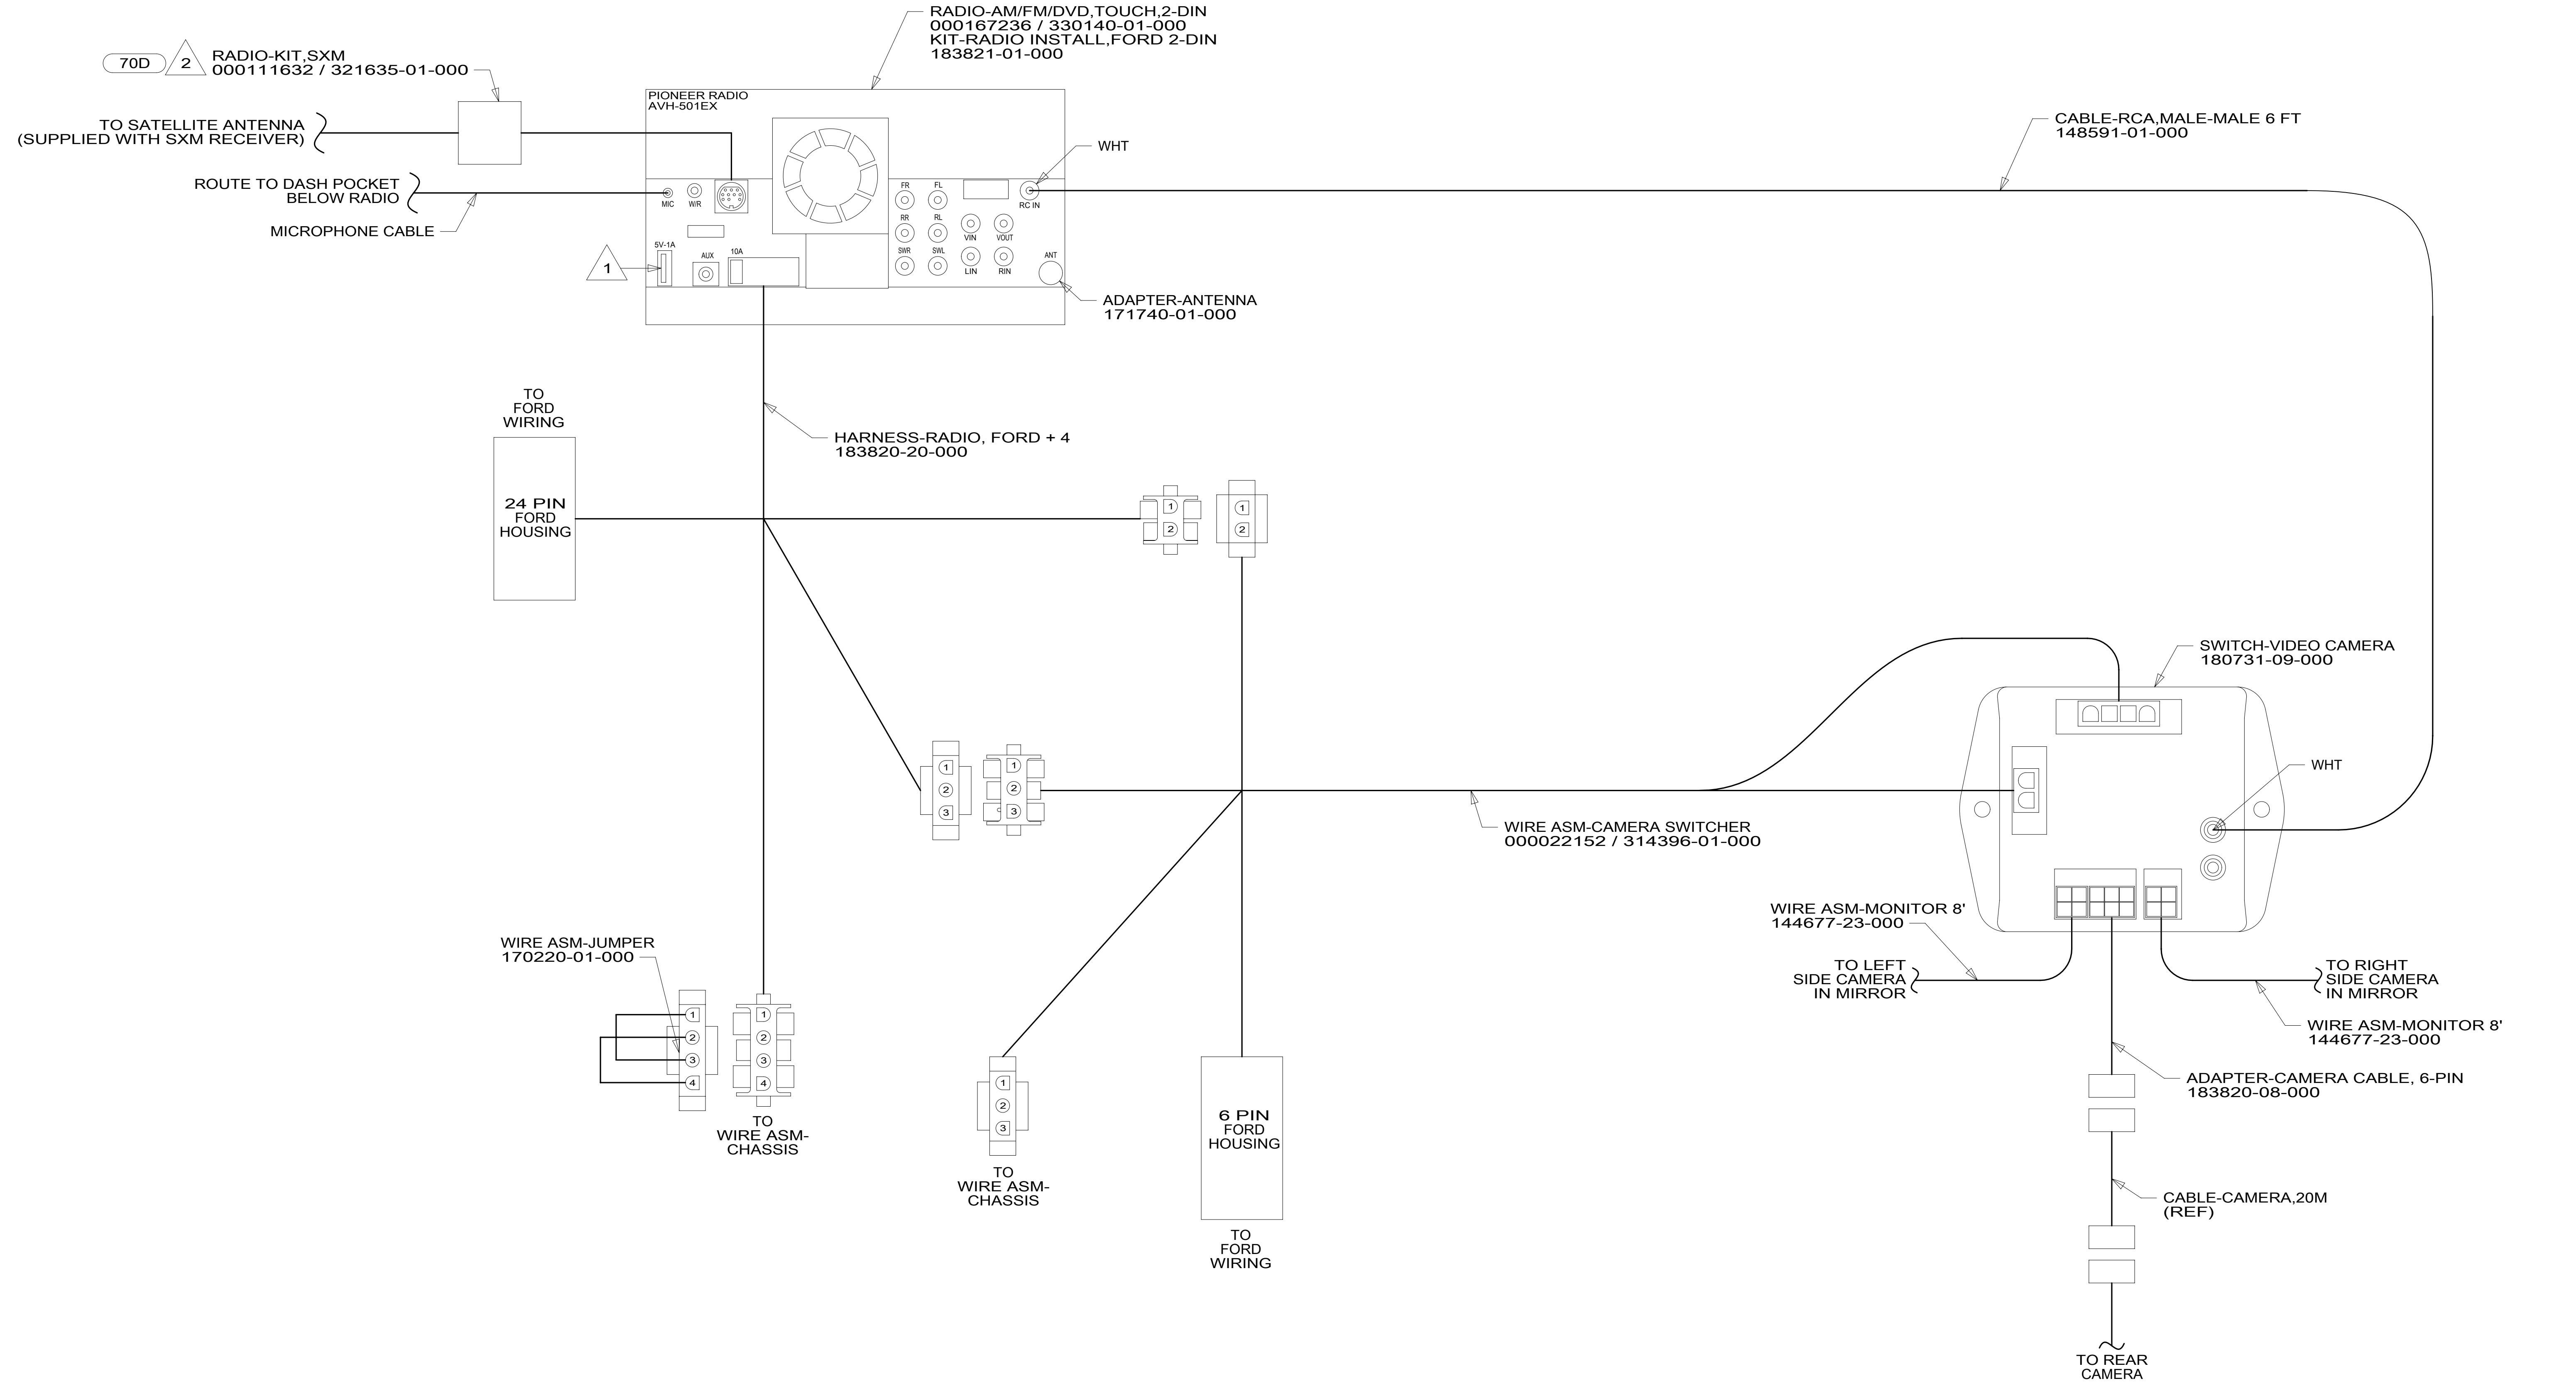
2 WIRE TIE TO RADIO WIRING.

1 PLUG USB CABLE SUPPLIED WITH RADIO INTO LEAD ON BACK OF RADIO MARKED 'USB'. ROUTE CABLE TO THE LEFT OF RADIO. WIRE TIE EXCESS CABLE UNDER DASH IN THE AREA LEFT OF THE RADIO. LEAVE 200 MM OF CABLE IN THE MOTOR COVER BEVERAGE TRAY. MAKE SURE CABLE DOES NOT GET PINCHED BY MOTOR COVER.

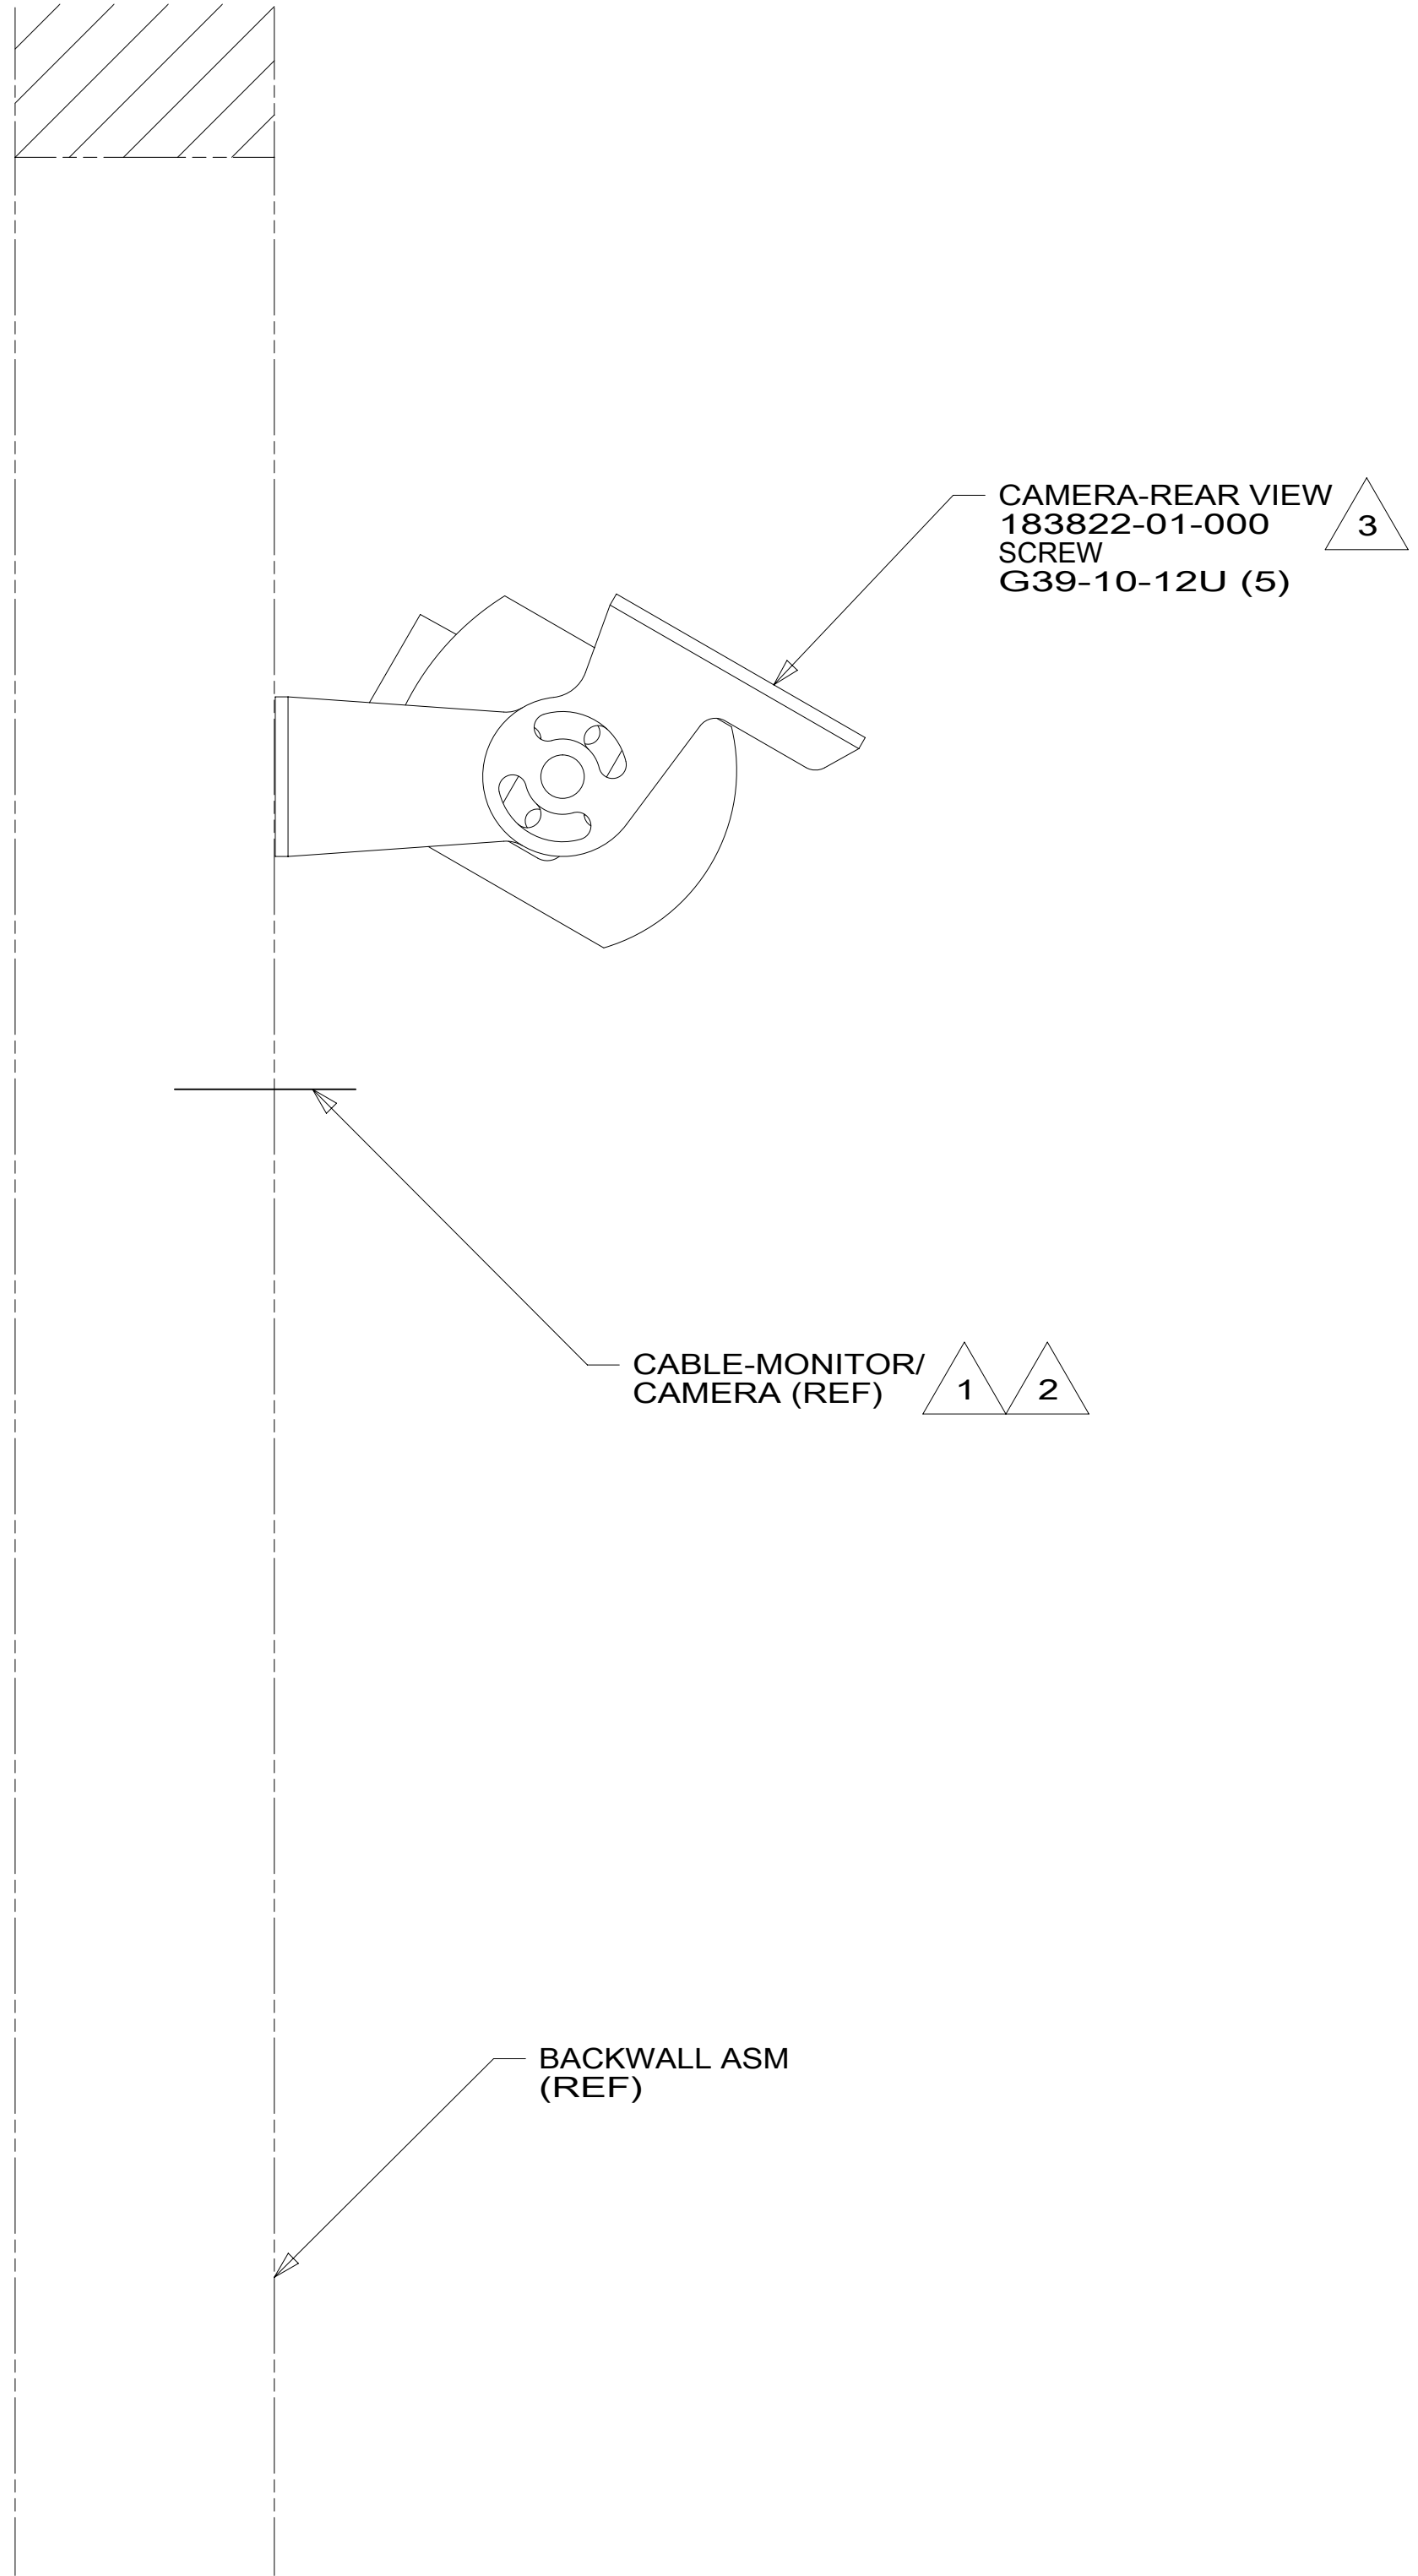
SECTION EA-EA

CAMERA-REAR VIEW
 183822-01-000
 SCREW
 G39-10-12U (5)

CABLE-MONITOR/
 CAMERA (REF)

BACKWALL ASM
 (REF)

- NOTES:
- ADJUST CAMERA AFTER MOUNTING SO BACKWALL IS JUST VISIBLE ON BOTTOM OF THE SCREEN.
 - REAR MONITOR CABLE IS PART OF THE WIRE ASM-CHASSIS. SEE WIRING INSTL-CHASSIS FOR ADDITIONAL INFORMATION.
 - CABLE ROUTED THRU BACKWALL.
